Fire Risk Assessment

Peartree Lane, Blocks 13-18 & 19-24

**Peartree Lane,
Cradley Heath, B64 6EH**

Date Completed: 16/03/2023

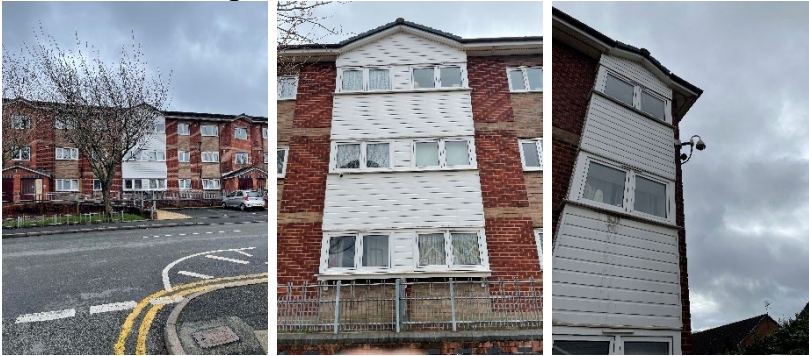
1. The exterior of the building is predominately brick clad with partial UPVC cladding.

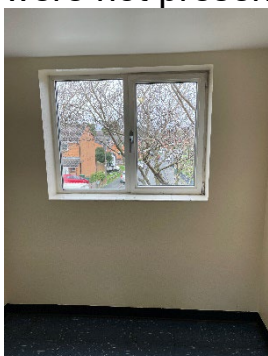
- 10) Communal windows are lockable however it was noted that keys were not present.

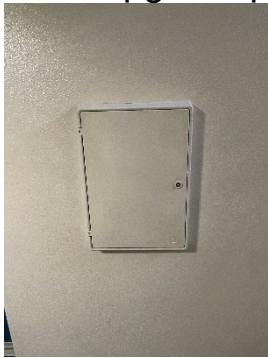
- 15) Individual flat electricity meters are located adjacent flat entrance doors on communal landings. The meters are within wall mounted GRP modular units fitted with budget locks. The fire rating of these units is unknown. The units have previously been recommended for upgrade or relocation to within resident's flats as part of a future works upgrade program.

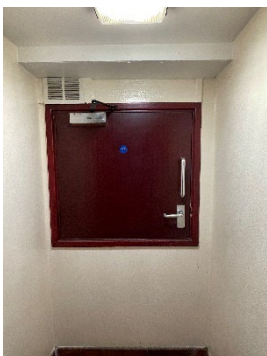
- 16) **Fire resisting hatch (block 13-18) does not fully close into frame.**

Question/ Ref No	Required Action	Supporting photograph	Priority	Timescale and Person Responsible	Date Completed
07/16	Adjust self -closer to ensure fire resisting hatch fully closes into frame. (Block 13-18)

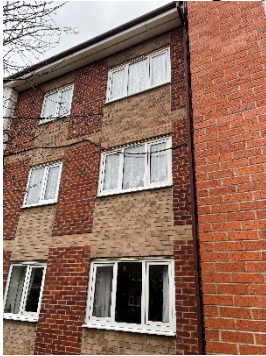
- 17) External cables (both blocks) are not adequately supported and are restricting operation of first floor windows.

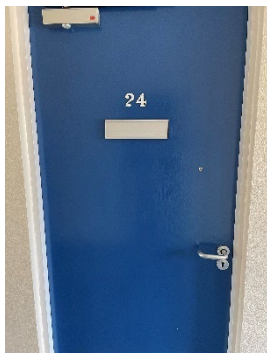
- a) Flat 24. Entrance door is not positively closing.**

07/20	Adjustment of self-closer to ensure entrance door to flat 24 fully closes into frame.

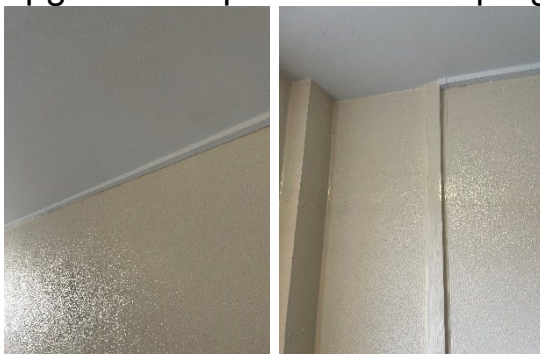
- 21) There is a small amount of plastic trunking within the communal landings. This was previously recommended on the last FRA to be upgraded as part of a future programme which is to be confirmed.

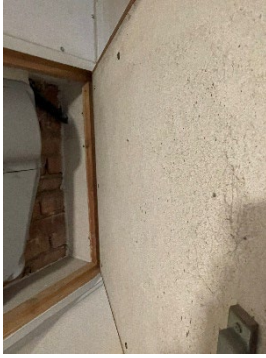
- 11) The service cupboard within the ground floor lobby wall has been lined with Supalux and is secured with a budget lock.

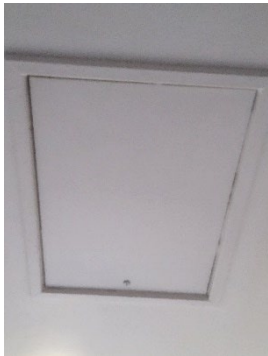
- 12) The loft hatches were secured and not assessable at the time of the FRA. The assessor will make arrangements to return to the blocks with additional resources and update this FRA accordingly.
