Fire Risk Assessment

1-6 Park Court

**Rowley Village, Rowley Regis,
B65 9ER**

Date Completed: 16-06-23

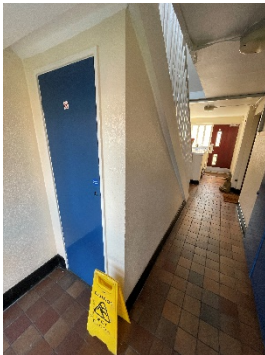
- 13) There is a cupboard under the stairs in the entrance lobby. Access was not possible during this FRA because the door was locked shut.

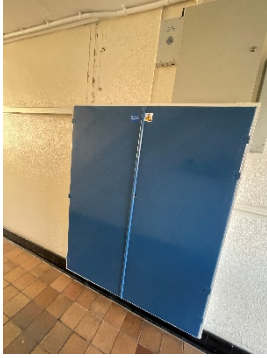
- 15) There is a service cupboard containing residents electricity meters within the ground floor entrance lobby. The doors are not fire rated but are secured by budget lock ([refer to section 10/4](#)).
-

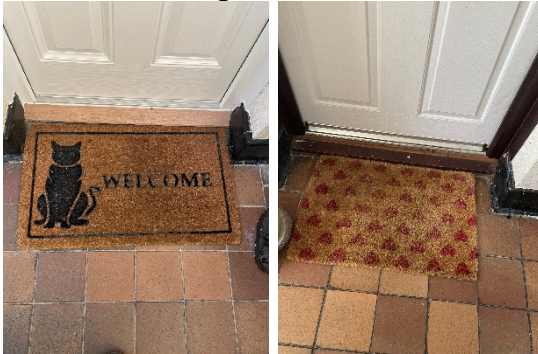
16) The fire rating of individual door mats is unknown.

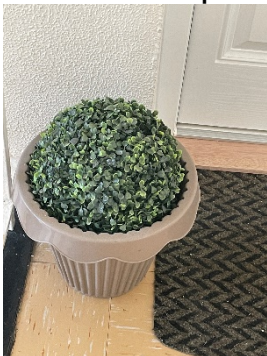
19) An artificial plant had been placed adjacent flat 5 entrance door on the 2nd floor landing. The occupier of flat 5 agreed to immediately remove the plant from the communal area.

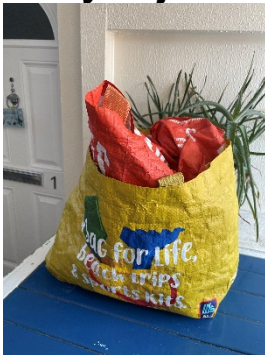
22) Plastic shopping bags have been left in the ground floor lobby adjacent flats 1 & 2.

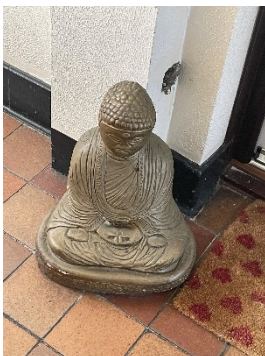
23) Garden ornament / statue placed on floor of the ground floor means of escape adjacent flat 2 and rear exit door. This has a potential to become a trip hazard to those escaping to the rear exit door.

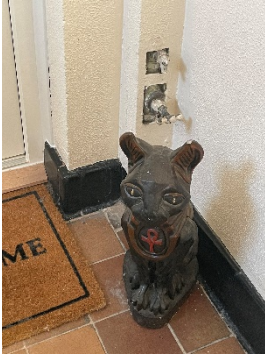
24) Garden ornament / statue placed on floor adjacent flat 1 and the foot of the stairs. This has the potential to become a trip hazard to those escaping from the upper floors.

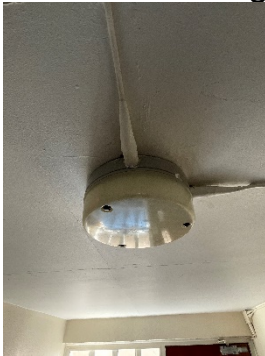
- 1) The premise doesn't have an emergency / escape lighting system. Although this premise is low risk, installation of an emergency / escape lighting system to the common escape routes should be considered as part of a future improvement plan to the block. Any new system should be in accordance with BS 5266.
- 2) Conventional lighting to the common areas is in place.

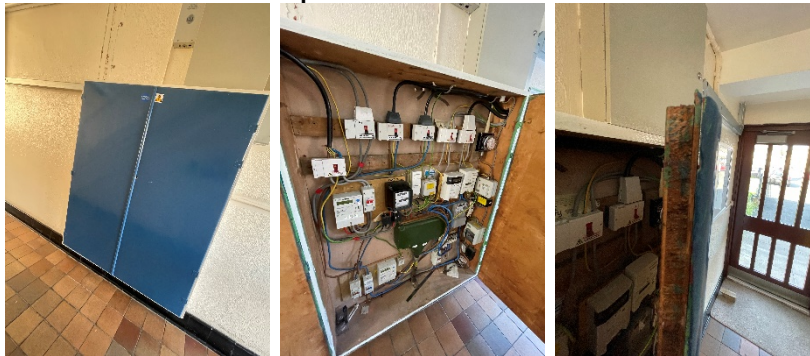
- 3) All communal fire doors are subject to an annual check by the Fire Safety Rapid Response Team.
 - 4) The G/F service cupboard housing the electrical intake & resident's electricity meters has non-fire rated doors. The doors appear to be original to the time of construction of the building and are lockable with a budget key. However, the doors are unlikely to provide adequate fire resistance because they are constructed of thin ply panels and do not close onto 25mm stops. A recommendation to form a new cabinet that would provide adequate fire resistance has been considered however, considering the proximity of the entrance door control box, cable trunking and the electrical components that have been fixed to the side walls of the existing carpentry, the recommended task could not be completed without substantial electrical works (re-wire). Considering the stay put-unless strategy and the level of

compartmentation to flats it is deemed that the existing service cupboard is tolerable until a future upgrade of the electrical installation is completed.

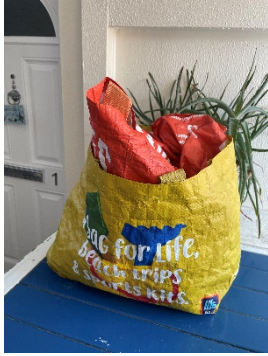
Question/ Ref No	Required Action	Supporting photograph	Priority	Timescale and Person Responsible	Date Completed
7/22	Plastic carrier bags to be removed from means of escape outside flats 1&2

P2	Within 1-3 months. Housing Manager.	04/07/2023

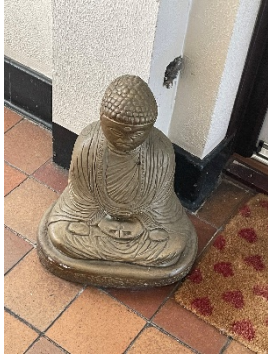
7/23	Garden ornament to be removed from means of escape near rear exit door adjacent flat 2.

P2	Within 1-3 months. Housing Manager.	04/07/2023
7/24	Garden ornament to be removed from means of escape / foot of stairs adjacent flat 1.
