### Fire Risk Assessment

# **3-6 Wheatley close**Oldbury B68 9HR

Date Completed: 8th July 2022

Officer: Carl Hill Fire Risk Assessor

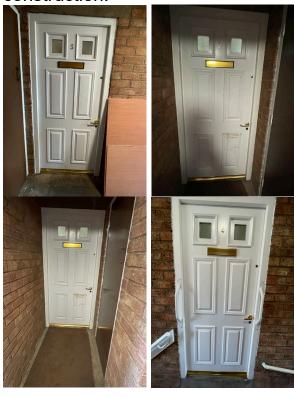
6) Individual flat doors are FD30s rated composite fire door construction.
