Fire Risk Assessment

1-6 Chandler House

**Shelsley Avenue, Oldbury,
B69 1BW**

Date Completed: 4th August 2022

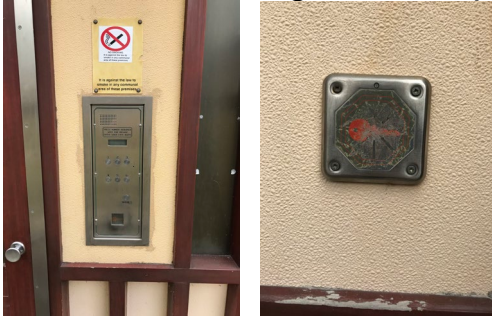
- 9) The final exit doors have door entry systems installed. These systems are designed to fail safe i.e. door unlocked in the event of a power failure. This prevents residents being locked in or out of the building. (image on next page)

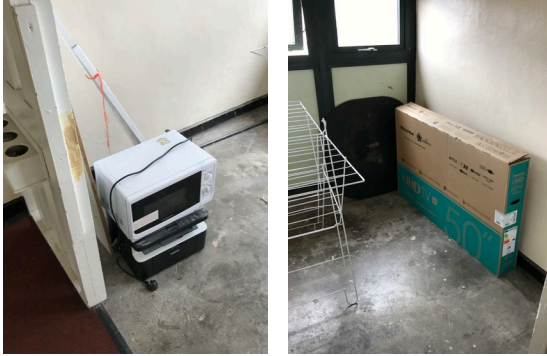
- 21) The first and second floor landing areas have communal 'drying rooms' separated from the communal landing by timber beams. The second floor 'drying room' contains electronics and other discarded items to be removed.

Question/ Ref No	Required Action	Supporting photograph	Risk Rating	Timescale and Person Responsible	Date Completed
07/21	The second floor 'drying room' contains electronics and other discarded items, arrange for tenants belongings to be removed.

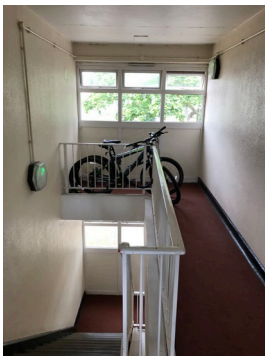
- 22) Two Bikes are held on the 2nd floor communal landing and should be removed to keep the area sterile.

07/22	Two bikes are being held on the communal landing, arrange with tenants to remove these items

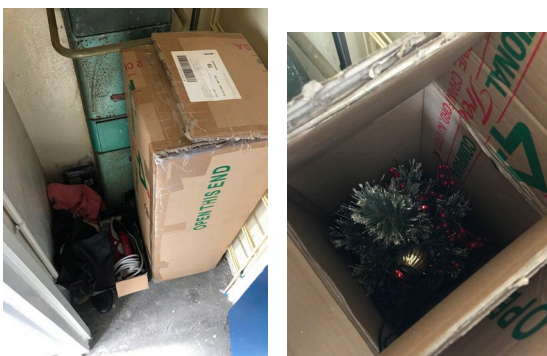
- 23) Combustible items stored in Void incinerator cupboard in the 1st floor 'drying room'. This door can also not be locked.

3	August 2022 Housing manager	08/11/2022
07/23	Arrange with tenants to remove combustible items from old incinerator cupboard

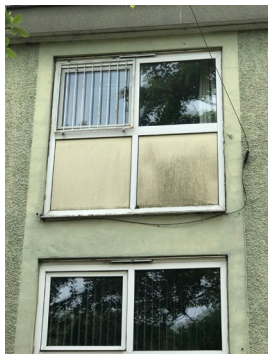
- 24) Metal bars fitted to the outside of 2nd floor front window of flat 5 this was also noted on the previous risk assessment.

07/24	Metal bars fitted to the outside of 2 nd floor front window of flat 5. This is not identified as a fire hazard however it is a recommendation these bars are removed	 	N/A	September 2022 Housing manager	08/11/2022

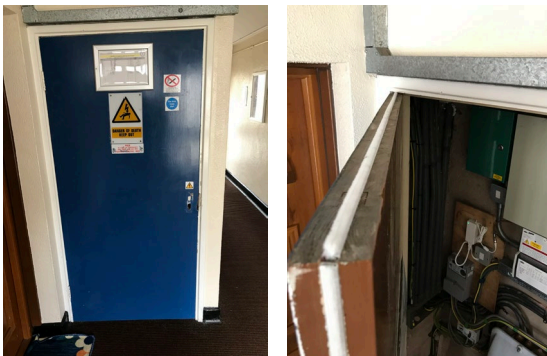
- 5) The electrical installation i.e. risers are contained within a dedicated service cupboard that is secure and protected by means of a FD30s door.
