# Fire Risk Assessment

## 7 - 12 Cleton Street

**Cleton St, Tipton,  
DY4 7TR**

**Date Completed: 16/11/22**

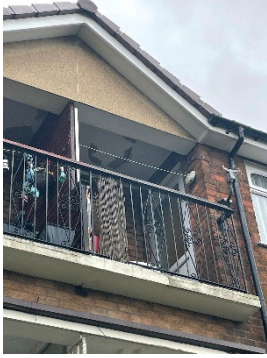
The addition of wicker screening to one balcony and a timber feather edge panel to another, could potentially support the surface spread of flame in that area which is an unnecessary risk. Once this is removed the level of risk presented by materials present to the external envelope of this building would become acceptable.

- 5) Flat 12 has installed wicker screening to the balcony.
-

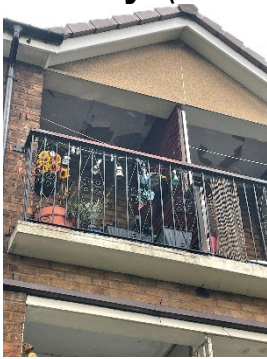
- 6) Flat 11 has installed a timber feather edge panel to the balcony. *(Removed 17/01/23)*

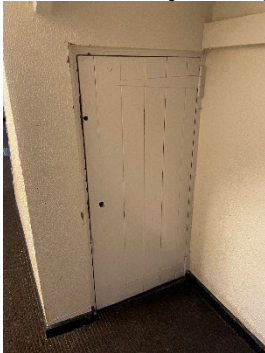
- 10) The electrical service cupboard is located on the ground floor beneath the stairs and contains resident's meters. The door is secured by budget lock and is none fire rated.

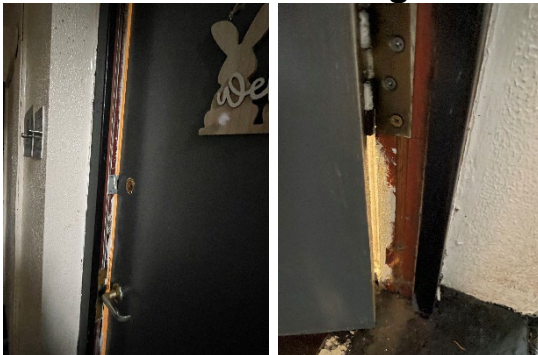
15) Access is gained to a sample of properties as part of the fire risk assessment to ensure the doors have not been tampered with by residents etc.

At the time of the visit access could only be gained to flats 7 & 9.

There was no sign of tampering to flat 7 entrance door.

Flat 9 door had no evidence of tampering to the door; **however, the door did fail to fully self-close into frame and there is a section of intumescent / cold smoke seal missing from beneath the lower hinge.**

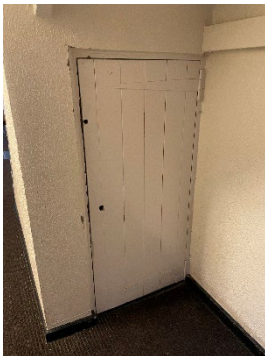
- 2) The premise does not have sufficient compartmentation to limit the travel and effect of smoke and flame in event of a fire in communal areas due to the open plan staircase.
- 3) There are no communal doors fitted with automatic closing devices other than the final exit doors. These are checked on a regular basis by Caretaking Teams as part of their checks. Defective closing devices are replaced either by the Caretaking Team(s) or the in-house repairs team(s).
- 4) **The service cupboard door to the ground floor contains resident's meters, is not fire rated but is secured by budget lock.**

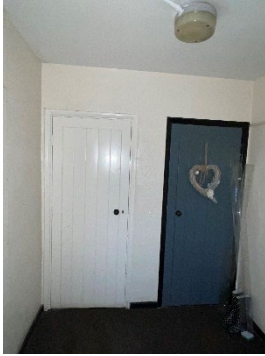
7) Resident storage cupboards to the 1<sup>st</sup> & 2<sup>nd</sup> floors have none fire rated doors.

*(Email received from contracts manager for housing informing upgrade works scheduled 2027/28)*

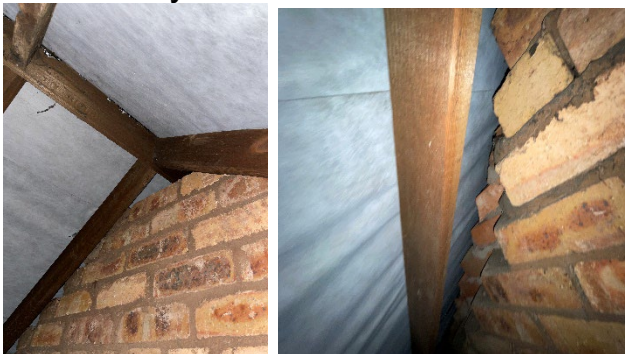
- 9) Inspection of the common roof space above the communal landing revealed limited evidence of firestopping by means of glass fibre insulation to the roof line above the party walls, which has been installed from the side above the flats. **However, there are areas which suggest there may be gaps and therefore would benefit from additional firestopping around the apex penetrations and the eaves.****

Due to the presence of water tanks it was not possible to access the entirety of this area.

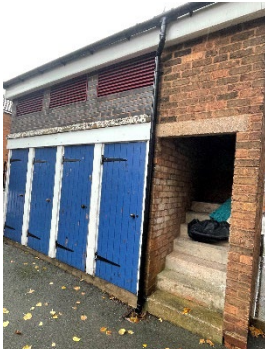
5) Rubbish has been discarded on the steps to the bin chute.
