Fire Risk Assessment

Martley Road 36-46,48-58

Martley Road, Oldbury, B69 1DZ

Date Completed: 15/08/2022

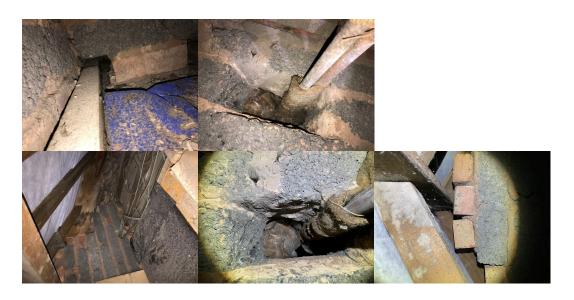
6) Access was gained to common loft space in block 48-58. Compartmentation in the loft space is inadequate as there are penetrations that have not been sealed and gaps between the wall and roof. At the time of the visit it was not possible Access block 36-46 loft space.

09/1	Install emergency lighting in both blocks.	N/A	2	Future upgrade plan	N/a
10/06	Fire stopping required within the common loft space of both blocks.		3	September 2022 Fire rapid response team JM9574574 – asb check JM9574525	07/10/2022

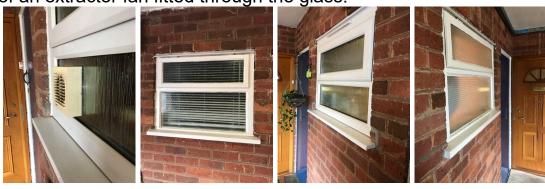
7) Flats 50, 56, 36 and 42 all have bathroom windows onto the communal landing with obscured glazed units fitted that are a mixture of UPVC and timber construction. Flat 50 has the addition of an extractor fan fitted through the glass.
