Fire Risk Assessment

Applewood Grove Blocks 1-6 & 7-12

Cradley Heath, B64 6EW

Date Completed: 28/03/23

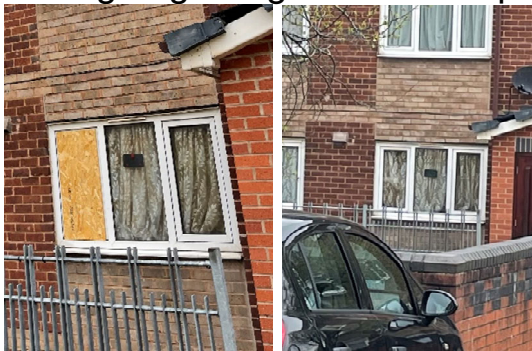
5. The glazing to the ground floor window of flat 7 was broken at the time of the visit. It was noted during a return visit (17/4/23) the damaged glazing had been replaced.

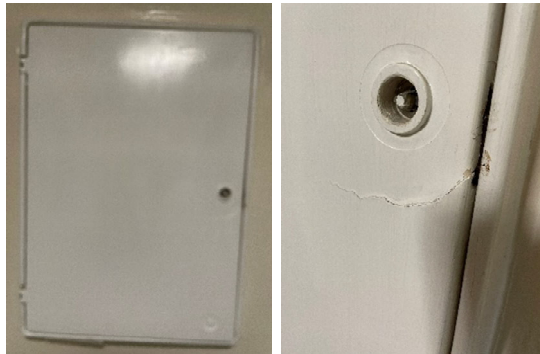
- a) Flat 1 meter cupboard door is cracked. Replacement fire resistant over box unit required which will ensure sufficient compartmentation is maintained to the communal area. *Resolved 15/05/23*

Question/ Ref No	Required Action	Supporting photograph	Priority	Timescale and Person Responsible	Date Completed
07/15a	Flat 1 meter cupboard door is cracked & requires fire resistant over box unit.

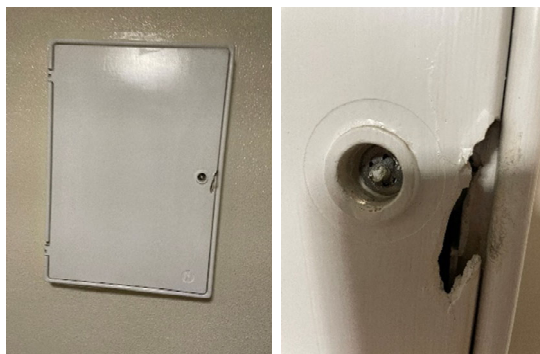
- b) Flat 2 meter cupboard door has a hole in. Replacement fire resistant over box unit required which will ensure sufficient compartmentation is maintained to the communal area. *Resolved 15/05/23*

07/15b	Flat 2 meter cupboard door is damaged & requires fire resistant over box unit.

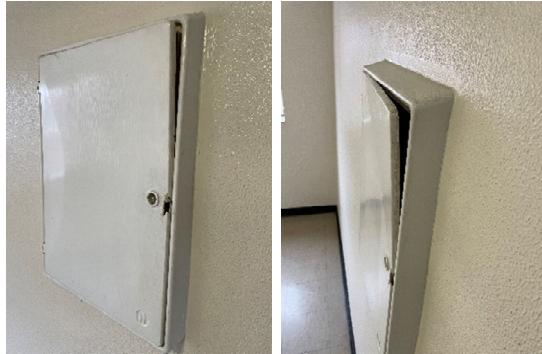
- c) Flat 3 meter cupboard door is damaged and bowed. Replacement fire resistant over box is required which will ensure sufficient compartmentation is maintained between to the communal area. *Resolved 15/05/23*

P2	Within 1-3 months Electrical	15/05/2023
07/15c	Flat 3 meter cupboard door is bowed & requires fire resistant over box unit.

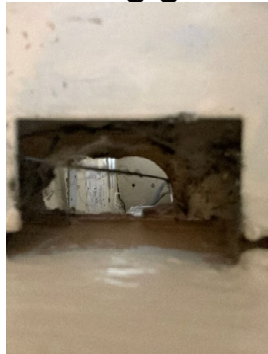
- d) Flat 7 meter cupboard would benefit from enhanced firestop to bottom panel where a hole is formed due to missing grommet / panel.

P2	Within 1-3 months Electrical	15/05/2023
07/15d	Flat 7 meter cupboard – fire stop hole within bottom panel.

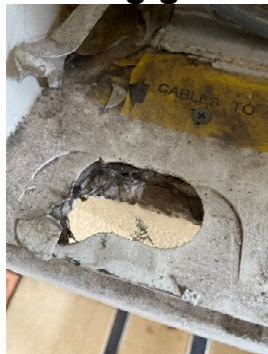
- e) Flat 9 meter cupboard would benefit from enhanced firestop to bottom panel where a hole is formed due to missing grommet / panel.

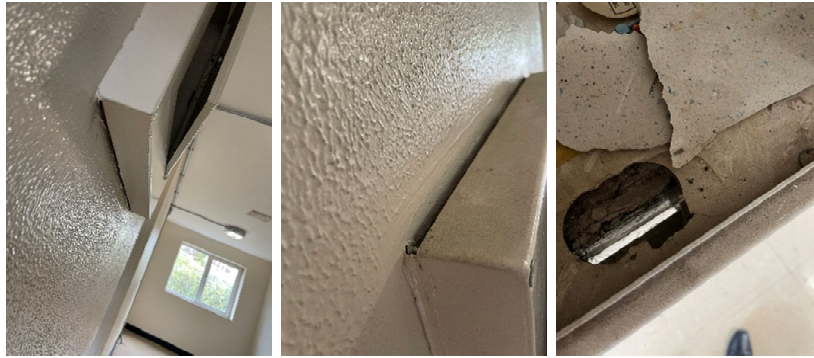
- f) Flat 10 meter cupboard would benefit from enhanced fire stopping by means of applying an intumescent mastic around the top and bottom of the unit to cover gaps.
-

P2	Within 1-3 months Rapid Fire Team JM:11413559	27/07/2023
07/15f	Flat 10 meter cupboard – fire stop around top and bottom external edge with intumescent mastic to cover gaps.

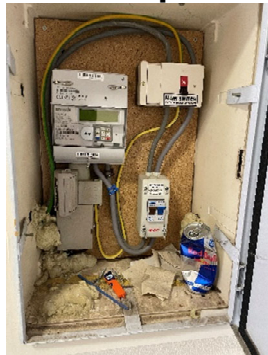
- g) Flat 11 meter cupboard – general expanding foam has been used and should be removed and replaced with a suitable product for fire stopping.**

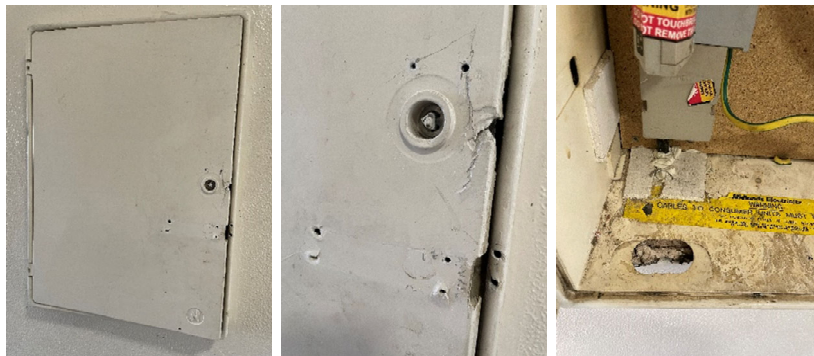
- h) Flat 12 meter cupboard door is damaged and has holes within. Replacement fire resistant over box unit is required to ensure sufficient compartmentation to the communal area is maintained. Resolved 15/05/23**

<p>P2</p>	<p>Within 1-3 months Rapid Fire Team JM:11413719</p>	<p>27/07/2023</p>
<p>07/15h</p>	<p>Flat 12 meter cupboard door is damaged & requires fire resistant over box unit.</p>

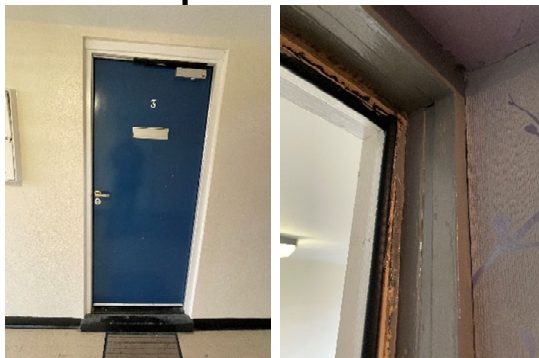
- a) **Flat 3 has a worn cold smoke seal that requires replacement. It was also noted that the intumescent strip had been painted over.**

<p>P2</p>	<p>Within 1-3 months Electrical</p>	<p>15/05/2023</p>
<p>07/18a</p>	<p>Flat 3 – replace worn cold smoke seal to entrance door.</p>

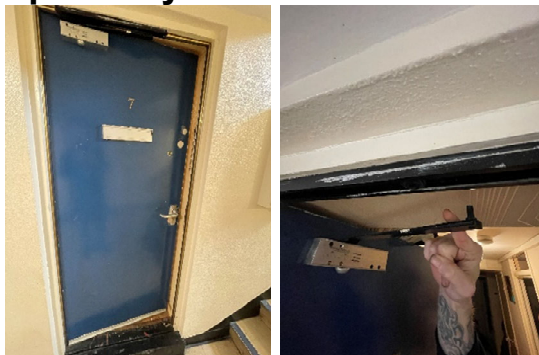
- b) **Flat 7 – the cold smoke seal was worn and brittle in places along the leading edge. The door did not reliably self close fully into frame because of binding against the flooring. It was also noted that the external self-closer would become detached from its rail if the door was open fully.**

07/18b	<p>Flat 7 – Replace worn cold smoke seal / adjust door to prevent binding on floor & ensure correctly self closes.</p> <p>Repair self-closer to prevent detachment from the guide rail.</p>

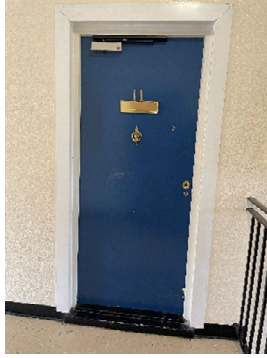
- c) **Flat 11 – access was not gained to this property however it was noted that the exterior handle to the flat entrance door was missing.**

P2	<p>Within 1-3 months Rapid Fire Response JM:11976517</p>	04/10/2023
07/18c	<p>Flat 11 – replace missing door handle to entrance door. <i>(access not gained during FRA)</i></p>

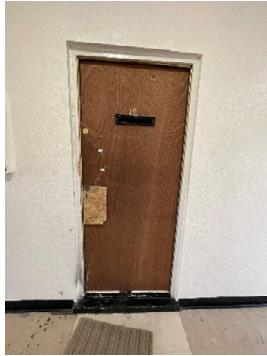
- d) Flat 12 – access was not gained to this property however it was noted that there is damage to the external side of the door which has subsequently been temporary repaired. A replacement door had already been requested prior to the FRA – Job number 10351586. *Confirmation received 11/05/23 that a replacement fire rated door has been fitted.*

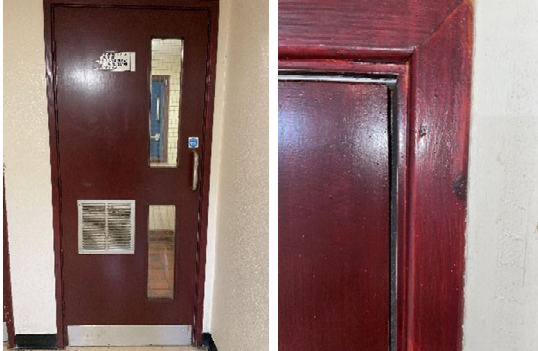
- 22) In block 7-12 the communal door separating the bin room and lobby has an excessive gap to the leading edge.

<p>P2</p>	<p>Within 1-3 months Rapid Fire Response JM:11414199</p>	<p>27/07/2023</p>
<p>07/22</p>	<p>Block 7-12 communal door to the bin room / lobby requires adjustment to correct excessive gap to handle side.</p>

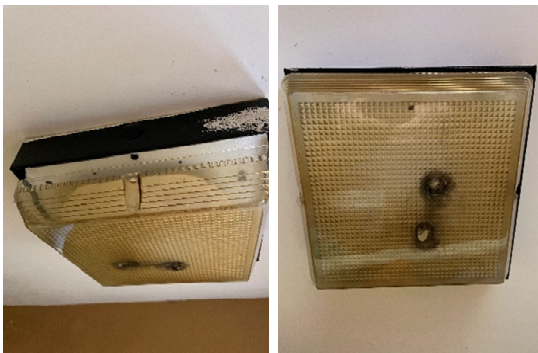
- 23) In block 7-12 cleaner's cupboard the ceiling light lens is not secured and there are what appear to be historic signs of burning which may require further investigation. *Resolved 15/05/23*

<p>P2</p>	<p>Within 1-3 months Rapid Fire Response JM:11414367</p>	<p>27/07/2023</p>
<p>07/23</p>	<p>In block 7-12 cleaners cupboard the ceiling light lens requires securing. Also investigate historic burns to lens</p>
