Fire Risk Assessment

Macauley House

**Glover Street,
West Bromwich, B70 6DY**

Date Completed: 12th December 2024

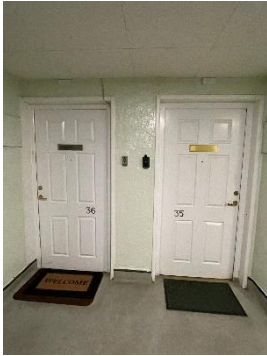
- 14) Individual floor mats were noted outside some flats. Fire rating of the mats is unknown but deemed to be of low risk.

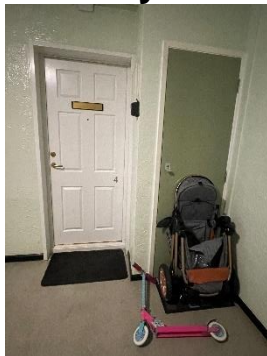
- 18) Pushchair and child's scooter stored outside flat 4 within the lift lobby.**

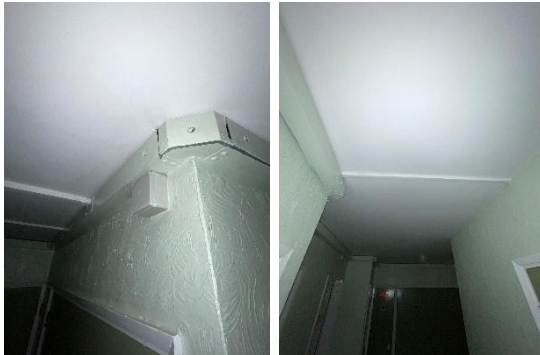
- 18) Cabling is generally housed in metal trunking however, small amounts of plastic trunking noted in the building's stairwell and corridors near lift motor room,

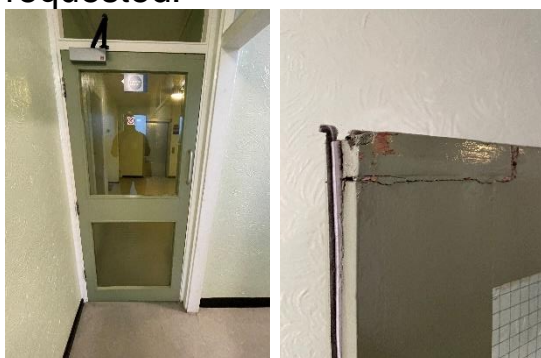
22) 6th floor – Landing door leaf previously damaged and repaired. The repaired section has failed and should be redone as a temporary measure. Replacement door will be requested.

P2	Within 1-3 months Fire Rapid Team	
10/22	6 th floor – previous damage/repair to landing door leaf needs repair

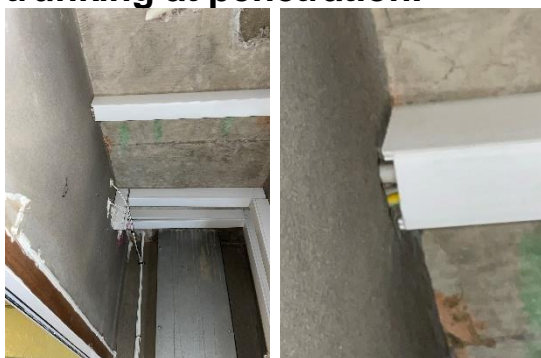
23) 6th floor service cupboard – Fire stop cables in plastic trunking at penetration.

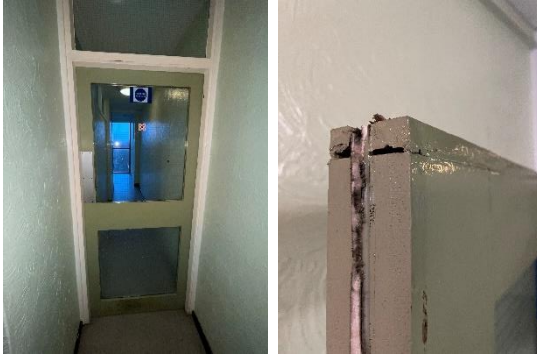
24) 5th floor – Landing door leaf previously damaged and repaired. The repaired section has failed and should be redone as a temporary measure. Replacement door will be requested.

P2	Within 1-3 months Fire Rapid Team	
10/24	5 th floor - previous damage/repair to landing door leaf needs repair

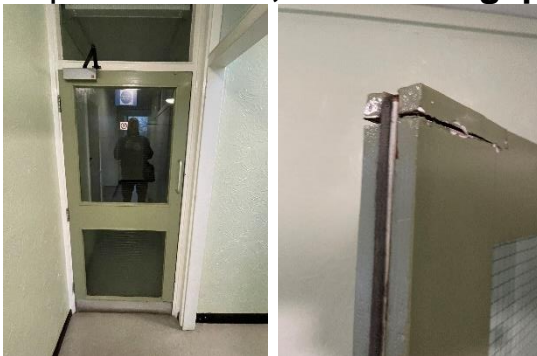
- 25) 3rd floor – Landing door leaf previously damaged and repaired. The repaired section has failed and should be redone as a temporary measure. Replacement door will be requested. Also, excessive gap on handle side to be reduced.**

P2	Within 1-3 months Fire Rapid Team	
10/25	3 rd floor - previous damage/repair to landing door leaf needs repair. Also, excessive gap handle side to be reduced

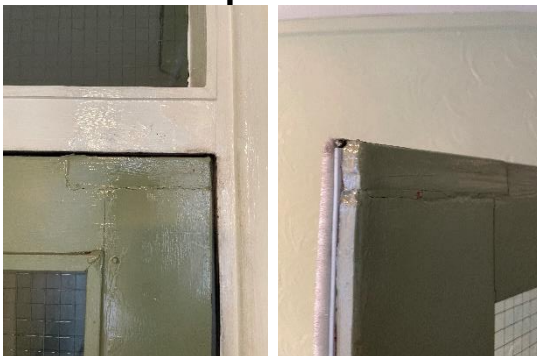
- 26) 8th floor – Notional landing door leaf previously damaged and repaired. Repairs are prone to failure therefore the door should be replaced with an FD30s self-closing fire door.**

10/26	8 th floor landing door which is damaged / previously repaired to be replaced with FD30s. <i>Approximate door leaf size 870 x 1975mm.</i>

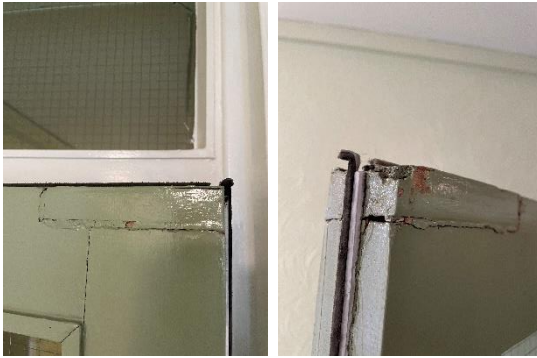
- 27) 6th floor - Notional landing door leaf previously damaged and repaired. Repairs are prone to failure therefore the door should be replaced with an FD30s self-closing fire door.**
-

P4	P4 Programmed Work Repairs	
10/27	6 th floor landing door which is damaged / previously repaired to be replaced with FD30s. <i>Approximate door leaf size 870 x 1975mm.</i>

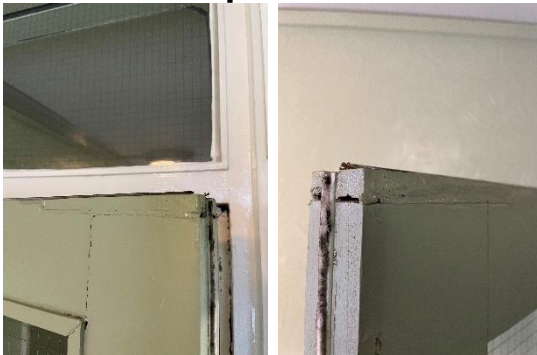
28) 5th floor - Notional landing door leaf previously damaged and repaired. Repairs are prone to failure therefore the door should be replaced with an FD30s self-closing fire door.

P4	P4 Programmed Work Repairs	
10/28	5 th floor landing door which is damaged / previously repaired to be replaced with FD30s. <i>Approximate door leaf size 870 x 1975mm.</i>

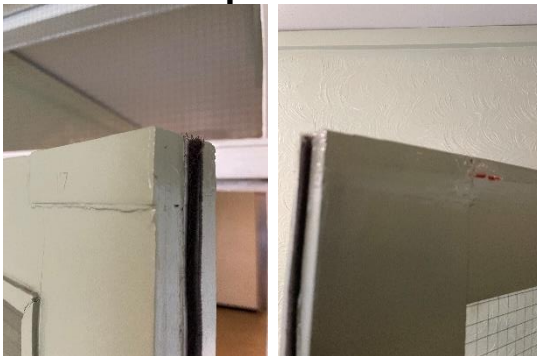
29) 4th floor – Notional landing door leaf previously damaged and repaired. Repairs are prone to failure therefore the door should be replaced with an FD30s self-closing fire door.

10/29	4 th floor landing door which is damaged / previously repaired to be replaced with FD30s. <i>Approximate door leaf size 870 x 1975mm.</i>

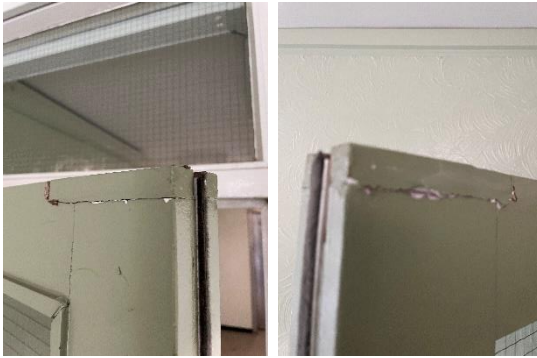
30) 3rd floor - Notional landing door leaf previously damaged and repaired. Repairs are prone to failure therefore the door should be replaced with an FD30s self-closing fire door.

P4	P4 Programmed Work Repairs	
10/30	3 rd floor landing door which is damaged / previously repaired to be replaced with FD30s. <i>Approximate door leaf size 870 x 1975mm.</i>

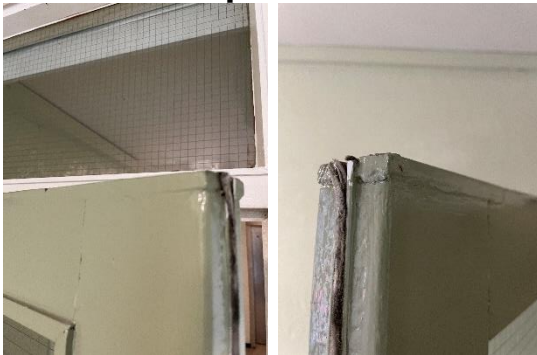
31) 2nd floor - Notional landing door leaf previously damaged and repaired. Repairs are prone to failure therefore the door should be replaced with an FD30s self-closing fire door.

P4	P4 Programmed Work Repairs	
10/31	2 nd floor landing door which is damaged / previously repaired to be replaced with FD30s. <i>Approximate door leaf size 870 x 1975mm.</i>

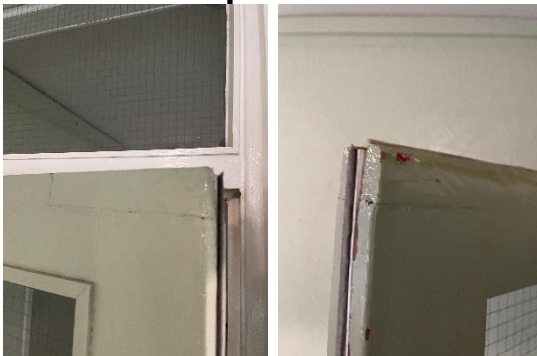
32) 1st floor - Notional landing door leaf previously damaged and repaired. Repairs are prone to failure therefore the door should be replaced with an FD30s self-closing fire door.

10/32	<p>1st floor landing door which is damaged / previously repaired to be replaced with FD30s. <i>Approximate door leaf size 870 x 1975mm.</i></p>	 	P4	P4 Programmed Work Repairs	
-------	--	--	----	----------------------------	--
