Fire Risk Assessment

Holly Court

**Acacia Avenue, Yew Tree Estate,
WS5 4BN**

Date Completed: 22/02/2024.

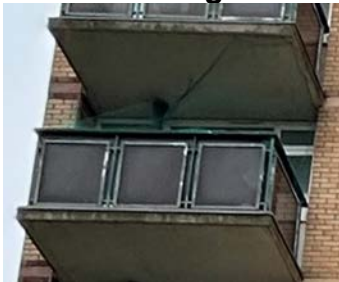
- 7) **Flat 32 Netting located on the 5th floor balcony**

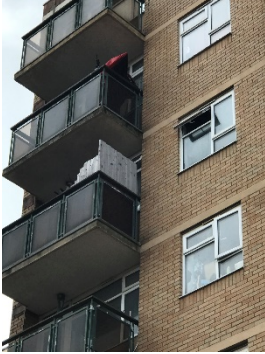
- 8) **Flat 30 Timber construction built on the 5th floor balcony**

06/08	Flat 30 remove timber construction from balcony	 	P3	3-6 months Housing Manager	
06/09	Flat 23 Remove netting from balcony	 	P3	3-6 months Housing Manager	
07/27	6 th floor communal door nearest flat 36 replace missing piece of intumescent strip from upper hinge side of door	 	P2	1-3 months Fire Rapid Response

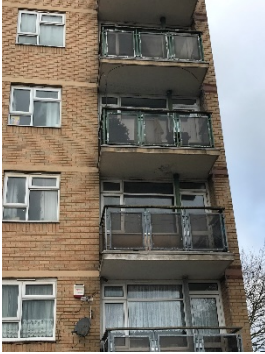
- 9) **Flat 23 netting present on the 3rd floor balcony**

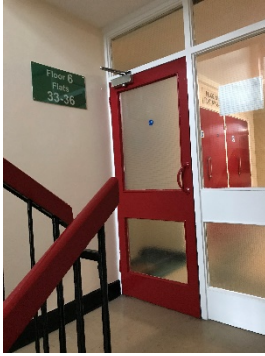
- 26) Wayfinding signage has been introduced on all floors within the block including lift lobby and each stair landing area. It was noted that during the FRA there was painting taking place at the block and some signage had been removed during the process
-

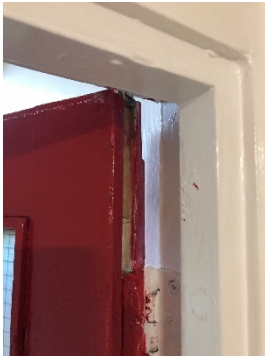
- 27) 6th floor communal door nearest flat 36 missing combined intumescent strip and cold smoke seal from top hinge side of door noted that communal doors utilise batwings, replace with combined intumescent strip & cold smoke seal or intumescent strip and batwing

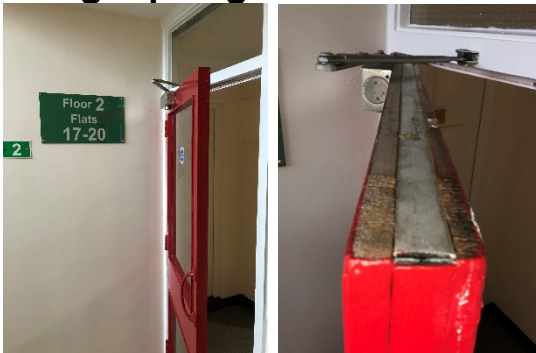
- 28) 2nd floor communal door nearest flat 18 does not self close correctly into frame and is also missing intumescent strip along top edge of door

07/28	2 nd floor communal door nearest flat 18 make suitable adjustments so door self closes correctly in frame and replace missing intumescent strip from top of door	 	P2	1-3 months Fire Rapid Response	
-------	---	--	----	-----------------------------------	--

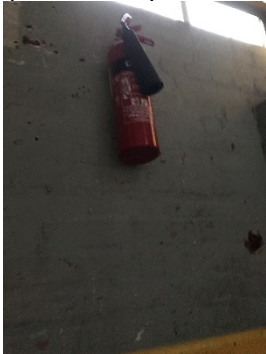
- 1) The dry riser inlet cupboard is located in the ground floor lift lobby and is appropriately signed. Access is granted utilising a triangular budget key **ground floor riser inlet cupboard missing appropriate signage**
- 2) The riser outlets are available on each floor lobby (1st – 7th) also secured within cupboards by Budget Locks.
- 3) The dry riser is checked regularly as part of the Caretakers duties.
- 4) Maintenance contracts in place to service the valves twice per year (April and October) with a hydraulic test undertaken annually (October) to comply with the requirements of BS9990.
- 5) Portable fire extinguisher (CO2) is provided to the lift motor room. Maintenance contracts in place for maintenance of the extinguisher. The frequency for the maintenance checks are once (October) of each calendar year.

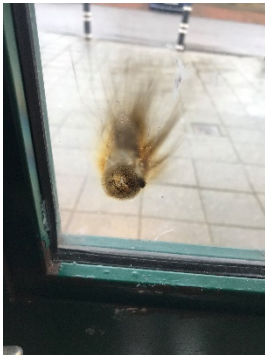
- 3) There are no provisions for CCTV within the block.
- 4) Noted that some small scorch marks were present on the entrance door to the block other than this there is no current evidence of arson within the block.
