Fire Risk Assessment

Darley House Wallace Close, Oldbury, B69 1HS

Date Completed: 15th July 2021

Current Risk Rating 3 = Medium

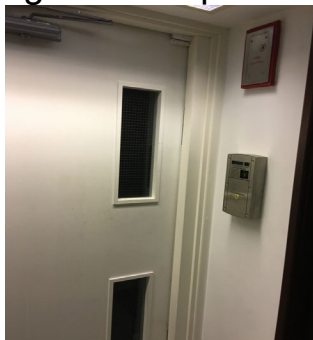
The ground floor has a former CCTV room that is now utilised by the Caretaking / Cleaning team as their office. This room contains the CCTV server room. Access is controlled to the CCTV server room is via a fire-fighter's drop latch override switch. (see photo)

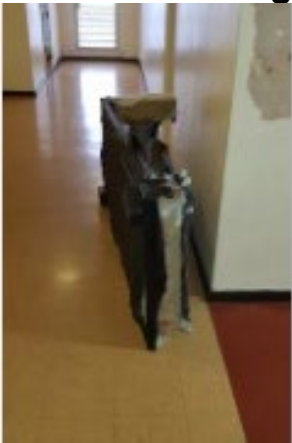
16) The remains of a two-seater settee had been left in the lift lobby of the 10th floor. This was reported immediately to the caretaker manager for removal.

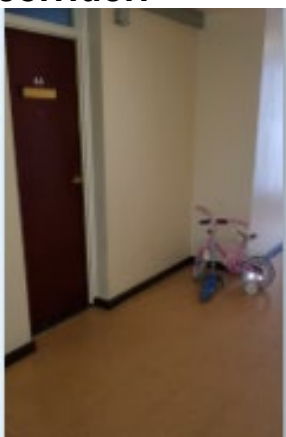
17) Flat 44 on 7th floor has left a child's bicycle and scooter in the corridor.

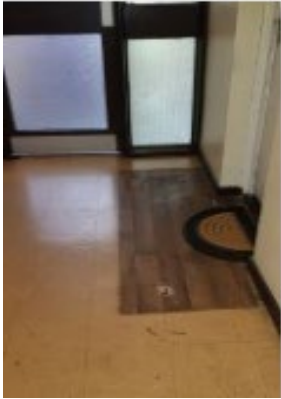
- 18) There is a trip hazard outside flat 61 in the form of a section of additional laminate floor. This presents a hazard as it is not obviously a raised section of floor which projects into the corridor close to the door. The mat *is* acceptable as it is more obviously above the floor and is confined to the area of the front door.

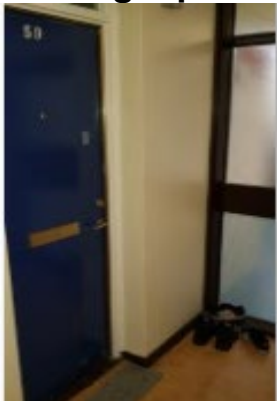
- 19) Flat 59 on 9th floor has footwear left outside in the corridor causing a potential trip hazard by the stair fire door.

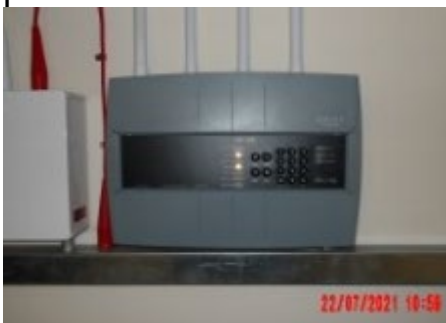
- 4) There is a fire alarm panel located within the CCTV server room adjacent to the Caretakers office on the ground floor which only protects the server room and the caretaker's office.

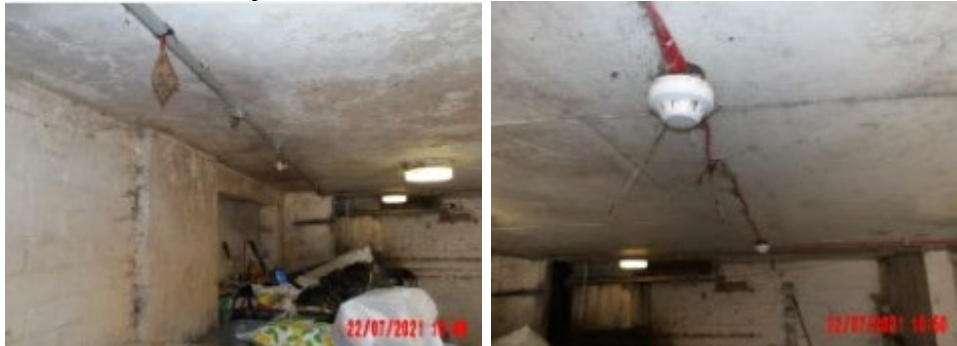
- 5) A water drenching system is provided to the refuse chute bin store. An approved contractor maintains the system. The frequency for the maintenance checks are twice per year (April and October) of each calendar year

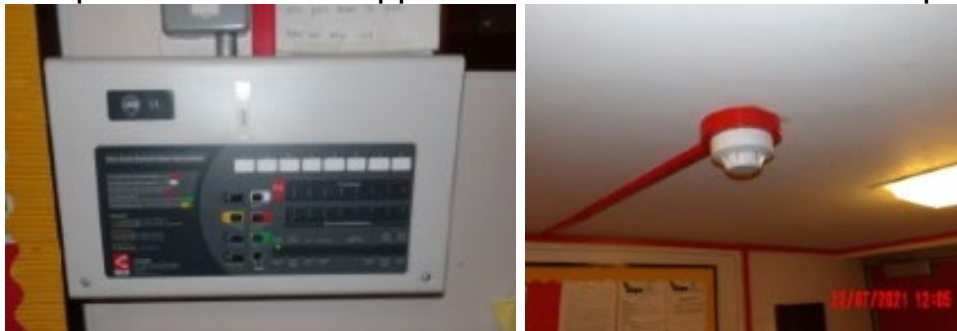
- 6) There is a detection system in the Warley playcentre which is separate from the rest of the building by structural compartmentation. It appears to be L4 with manual call points.

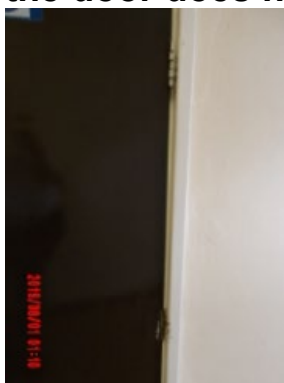
- 8) The fire door to the 17th floor bin chute room has a missing centre hinge and the pin is coming out of the top hinge. Also the door does not close into the rebate.

07/08	Replace top and centre hinge to the fire door to the 17 th floor bin chute room and rehang door (not closing into the rebate)

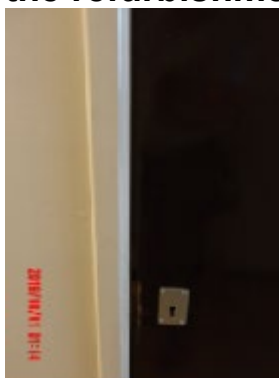
- 10) The service cupboard door on 17th floor opposite flat 103 has an excessive gap on the lock edge. This cupboard is not a shaft and holds minimal wiring. This can therefore wait until the refurbishment.

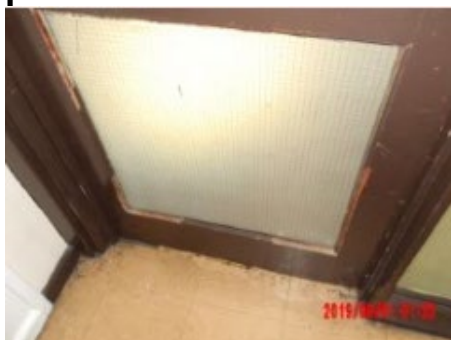
- 11) The fire door on 16th floor by flat 97 requires reglazing to provide a seal and secure the glass.

07/11	The fire door on 16 th floor by flat 97 requires reglazing using intumescent glazing tape to provide a seal and secure the glass.

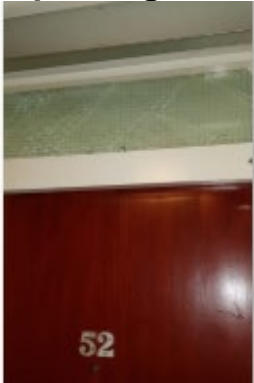
- 20) Flat 52 on 8th floor has a broken transom window and requires replacing.

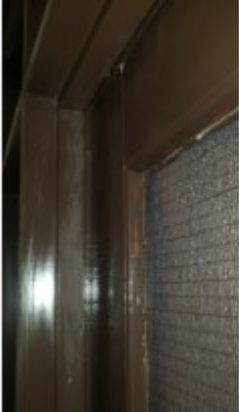
- 26) The fire door on 3rd floor by flat 24 is excessively warped. It may be possible to recut the rebate to accommodate the warped door as a temporary measure as the door will be replaced shortly as part of the planned major refurbishment works

07/26	The fire door on 3 rd floor by flat 24 is excessively warped It may be possible to recut the rebate to accommodate the warped door as a temporary measure as the door will be replaced shortly as part of the planned major refurbishment works.

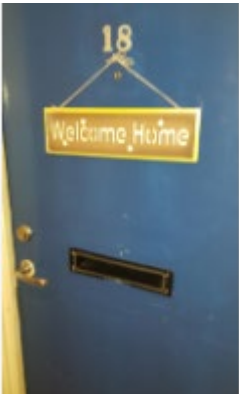
- 30) Flat 18 on the 2nd floor is missing its letterplate.

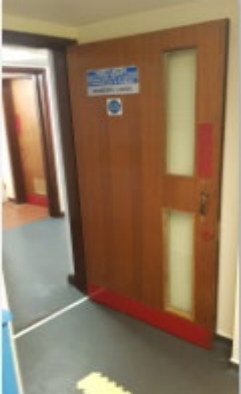
33) The door to the resident's lounge is not closing.

07/33	Fit new door closer to door to the resident's lounge

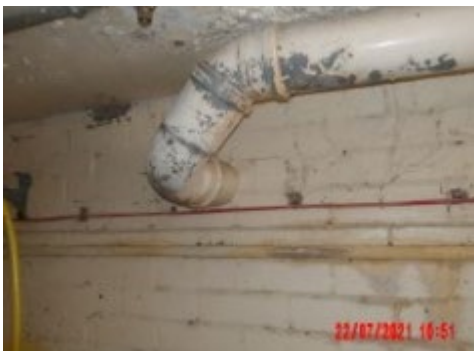
35) There is a 110mm pvc waste pipe in the bin room that requires an intumescent collar.

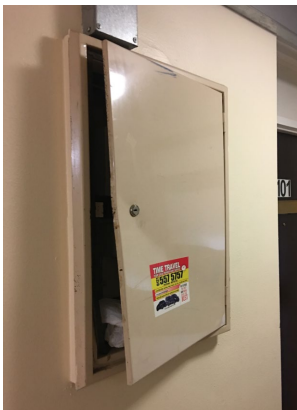
- 5) **The tenant’s own electricity meters are located on the landing area. A number of the meter boxes were found to be damaged. These will be replaced in the forthcoming refurbishment.**

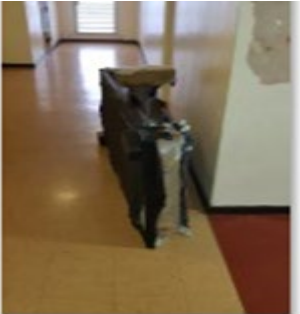
04/16	The remains of a two-seater settee had been left in the lift lobby of the 10 th floor. This was reported immediately to the caretaker manager for removal.

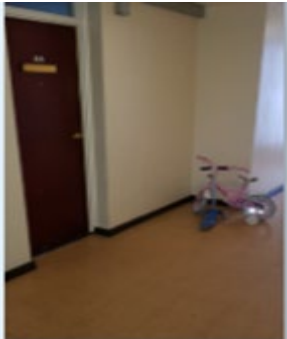
3	Caretaker Manager July 2021	15/07/2021
04/17	Flat 44 on 7 th floor has left a child's bicycle and scooter in the corridor.

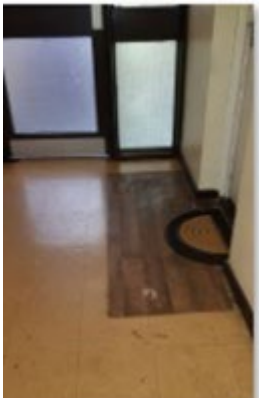
2	Housing Manager August 2021	14/09/2021
04/18	There is a trip hazard outside flat 61 in the form of a section of additional laminate floor. This presents a hazard as it is not obviously a raised section of floor which projects into the corridor close to the door. The mat is acceptable as it is more obviously above the floor and is confined to the area of the front door.

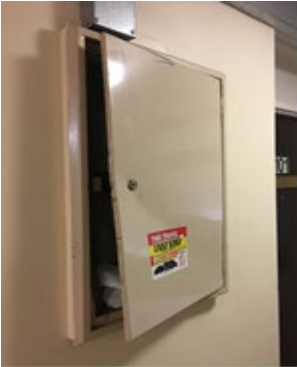
11/05	The tenant's own electricity meters are located on the landing area. A number of the meter boxes were found to be damaged. These will be replaced during refurbishment.
