Fire Risk Assessment

33-64 Horton St

Tipton, DY4 7JW

Date Completed: 06/10/2023

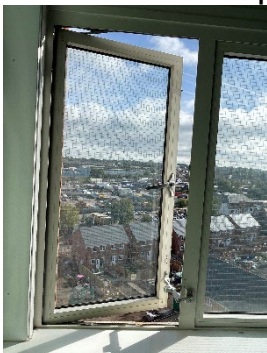
- 12) Communal windows are lockable however, all windows were unlocked and openable.

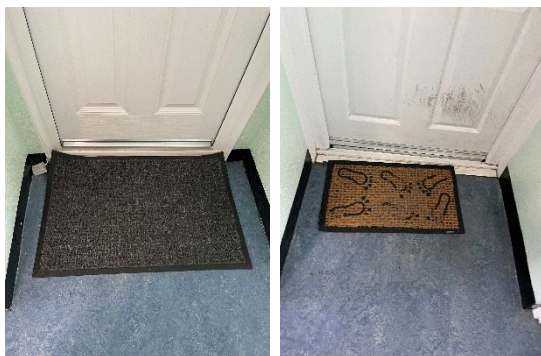
14) Individual floor mats were noted outside some flats. Fire rating of the mats is unknown but deemed to be of low risk.

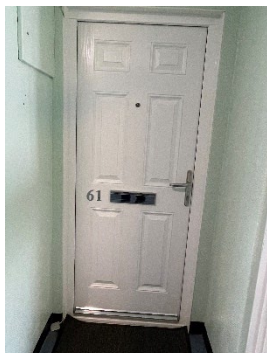
a) Flat 61 – Overhead self-closing device is missing.

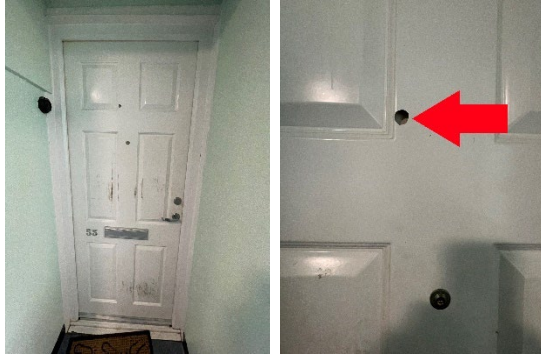
b) Flat 55 – Entrance door fails to overcome the latch when self-closing. Also, small hole in exterior of door but not penetrating door leaf.

P2	Within 1-3 months. Fire Rapid Response JM:12065035	16/10/2023
7/21b	Flat 55 / 5 th floor adjust self closer to overcome latch & repair small hole in exterior finish to door leaf with suitable fire resistant product.

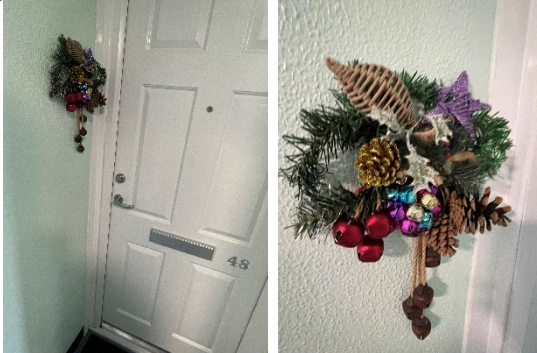
22) Combustible decoration fixed to wall outside flat 48.

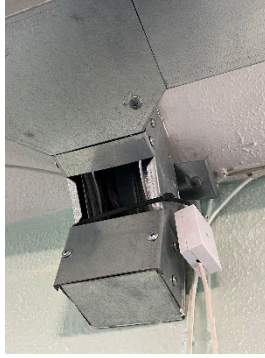
a) Section of trunking to be re-instated by flat 44 / 2nd floor. Missing section is present and tucked behind.

P2	Within 1-3 months. Housing Manager	
7/24a	Reinstate missing section to trunking. Outside flat 44 / 2 nd floor (piece is there behind trunking)

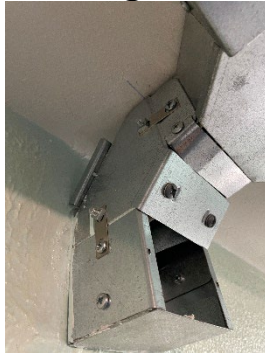
- b) Section of trunking to be re-instated by flat 39 1st floor. Missing section is present and tucked behind.**

7/24b	Reinstate missing section to trunking. Outside flat 39 / 1 st floor (piece is there behind trunking)

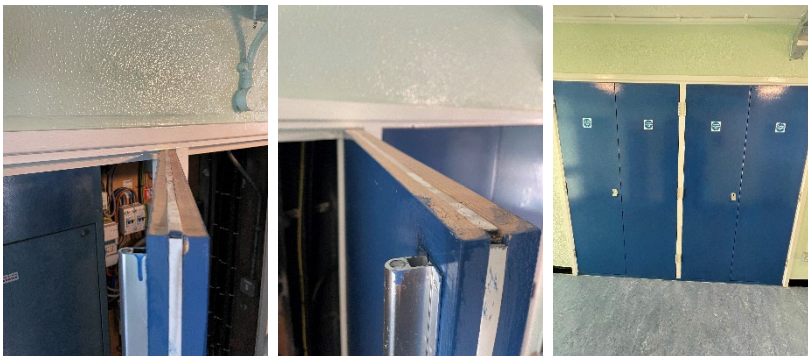
- 13) All floors - The majority of slave doors to service cupboards are without cold smoke seals to head.

P2	Within 1-3 months. Fire Rapid Response JM:12064435	16/10/2023
10/13	All floors - Install cold smoke seals to heads of all service cupboard slave doors were missing.

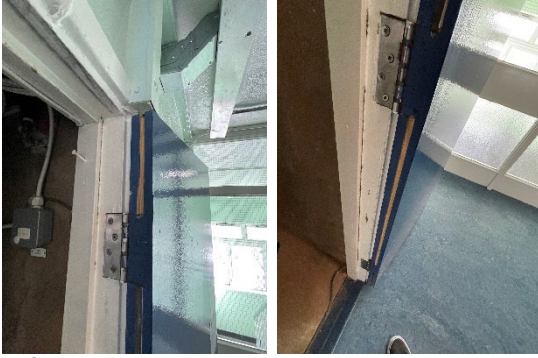
- 14) 7th floor riser cupboard door has sections of combined intumescent strip missing from hinge side.

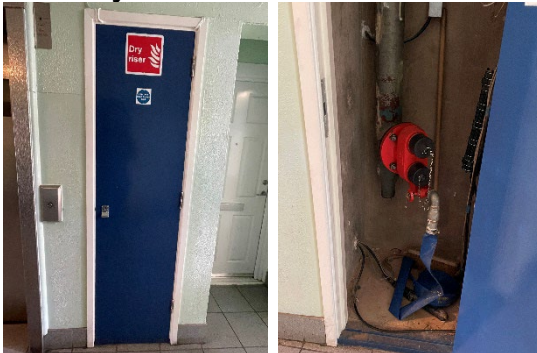
17) Ground floor left service cupboard door requires 2 x screws to hinge.
