Fire Risk Assessment

33-64 Horton St

Tipton, DY4 7JW

Date Completed: 17/09/2024

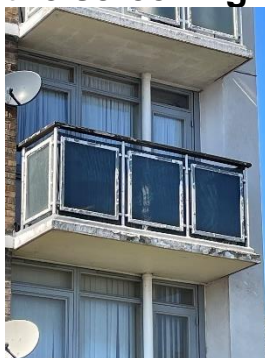
- c) **Flat 43 screening installed to balcony. Tenant spoke to the assessor during the survey and agreed to remove the screening.**

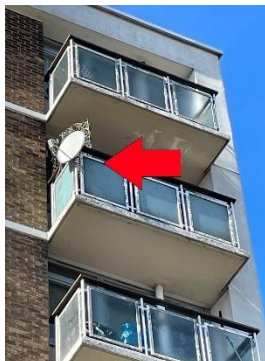
- d) **Flat 59 decorative trellis installed to balcony.**

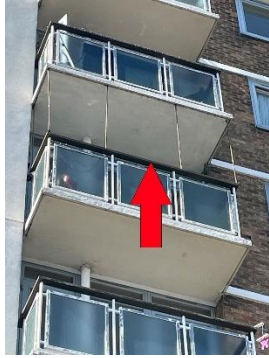
f) Flat 54 anti-bird netting installed to balcony.

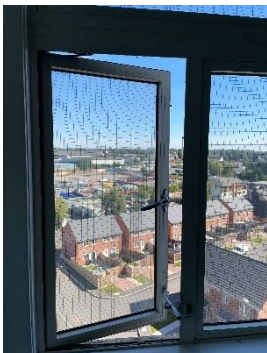
- 12) Communal windows are lockable however, all windows were noted as unlocked and openable.

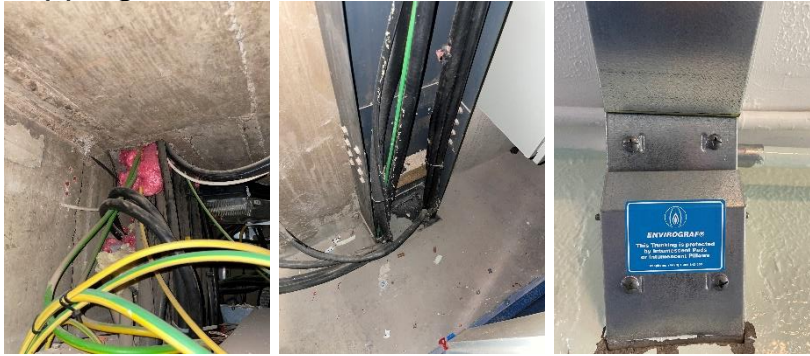
- 6) A variety of methods / materials have been used to achieve fire-stopping including Rockwool, fire rated sponge and intumescent pads or pillows. Minor remnants of expanding fire foam within cabling was noted in service cupboards on the ground and 3rd and 6th floor however, enhancement was not required as suitable fire stopping was confirmed from above.

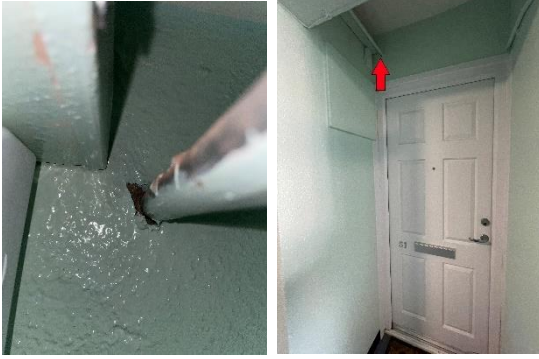
- 12) Fire stop small hole around penetration above flat 51 entrance door (4th floor).

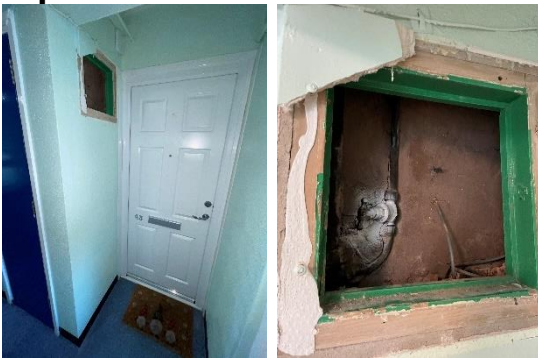
13) 2nd floor – missing stop tap cover from outside flat 43 to be replaced.

10/13	2 nd floor - flat 43 replace missing stop tap cover with suitable 1hr fire resistant product.

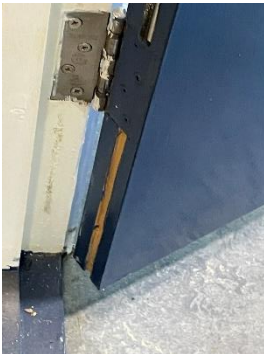
14) 2nd floor right-hand service cupboard slave door is missing a section of combined intumescent strip - cold smoke seal.

P2	Within 1-3 months Rapid Response Fire	
10/14	2 nd floor R/H service cupboard slave door, replace missing section of combined intumescent strip / css

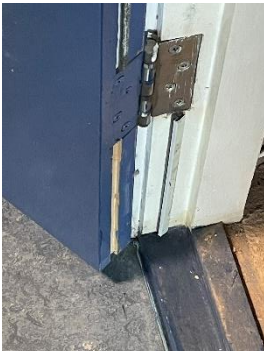
15) 1st floor left hand service cupboard / left hand door, a section of combined intumescent strip - cold smoke seal is missing.

P2	Within 1-3 months Rapid Response Fire	
10/15	1 st floor L/H service cupboard L/H door replace missing section of combined intumescent strip / css

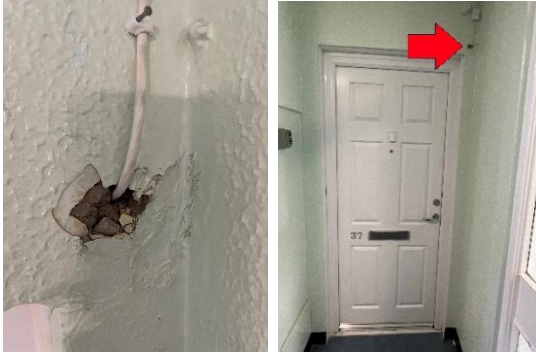
16) Fire stop cable penetration above flat 37 entrance door.
