Fire Risk Assessment

97-128 Farley Street

Tipton, DY4 7LA

Date Completed: 25/09/2023

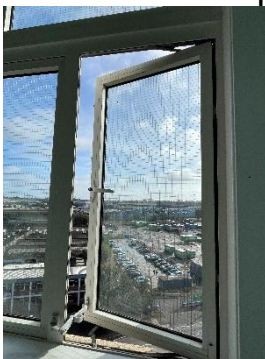
12) Communal windows are lockable however, all windows were unlocked and openable.

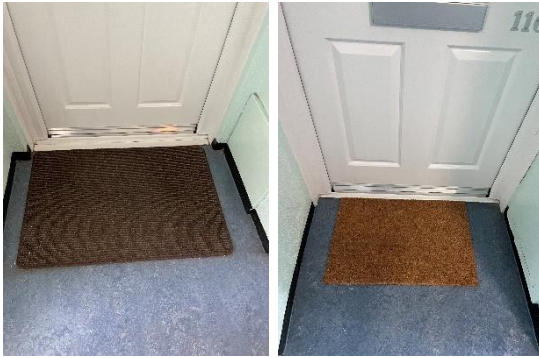
14) Individual floor mats were noted outside some flats. Fire rating of the mats is unknown but deemed to be of low risk.

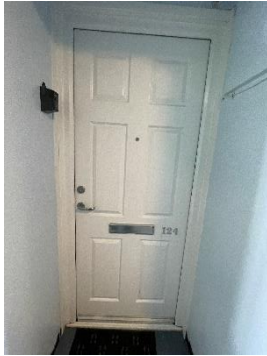
- b) Flat 124 – Overhead self-closing device missing from door.**

<p>P2</p>	<p>Within 1-3 months Housing Manager</p>	
<p>7/21b</p>	<p>Flat 124 – install overhead self-closing device to flat entrance door.</p>

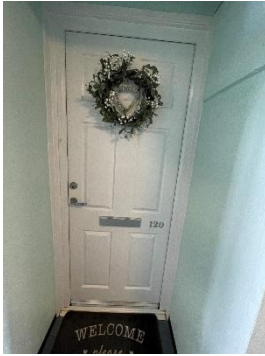
- c) Flat 120 – Door found to be correct. Occupier agreed to remove wreath from the door.**

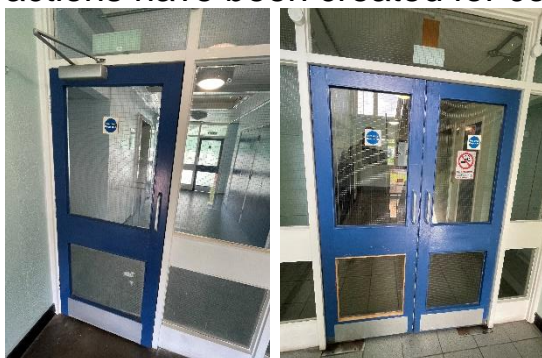
- 11) 7th floor by flat 126 - communal door to stairs excessive gap of approximately 8mm from handle side down. Gap to head is over 4mm and smoke seals not in contact with opposite edge door leaf is warped towards head. Upper glazing slight rattle**

<p>P2</p>	<p>Within 1-3 months Rapid Fire Team JM:12023438 JM:12034613</p>	<p>Carded 10/10/2023 12/10/2023</p>
<p>10/11</p>	<p>7th floor by flat 126 – Landing door warped towards head, requires replacement FD30s.</p>

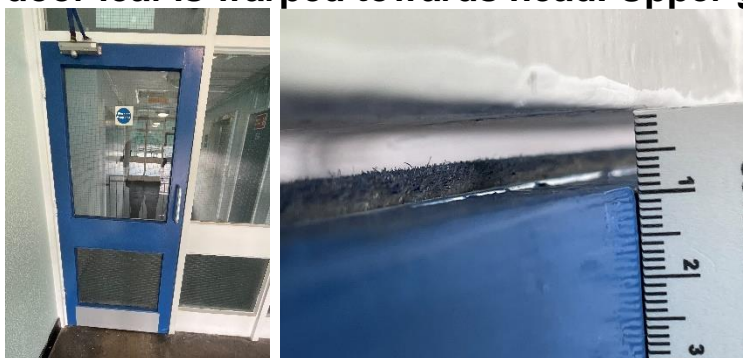
- 12) 7th floor by flat 128 – communal door to stairs excessive gaps and warped towards bottom edge.**

10/12	7 th floor by flat 128 – landing door warped and requires replacement FD30s.

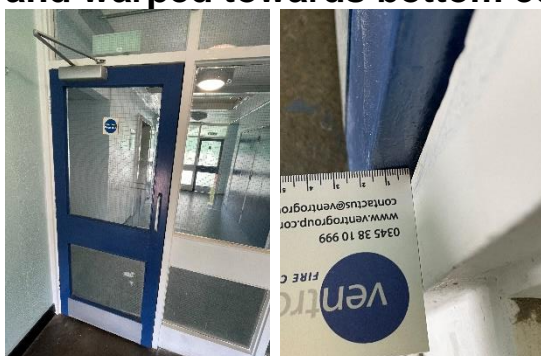
- 13) 6th floor by flat 122 – communal door to stairs gaps of approximately 6mm on handle side / cold smoke seal not in contact with opposite edge.

P4	Exceeding 6 months Repairs Emailed Ian Sorrell	
10/13	6 th floor by flat 122 – landing door - install bigger cold smoke seal to handle side of door leaf.

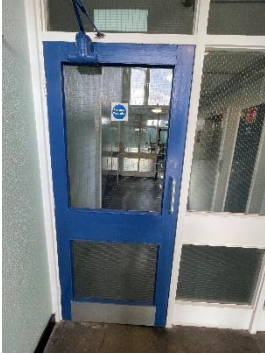
- 14) 5th floor by flat 120 – glazing loose within communal door.

P2	Within 1-3 months Rapid Fire Team JM:12033835	11/10/2023
10/14	5 th floor by flat 120 – secure loose glazing within door communal door.

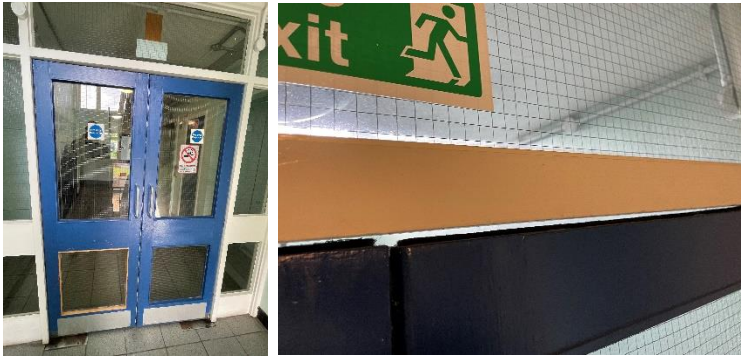
- 21) Ground floor double doors cold smoke seal to head not in contact with opposite edge.**
