Fire Risk Assessment

65-96 Horton St

Tipton, DY4 7JW

Date Completed: 26/09/2023

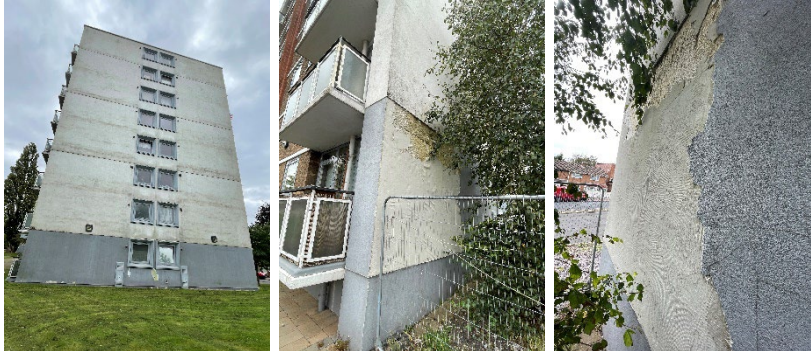
- 2) The side elevations were clad with a Wetherby mineral wool, silicon render system, fire classification A2 during a 2009 refurbishment. It was noted that a section of the render to the south facing side elevation of approximately 4m² has come away exposing the mineral wool insulation. Temporary fencing is in place whilst corrective works are arranged.

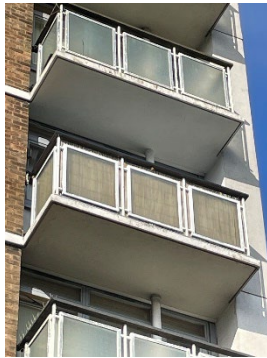
- a) **Flat 85 bamboo screening installed to balcony.**

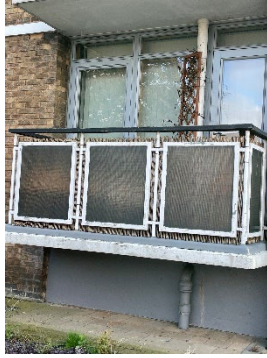
- c) **Flat 67 bamboo screening & trellis installed to balcony.**
-

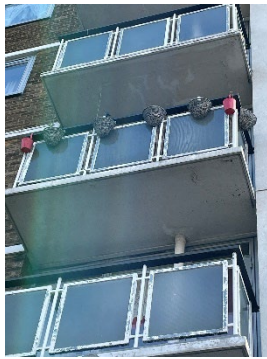
d) Flat 79 bamboo screening and timber based hanging baskets installed to balcony.

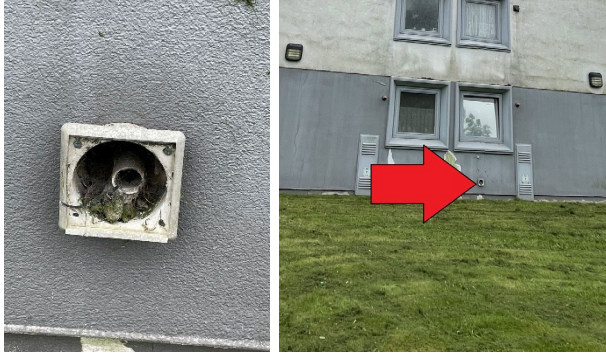
- 5) What appears to be a waste pipe or vent has been installed to the north facing side elevation at ground floor level (flat 66). The modification should be appropriately finished to protect the cavity of the external wall system.

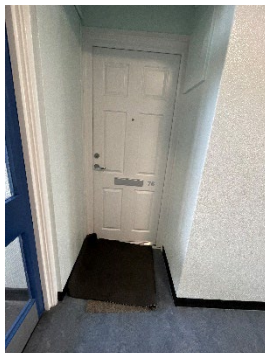
- a) Flat 76 – door mat is too large for the area and therefore folded in half creating a trip hazard.

P2	Within 1-3 months. Repairs	
7/14a	Flat 76 – remove large door matted (folded)

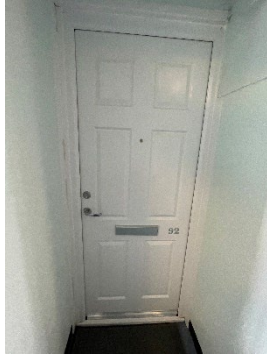
a) Flat 92 – Self closer is missing.

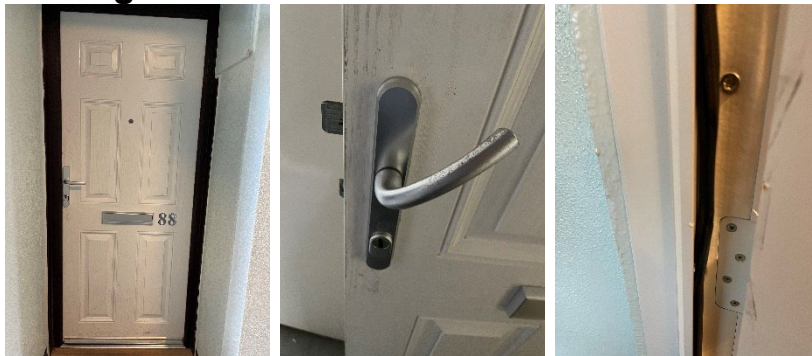
- b) Flat 88 – Handle doesn't reliably return to horizontal from the up position this results in the locking system remaining out which prevents the door from fully self-closing.

P2	Within 1-3 months Rapid Fire Team JM:12021953	10/10/2023
7/21b	Flat 88 / 5th– Service door handle to prevent sticking in the upright position

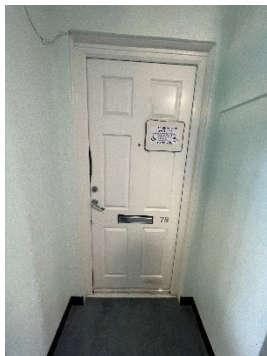
- c) Flat 85 – Door fails to reliably self-close / adjustment required. Seal is also loose and requires re-fixing. photo
- d) Flat 78 – Door is correct.

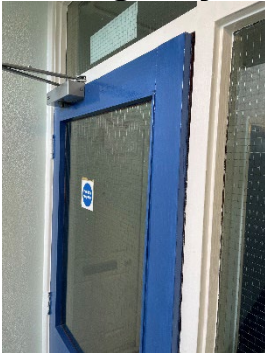
- 12) 5th floor by flat 86 - communal door to stairs not reliably self-closing fully into frame and requires adjustment.

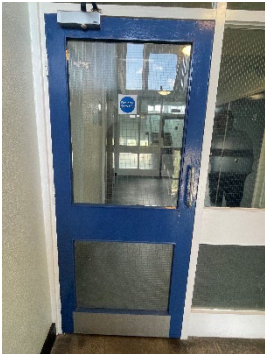
- 13) 5th floor by flat 88 – communal door to stairs glazing loose / rattles because beading is not secure to.

10/13	5 th floor Communal landing door by flat 88 – secure loose glazing to upper panel

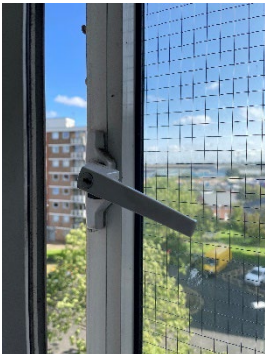
- 14) 5th floor – handle loose to window in front staircase.

P2	Within 1-3 months Glazing Repairs JM12035432	30/10/2023
10/14	5 th floor front staircase – re-secure handle to communal window / RHS

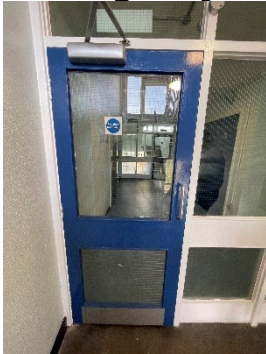
- 15) 4th floor by flat 84 – communal door to stairs not reliably self-closing fully into frame and requires adjustment.

P2	Within 1-3 months Repairs	13/10/2023
10/15	4 th floor by 84 – landing door Adjust self-closer.	 	P2	Within 1-3 months Rapid Fire Team JM:12023057	10/10/2023

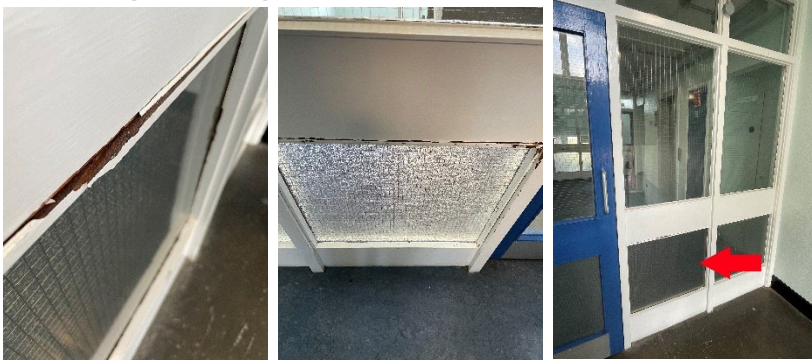
- 16) 4th floor by flat 82 glazing to combination frame is loose and beading damaged and not secure.

10/16	4 th floor by flat 82 – secure lower glazing to combination frame / beading damaged & not secure	 	P2	Within 1-3 months Glazing Repairs JM:12035483	30/10/2023
10/17	3 rd floor by 78 - landing door Adjust self-closer.	 	P2	Within 1-3 months Rapid Fire Team JM:12023231	10/10/2023
10/18	2 nd floor by 76 - landing door Adjust self-closer.	 	P2	Within 1-3 months Rapid Fire Team JM:12023255	10/10/2023

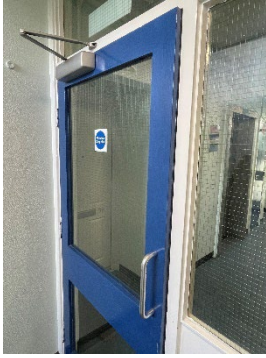
- 18) 2nd floor by flat 76 - communal door to stairs not reliably self-closing fully into frame and requires adjustment.
