Fire Risk Assessment

65-96 Horton St

Tipton, DY4 7JW

Date Completed: 19/09/2024

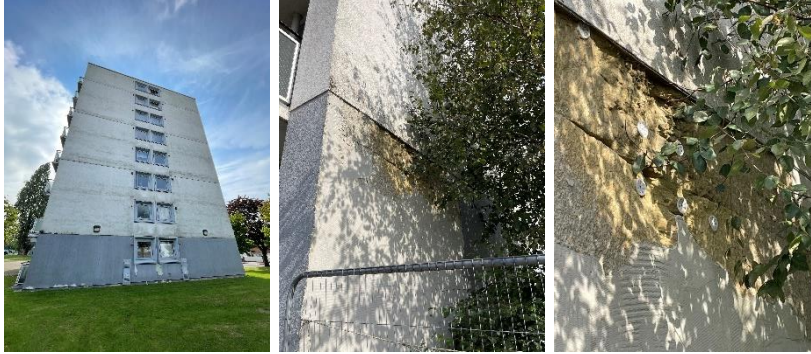
- 2) The side elevations were clad with a Wetherby mineral wool, silicon render system, fire classification A2 during a 2009 refurbishment. It was noted that a section of the render to the south facing side elevation of approximately 4m² has come away exposing the mineral wool insulation beneath. The area has been cordoned off and the risk to fire remains low.

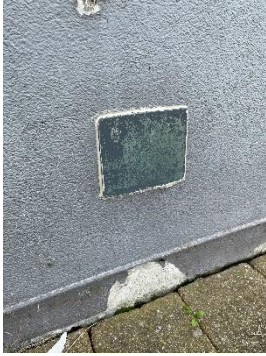
- 5) A repair to the external north facing ground floor side elevation, where an exhaust vent had previously been installed is evident.
-

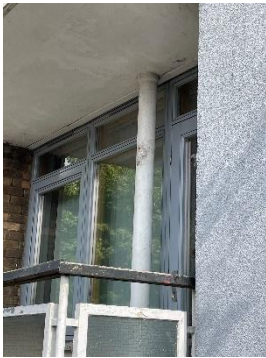
- 6) Rainwater downpipes penetrate each balcony floor slab. The material is unknown however the risk is deemed minimal.

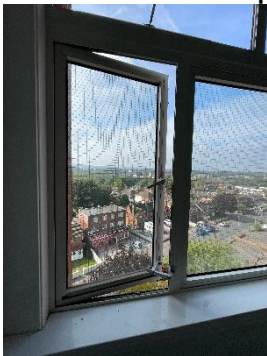
- 12) Communal windows are lockable however, all windows were unlocked and openable.

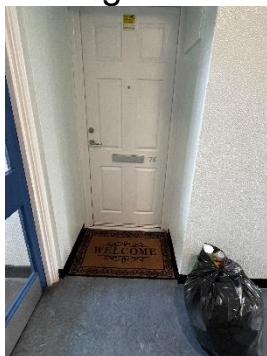
- 14) Refuse bag in communal corridor outside flat 76. Housing Manager has been requested to write to resident to ask them to refrain from leaving combustible items within the means of escape.

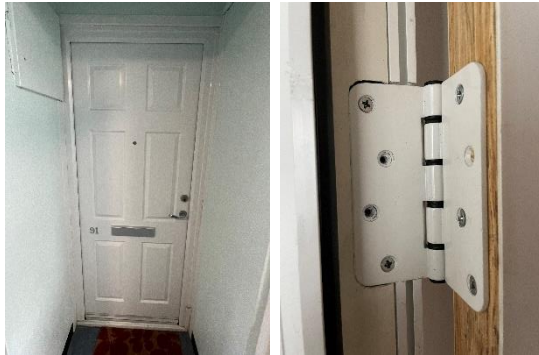
- a) Flat 91 – there are screws missing from each hinge, six in total.**

Question/ Ref No	Required Action	Supporting photograph	Priority	Timescale and Person Responsible	Date Completed
7/22a	Flat 91 entrance door – replace all missing screws within 3 x hinges.

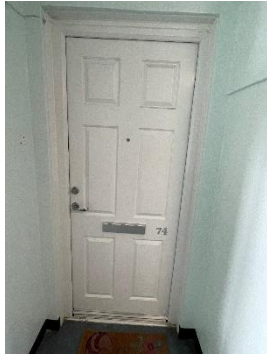
d) Flat 74 – Door fails to reliably self-close.

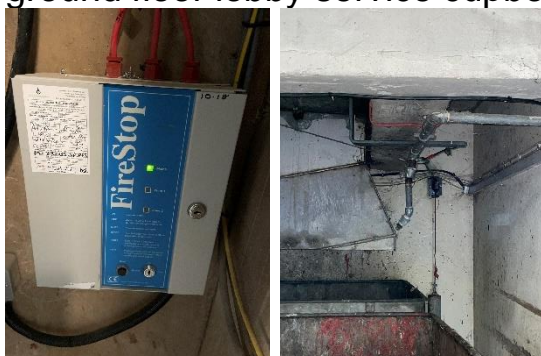
- 3) There is no effective means for detecting an outbreak of fire to communal areas. The reason for this are:
 - I. Such systems may get vandalised.
 - II. False alarms would occur.
 - III. A Stay Put - Unless policy is in place
- 4) A fire suppression system is provided to the refuse chute bin store. An approved contractor maintains the system. The frequency for the maintenance checks are twice per year (April and October) of each calendar year. The control panel for the system is located in the ground floor lobby service cupboard.

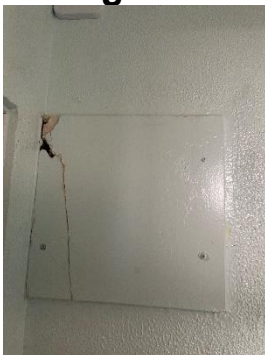
- 10) Access panels to stop taps are fixed to masonry and bedded on Intumescent material. **Stop tap cover adjacent flat 90 is damaged and requires replacement.**

P2	Within 1-3 months. Fire rapid response	
10/10	Replace damaged stop tap cover adjacent flat 90 with suitable 1hr fire resistant product.

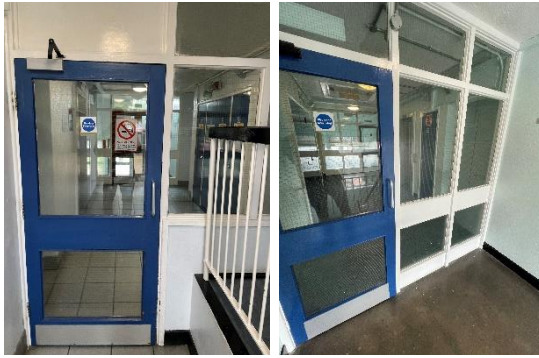
- 12) The communal landing & staircases are protected by use of notional self-closing 44mm 30-minute timber fire doors with vision panels, 25mm stops & screens. It is recognised that these doors do not meet today's benchmark of a certified FD30s fire door install however, because they were installed at the time of the building's construction and to the standard of that time they are deemed as acceptable so long as the doors are free of damage and function as they were intended to do so. It has been recognised that all of the landing / staircase notional doors in this block have been upgraded with combined intumescent strips & cold smoke seals to enhance their original design and minimise departures from today's standards (upgraded notional fire door). Were minor shortcomings have been identified actions have previously been created for corrective works.

Some notional communal landing doors show signs of wear and tear due to age. Consideration should be given to upgrade with certified FD30s door sets & combination frames.
