Fire Risk Assessment

**1 – 32, Horton Street
Tipton,
DY4 7JN**

Date Completed: 17/09/2024.

Current Risk Rating = Tolerable

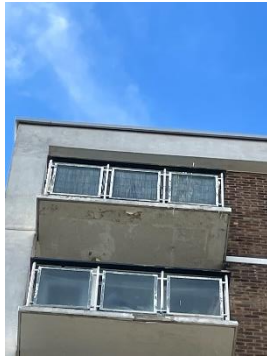
| | Flats 3, 9 and 32, have installed combustible screening within the balcony area, this should be removed. | |

c) Flat 32 screening installed to balcony.

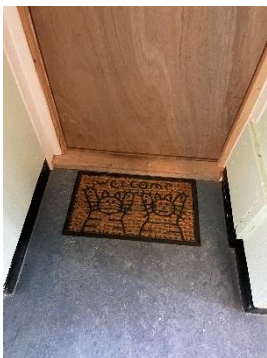
- 14) Individual floor mats were noted outside some flats. Fire rating of these mats is unknown but deemed to be of low risk.

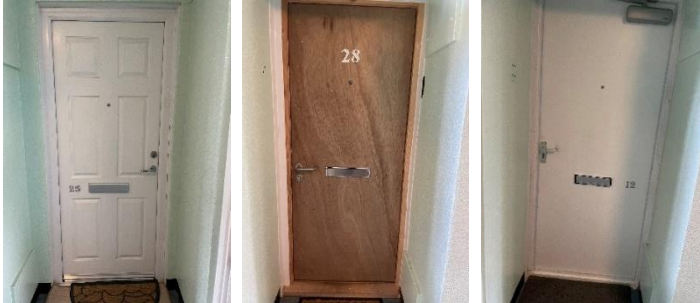
20) Individual flat doors are FD30s composite doors with the majority being manufactured by Permadoor. Flats 12 & 28 have nominal timber flush fire doors with intumescent letterbox liners however, access was not gained for further inspection.

| Observations | |
|--|--|
| Consideration should be given to install FD30s certified composite door set to flats 12 & 28 as part of a future door programme. | |

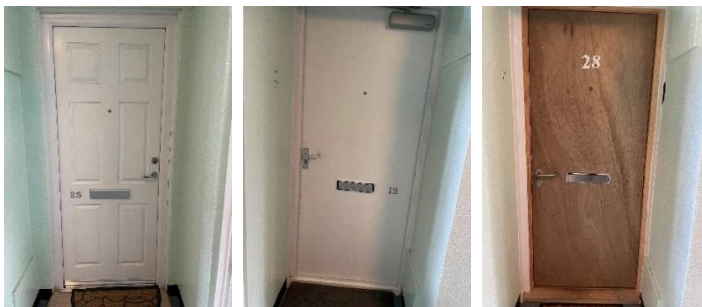
- 10) Individual flat doors are FD30s composite doors with the majority being manufactured by Permadoor. Flats 12 & 28 have nominal timber flush fire doors with intumescent letterbox liners, however access was not gained for further inspection.

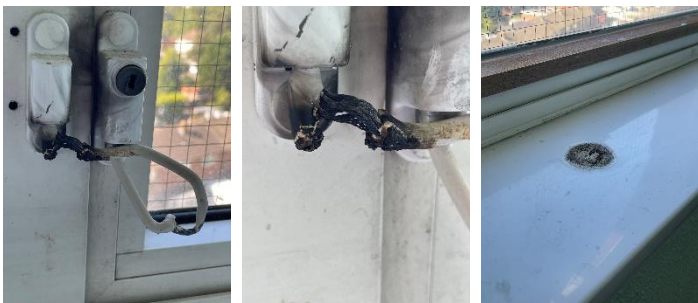
- 4) Evidence of Arson was noted on the stairwell of floor six where burning seemed apparent to a windowsill and window restrictor. (Email sent to Housing Manager).

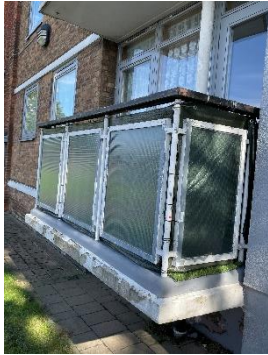
| Question/ Ref No | Required Action | Supporting photograph | Priority | Timescale and Person Responsible | Date Completed |
|---|---|---|---|---|---|
| 6/3a | Flat 3 - Remove combustible screening from balcony. | | P2 | Within 1-3 months. Housing Manager | |
