Fire Risk Assessment

1-32 Horton St

Tipton, DY4 7JN

Date Completed: 06/10/2023

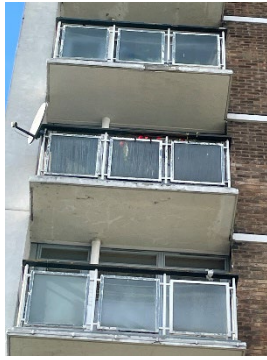
- c) Flat 24 screening installed to balcony.**

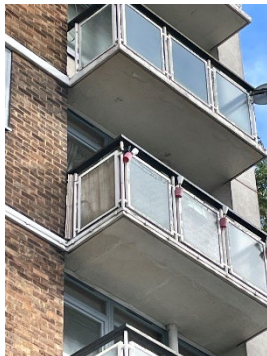
g) Flat 6 screening and parasol installed to balcony.

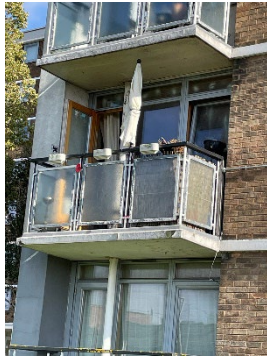
h) Flat 18 screening installed to balcony.

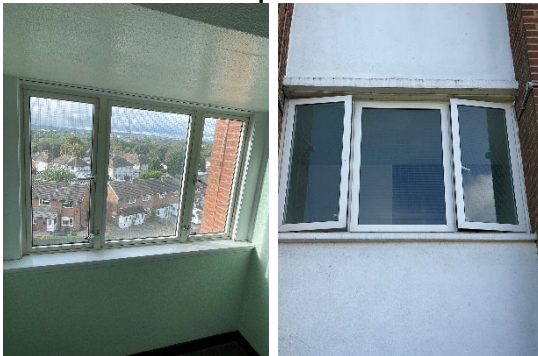
12) Communal windows are lockable however, all windows were unlocked and openable.

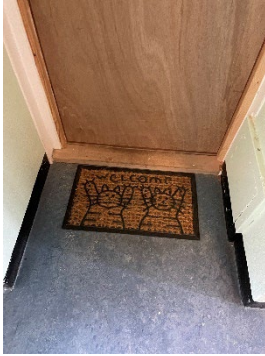
14) Individual floor mats were noted outside some flats. Fire rating of the mats is unknown but deemed to be of low risk.

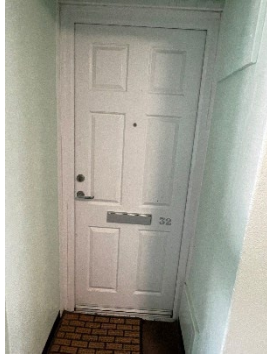
a) Flat 32 – Entrance door fails to overcome the latch when self-closing.

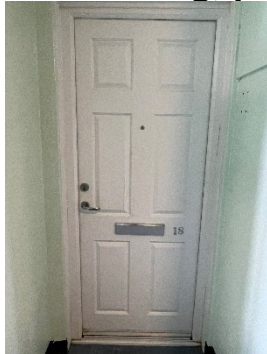
c) Flat 18 - Entrance door fails to overcome the latch when self-closing, possible issue with locking mechanism.

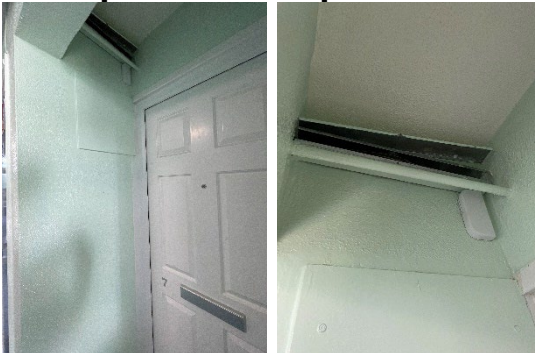
- 24) 1st floor cable trunking above flat 7 entrance door has a section missing that requires re-fixing. Missing section has been placed on top.

<p>P2</p>	<p>Within 1-3 months. Repairs Glazing</p>	
<p>7/24</p>	<p>1st floor by flat 7 door - Refit missing section to trunking. (missing piece is there)</p>

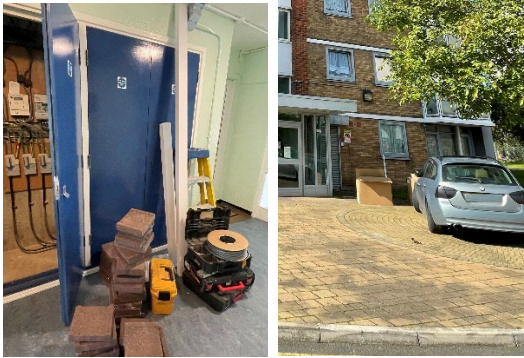
- 25) Tradespersons tools and consumables were temporary present to the 7th floor communal lobby during the inspection. It was also noted that a vehicle parked in close proximity to the front of the building also belonged to the tradesperson. All items and the vehicle were moved following the completion of the works to flat 32.
-

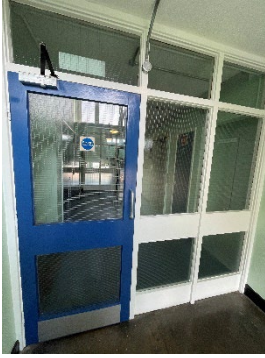
- 11) The communal landing & staircases are protected by use of notional self-closing 44mm 30-minute timber fire doors with vision panels & 25mm stops. It is recognised that these doors do not meet today's benchmark of a certified FD30s fire door install however, because they were installed at the time of the buildings construction and to the standard of that time they are deemed as acceptable so long as the doors are free of damage and function as they were intended to do so. It has been recognised that all of the landing / staircase notional doors in this block have been upgraded with combined intumescent strips & cold smoke seals to enhance their original design and minimise departures from today's standards. Where minor shortcomings have been identified actions have been created for corrective works.

Observations	
Some notional communal landing doors show signs of wear and tear due to age. Consideration should be given to upgrade with certified FD30s door sets & combination frames.

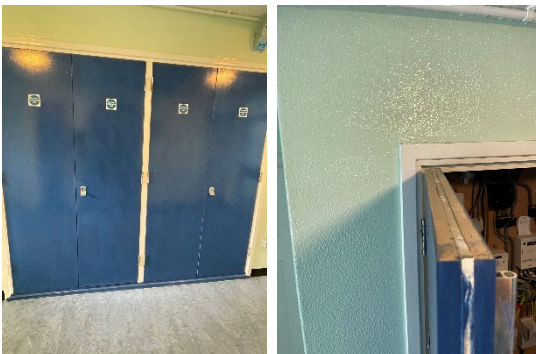
14) All floors - The majority of slave doors to service cupboards are without cold smoke seals to head.

<p>P2</p>	<p>Within 1-3 months. Electrical Compliance Manager</p>	
<p>10/14</p>	<p>All floors – install cold smoke seals to head of service cupboards slave doors.</p>
