# Fire Risk Assessment

## Mountford House

**1-66, Glover Street,  
West Bromwich, B70 6DS**

**Date Completed: 04/12/2024**

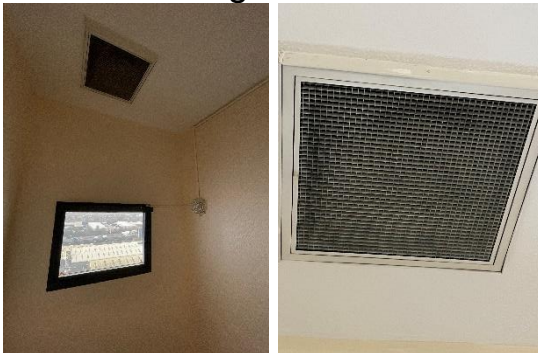
15) A ventilation grill was noted to the head of the staircase.

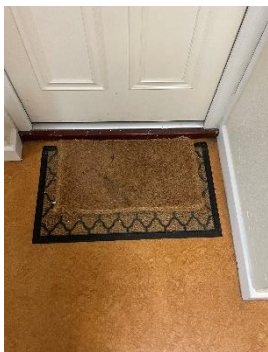
20) Individual floor mats were noted outside some flats. Fire rating of the mats is unknown but deemed to be of low risk.

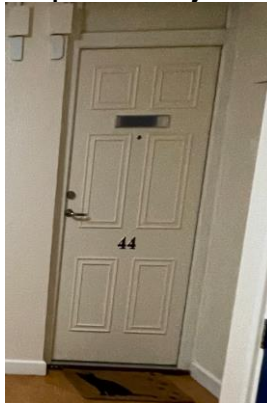
b) Flat 44 – Door slams shut with force when self-closing and requires adjustment.

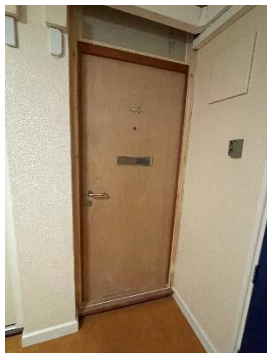
c) Flat 40 – Temporary nominal timber FD30s door with no defects.

Flat 40 – replacement timber nominal fd30s door installed. Consider certified FD30s door set.

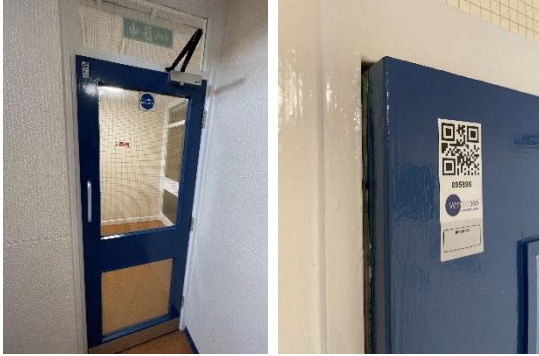
**22) 6<sup>th</sup> floor landing door to stairs not reliably self-closing and requires adjustment.**

<p>P2</p>	<p>Within 1-3 months. Fire Safety Rapid Team</p>	
<p>10/22</p>	<p>6<sup>th</sup> floor – Landing door to stairs not reliably self-closing requires adjustment</p>

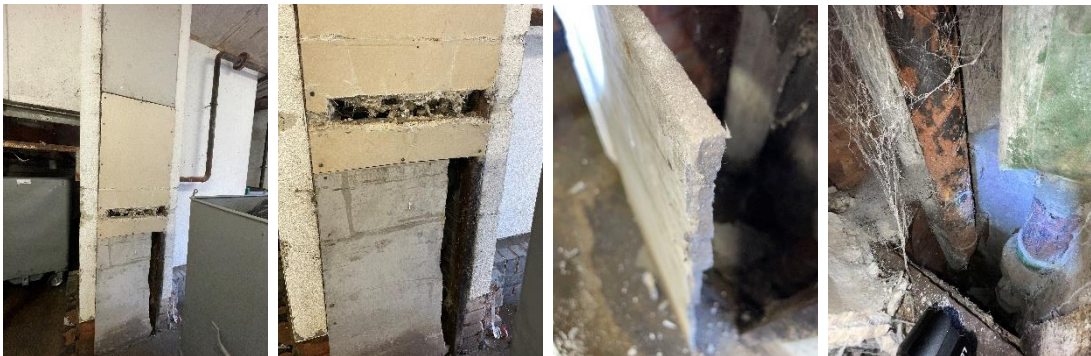
**23) Bin storage room – The fibre cement boards enclosing a shaft containing soil stack and gas main have been damaged by the movement of bins. The fire resistant boards should be replaced with a product of equal or better fire resistance to enable 60 minutes protection. Because the shaft contains a gas main an intumescent vent should be installed to the finished surface.**

10/23	Bin Storage room – Remove / replace damaged fibre cement boards to shaft to provide 60 minutes fire resistance & install intumescent ventilation grill to surface. (barrier to erected / contact CH)	 	P2	Within 1-3 months. Fire Safety Rapid Team	
-------	--	--	----	--	--
