Fire Risk Assessment

Mountford House

**1-66, Glover Street,
West Bromwich, B70 6DS**

Date Completed: 14/12/2023

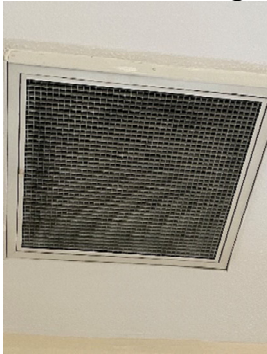
15) A ventilation grill was noted to the head of the staircase.

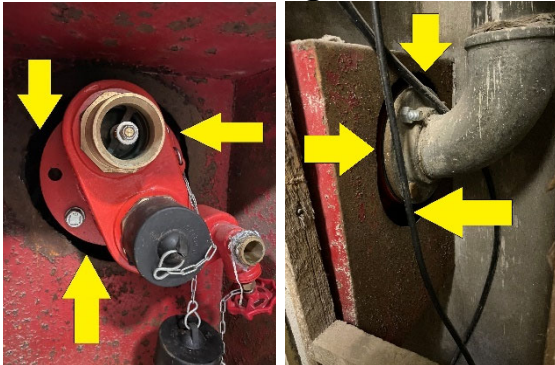
- 15) Fire stopping required to rear of riser inlet. Significant draught was noted from service corridor behind containing electrical switch gear.

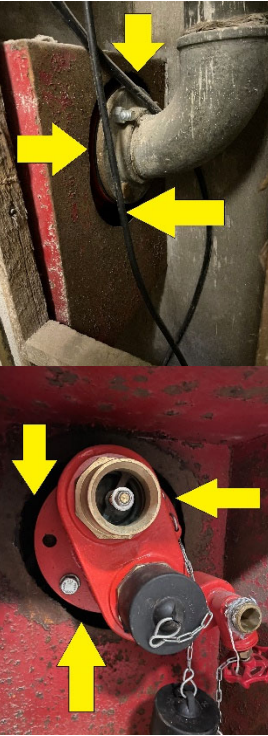
Two photographs showing firestop details. The top photo shows a pipe entering a wall with a firestop device and yellow arrows pointing to the seal. The bottom photo shows a red firestop device on a riser inlet with yellow arrows pointing to the seal and the device.	<p>P2</p>	<p>Within 1- 3 months Fire Rapid Response</p>
