Fire Risk Assessment

Ashcroft

**Windmill Lane,
Smethwick, B66 3JR**

Date Completed: 06/10/2023

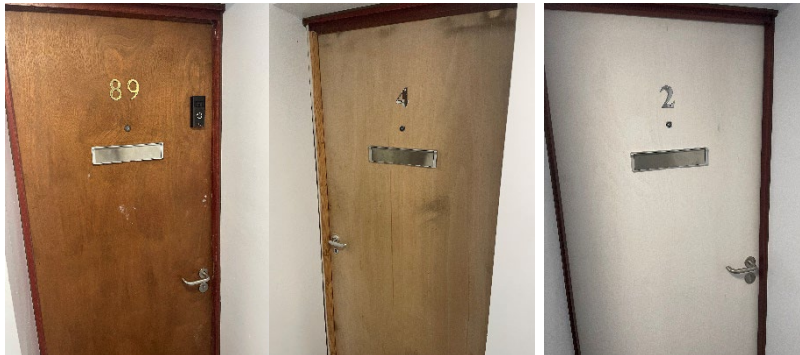
20) Individual flat doors are self-closing nominal 30-minute composite fire door sets with intumescent strips, cold smoke seals and self-closing devices. Doors are manufactured by Permadoor or Nationwide. Timber doors were noted to flats: 89, 4 and 2.

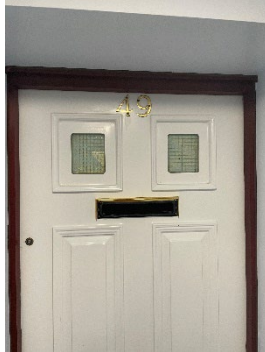
- a) Flat 63 - Door not positively shutting against latch.
- b) Flat 38 - Door not positively shutting against latch.
- c) External inspection. Flat 49 has a missing letter plate.

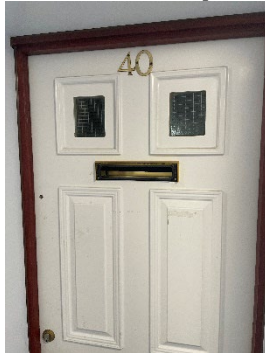
- d) External inspection. Flat 40 has a missing letter plate.

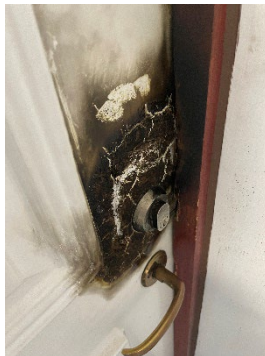
- e) External inspection. Flat 36. Fire Damage to door and frame.

07/21-E	Flat 36. Emergency door and frame replacement required.

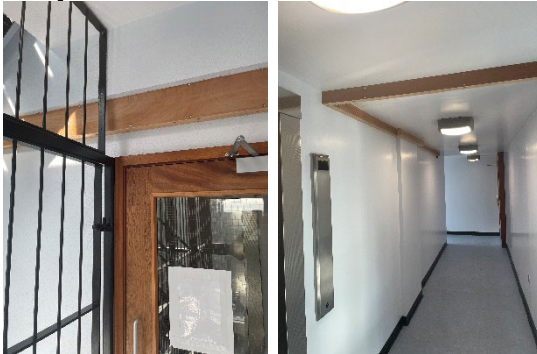
22) Floor 14. Exposed timber to corridor and staircase ceiling to be painted to achieve a class 0 spread of flame.

P2	Fire Rapid Response 1-3 Months JM:12067796	16/10/2023
07/22	Floor 14. Exposed timber to corridor and staircase to be treated to achieve class 0 spread of flame.

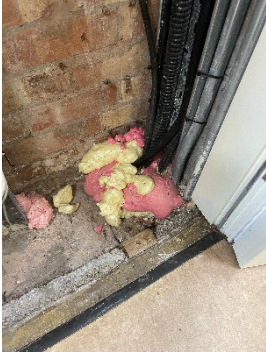
- 12) Fire foam was evident in some service risers. This should be removed and replaced with suitable fire stopping material during programmed works.

Section 10/12. As part of a future works programme the fire foam within service risers should be replaced with a suitable fire stopping material.

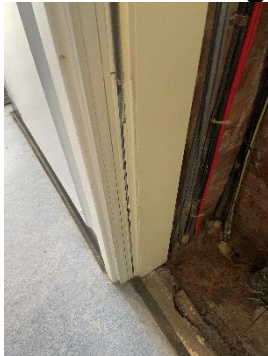
- 13) **Partial missing smoke seal noted to service riser by flat 49.**

10/13	Service riser by flat 49. Replace missing smoke seal.

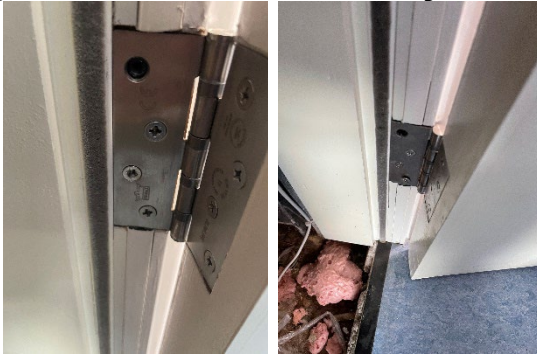
15) Floor 5. Service riser by Flat 31 requires screws to hinges.

P2	Fire Rapid Response Team 1-3 Months JM:12067951	16/10/2023
10/15	Floor 5. Service riser by Flat 31 requires screw to hinges.

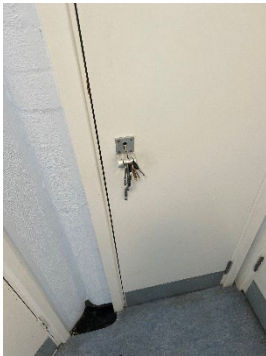
16) Floor 5. Chute room. Unable to operate lock to secure small door.

10/16	Floor 5. Chute room. Small door. Repair required to lock to ensure it can be turned to engage.

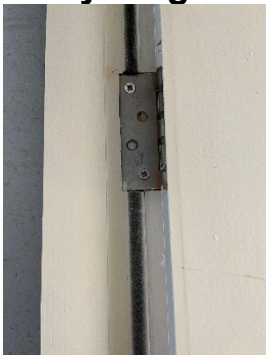
17) Floor 3. Chute room double doors. Screws missing from every hinge.

P2	Fire Rapid Response Team 1-3 Months JM:12067996	16/10/2023
10/17	Floor 3. Chute room. Double doors. Screws required to every hinge.

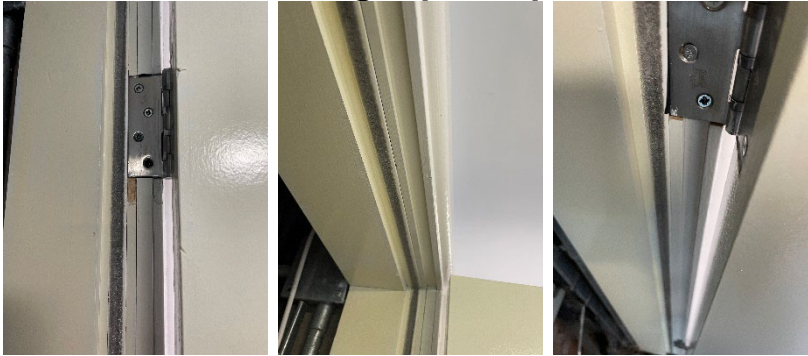
- 18) Riser cupboard by Flat 16. Screw missing in hinge and intumescent missing top and partial side.**

P2	Fire Rapid Response Team 1-3 Months JM:12068011	16/10/2023
10/18	Riser Cupboard by Flat 16. Intumescent strip required to frame head and partial side. Also, screw required to hinge.

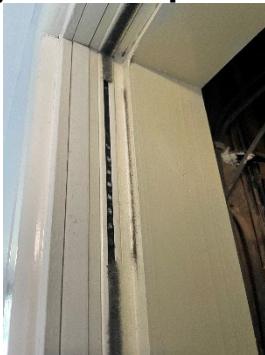
- 19) Riser cupboard by Flat 7. Worn smoke seal.**

10/19	Riser cupboard by Flat 7. Replace worn combined smoke seal.

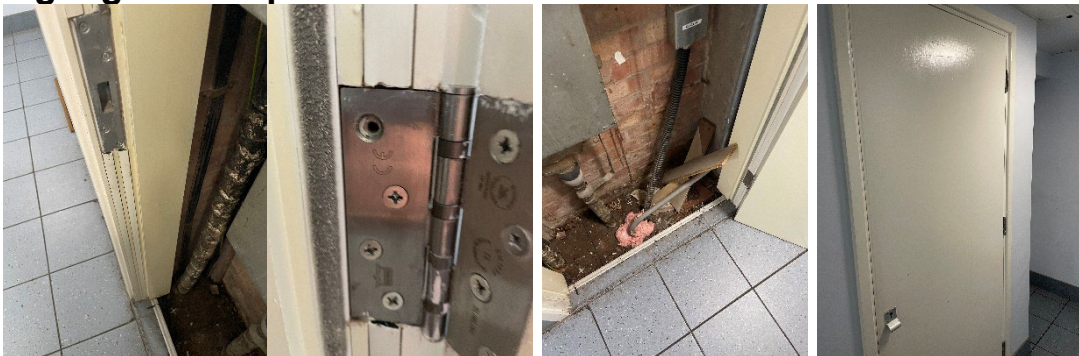
- 20) Riser cupboard by Flat 1. Combustibles noted. Screw missing from hinge. Partial combined seal missing. Door signage not in position.**

P2	Fire Rapid Response Team 1-3 Months JM:12068073	16/10/2023
10/20	Riser cupboard by Flat 1. Remove combustibles, replace missing smoke seal and screw required to hinge.

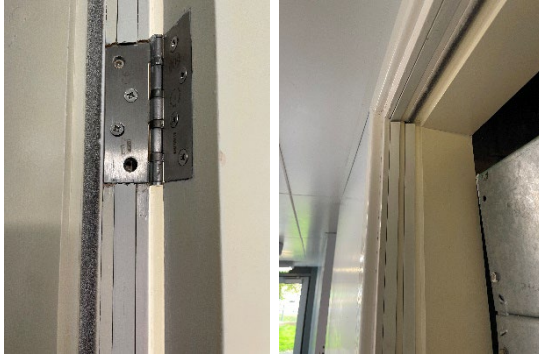
- 21) Riser Cupboard by Flat 4. Partial missing combined smoke seal noted. Screws missing to two hinges.**
-

P2	Fire Rapid Response Team 1-3 Months JM:12068091	16/10/2023
10/21	Riser cupboard by flat 4. Replace missing smoke seal. Screws required to two hinges.

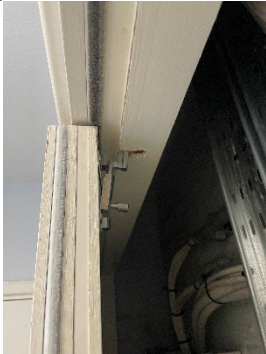
22) Ground Floor. Chute Room. Bolt lock Broken

10/22	Ground floor. Chute room. Replace broken boltH to double doors.

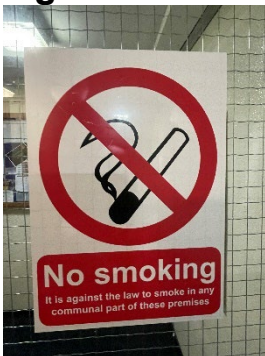
- 1) Smoking is prohibited within any communal parts of the building in line with Smoke Free England legislation. However signs of smoking were evident within the staircase.

P2	Fire Rapid Response Team 1-3 Months JM:12068188	16/10/2023
14/01	Tenants to be reminded that no smoking is allowed within communal areas.

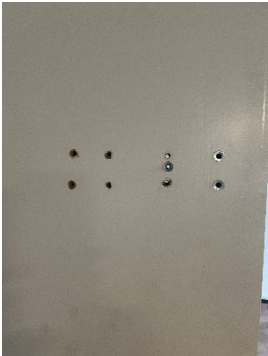
f) Fire door to roof (directly behind steel door) Open at time of inspection and several holes evident the full width of the door.

P2	Repairs. 1-3 months	
07/21-F	Fire door to roof void. Fill door with intumescent filler.

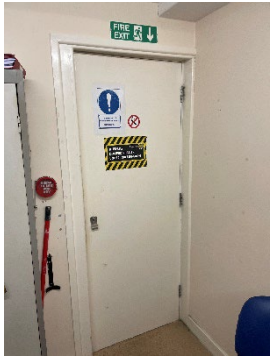
23) Ground Floor Welfare room door not positively closing against latch.

P2	Fire Rapid Response Team 1-3 Months JM:12068153	16/10/2023
10/23	Ground Floor. Welfare room. Adjust self-closer to ensure door closes against latch.

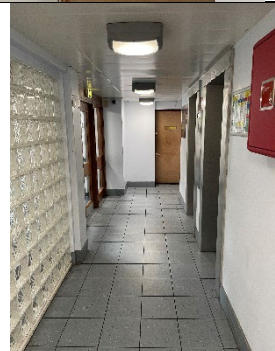
23) The lift doors at ground floor have no fire separation from the flats on the left-hand side of the building. The installation of a fire resisting door and partition should be considered as part of future works programme.

<p>Section 07/23. Fire separation between the lift doors and flat entrance doors should be considered for future works programme.</p>
