# Fire Risk Assessment Beaconview House

**Beaconview Road, West Bromwich ,  
B71 3PL**

**Date Completed: 02/02/2024**

**Current Risk Rating = Tolerable**

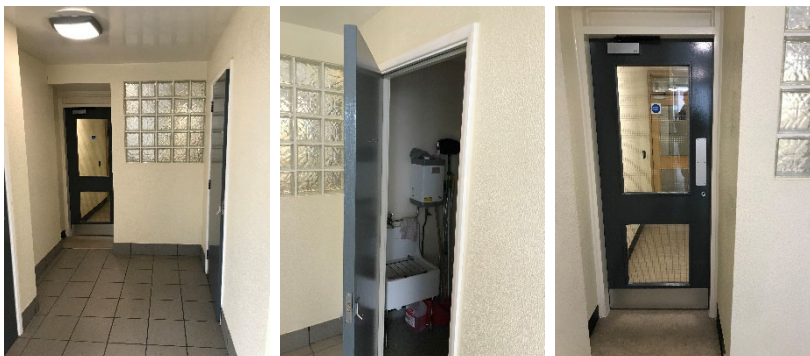
- 20) Communal viewing pod located on the first floor secured with a 44mm timber nominal door with intumescent strips, cold smoke seals and vision panels is secured with a type 34 mortice lock that residents have access to this room remains relatively sterile with the cleaners cupboard also being within this area noted the cleaners cupboard is missing the addition of combined intumescent strips and smoke seals as this is a notional door and the area being regularly accessed by cleaning / caretaking teams the element of risk is tolerable however with future improvements to the block it should be considered that this door is upgraded to a FD30s

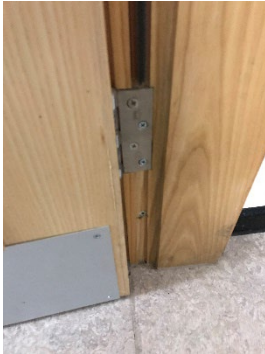
- 21) 4<sup>th</sup> floor communal door to protecting staircase missing intumescent strip and cold smoke seal to bottom hinge side of door

07/24	4 <sup>th</sup> floor communal door replace missing combined intumescent cold smoke seal bottom hinge side of door

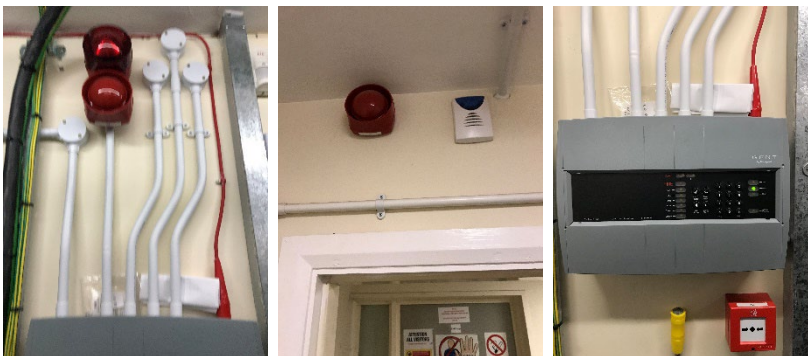
- 6) Noted that no detection was present within the main office area and the small office/ storeroom. Due to the occupancy/use, multiple escape routes and items stored within this is a tolerable risk however when upgrades take place at the block consideration should be made to introduce fire detection within these areas.
-

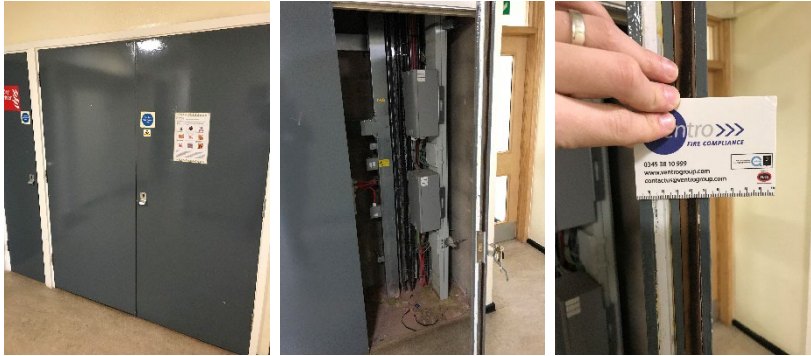
- 12) Noted the use of expanding foam was present within the communal cupboards around cabling as part of the fire stopping knowing that intumescent pads and a concrete slab is present and this foam is only used as an enhancement it is deemed tolerable. This should be enhanced as part of future works to the building and replaced with intumescent mastic to improve fire stopping

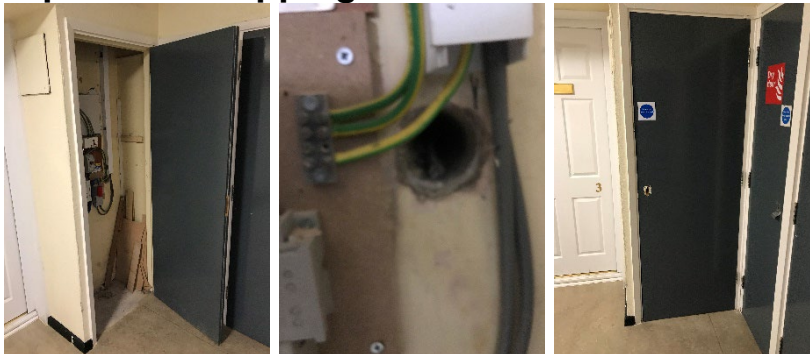
- 17) 1<sup>st</sup> floor, flat 3 residents cupboard can not be secured due to broken lock, there is also holes within the cupboard that require fire stopping

10/17	Flat 3, 1 <sup>st</sup> floor replace lock to resident's cupboard, tag / post keys, and fire stop holes within cupboard

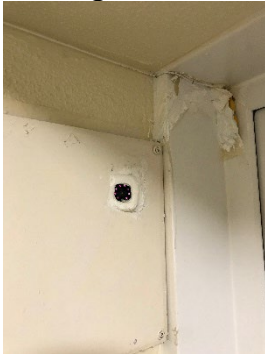
- 18) Hole in access panels to stop taps next to flat 32 where a camera has been installed through the intumescent, also cabling breaching through door

**18a) Flat 32 the camera and associated camera should be removed**

**18b) Replace access panel to stop taps and seal front door frame to flat 32**

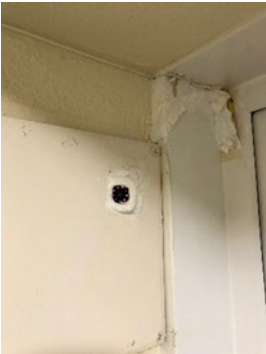
P2	Fire Rapid Response 1-3 months	
10/18a	Flat 32 remove camera and associated cabling

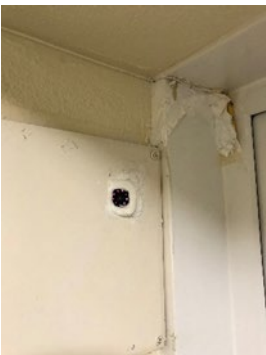
P3	Housing Manager 1-3 months	
10/18b	Replace access panel to stop taps and seal front door frame to flat 32
