Fire Risk Assessment

Broome House

**Beaconview Road, West Bromwich ,
B71 3PN**

Date Completed: 26/01/2024

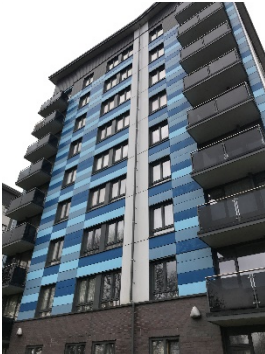
- 6) It was noted that some balconies may have had combustible materials in the form of hanging washing this is deemed acceptable risk due to the likelihood of a fire starting in this area being low and combined with the temporary nature of the activity
- 7) Aluminium faced timber composite windows to residents flat windows/balcony doors and communal windows

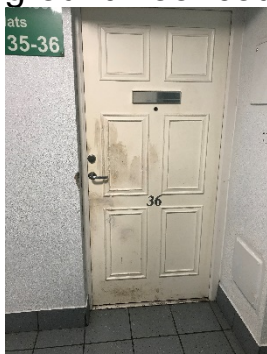
- 21) Noted superficial damage to flat entrance door of flat 36 on the ground floor could not gain access to flat.

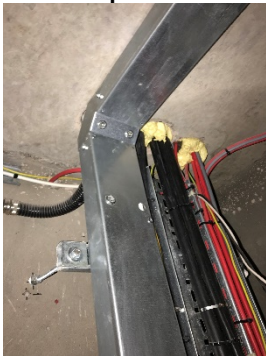
- 12) Noted the use of expanding foam was present within the communal cupboards around cabling as part of the fire stopping knowing that intumescent pads and a concrete slab is present and this foam is only used as an enhancement it is deemed tolerable. This should be enhanced as part of future works to the building and replaced with intumescent mastic to improve fire stopping

<p>Noted the use of expanding foam was present within the communal cupboards around cabling as part of the fire stopping knowing that intumecent pads and a concrete slabe is present and this foam is only used as a enhancment it is deemed tolerable. This should be enhanced as part of future works to the building and replaced with intumecent mastic to imporve fire stopping.</p>	
--	--

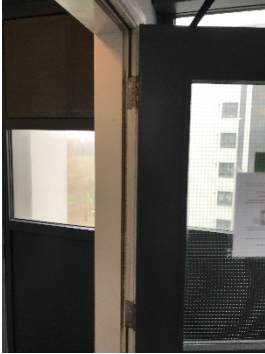
- 15) Missing cold smoke seal from 6th floor bin chute door on hinge side

10/15	6 th floor bin chute door replacement of missing cold smoke seals to hinge side of door
