# Fire Risk Assessment

## Bowater House

Moor Street, West Bromwich,  
B70 7AZ

**Date Completed:** 20<sup>th</sup> December 2024

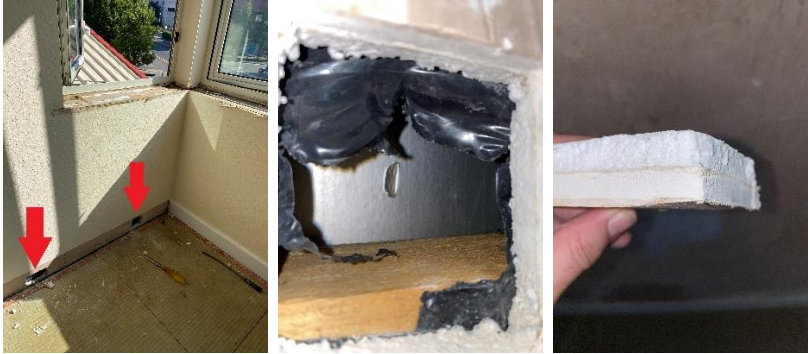
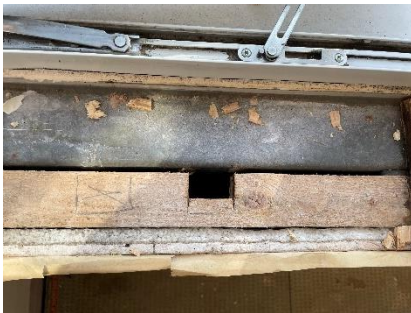
*The borescope could not access beneath or behind the PUR boards or the area where the cavity within the balcony meets the masonry or masonry cavity.*

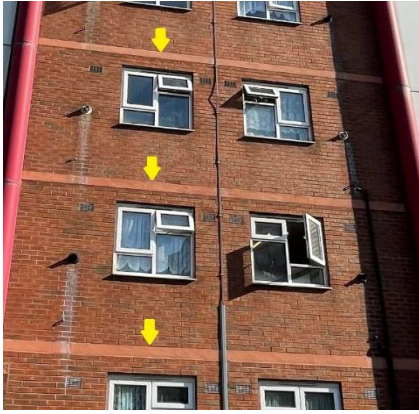
*At the time of the assessment, it was not determined if cavity barriers are in place around openings for windows, ventilation pipework and flues.*

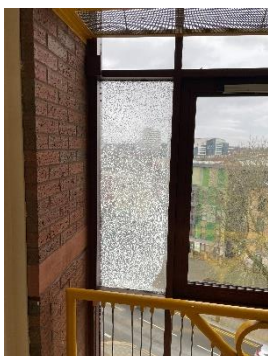
- 15) Inner glazing to the communal double glazed window between the 5<sup>th</sup> – 6<sup>th</sup> floor staircase has shattered; an emergency repair film has been applied. This is an outstanding action from the previous 2023 FRA
-

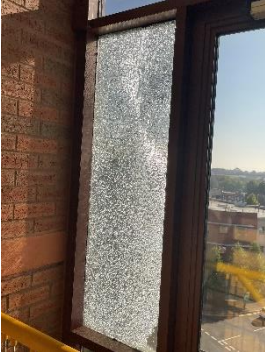
Question/ Ref No	Required Action	Supporting photograph	Priority	Timescale and Person Responsible	Date Completed
06/12	Upgrade internal walls to all balconies in all flats to provide a minimum 30 minute fire resistance. In conjunction with point 06/14 <b><i>Subject to outcome of the FRAEW Jan 2025.</i></b>	N/A	P3	Within 3 – 6 months. Specialist contractor	
07/14	Replace damaged glazing to communal window 5 <sup>th</sup> / 6 <sup>th</sup> floor front staircase. <b><i>Do not raise as new defect. Previously captured 09/23</i></b>

P2	Within 1 - 3 months. Glazing Repairs
