# Fire Risk Assessment

## Bowater House

Moor Street, West Bromwich,  
B70 7AZ

**Date Completed:** 5<sup>th</sup> September 2023

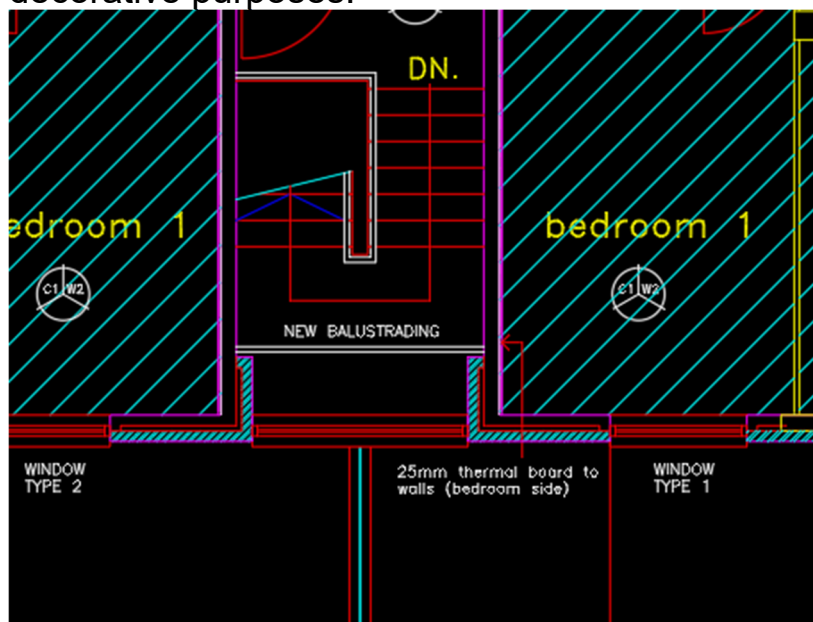
An MDF strip with unknown fire rating was removed to inspect the cavity between the 1-hour party wall between a flat and the stairwell. This is where external masonry returns into the protected front stairwell. The cavity between the two surfaces was insulated with mineral wool. At the time of the inspection it could not be determined if this cavity extended into the cavity of the external wall system.

Additional information was received after the inspection confirming that these cavities are in fact closed off by the return of the blockwork at the window positions. The MDF trim is in place for decorative purposes.

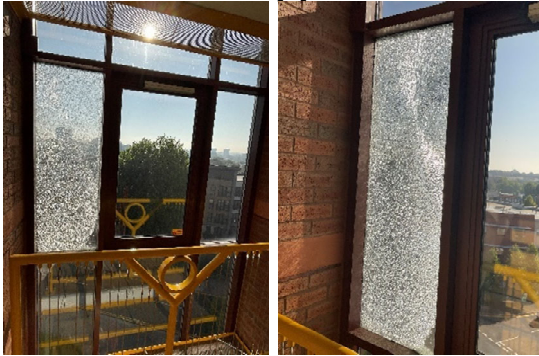
**Glazing to the communal window between the 5<sup>th</sup> – 6<sup>th</sup> floor staircase has shattered. It was noted that an emergency repair film had been applied.**

P1	Within 7-10 days. Team Lead Fire Safety (JB)	27/09/2023
07/14	Replace damaged glazing to communal window 5 <sup>th</sup> / 6 <sup>th</sup> floor front staircase.

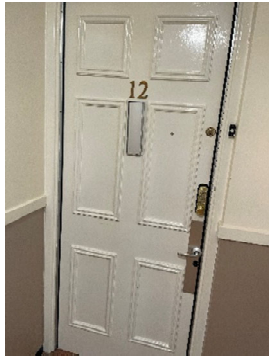
- a) It was noted that a digital lock had been installed to the door of flat 12.
-

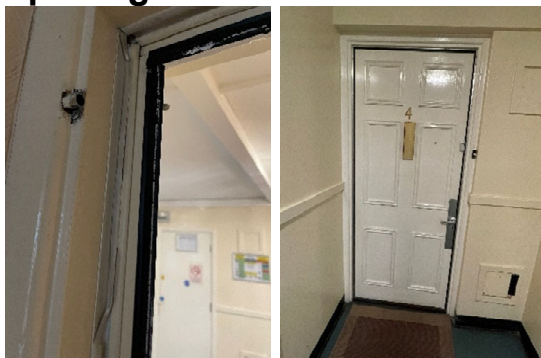
**b) Flat 4 – bat wing smoke seal part deteriorated on opening side of frame.**

<p>07/23b</p>	<p>Flat 4 – replace damaged batwing seal to entrance door</p>

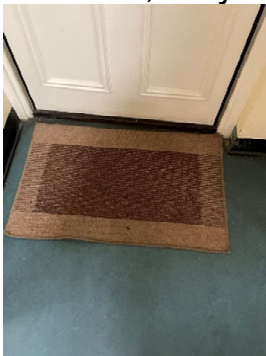
24) Access Individual floor mats were noted outside some flat entrance doors. The fire rating of the individual mats is unknown however, they are deemed to be of low risk.

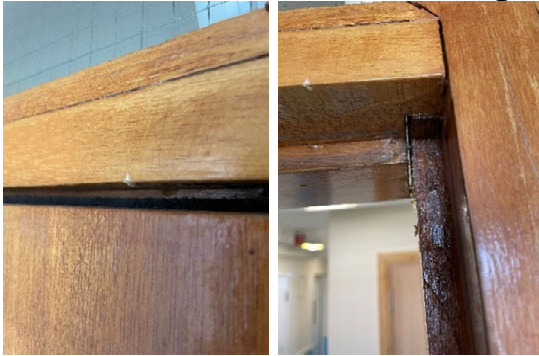
- 26) 8<sup>th</sup> floor communal door by flat 36 slight gap in joinery and cold smoke seal not meeting opposite edge to head.

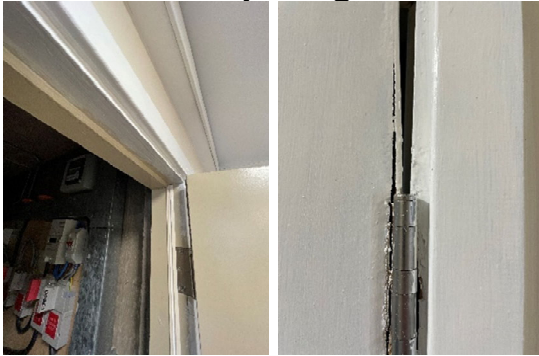
- 27) 8<sup>th</sup> floor service cupboard door missing batwing cold smoke seal to head. Also, excessive gaps to head and lower leading edge. It was also noted that there is a split in the door lip around the top hinge.

07/27	8 <sup>th</sup> floor service cupboard door - replace missing batwing seal to head of frame and repair split near top hinge.

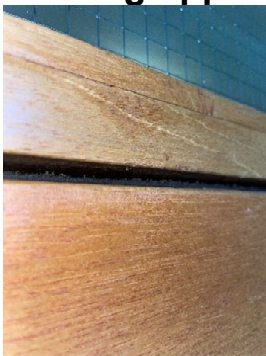
- 28) 8<sup>th</sup> floor by flat 34 excessive gap cold smoke seal not meeting opposite edge.

P2	Within 1 - 3 months. Rapid Fire Response JM:11817899	14/09/2023
07/28	8 <sup>th</sup> floor communal door by flat 34 - Rehang door to ensure cold smoke seal to head meets opposite edge.

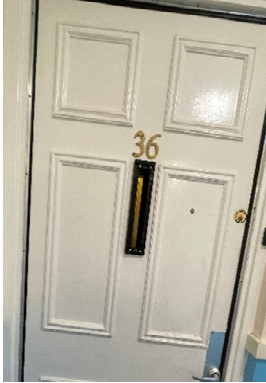
29) 8<sup>th</sup> floor flat 36 entrance door outer letterbox plate is missing.

P2	Within 1 - 3 months. Rapid Fire Response JM:11818003	14/09/2023
07/29	8 <sup>th</sup> floor flat 36 – replace missing outer letterbox plate.

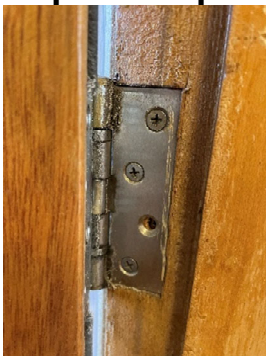
32) 6<sup>th</sup> floor communal door to stairs by flat 26 stairs a gap slightly larger than 4mm was noted however cold smoke seal maintains contact with opposite edge. **Missing screw form centre hinge requires replacement.**

P2	Within 1 - 3 months. Rapid Fire Response JM:11819051	14/09/2023
07/32	6 <sup>th</sup> floor communal door by flat 26 – replace missing screw to centre hinge.

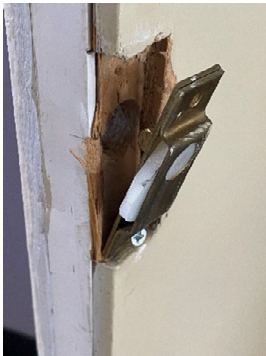
**33) 5<sup>th</sup> floor chute room door not over coming latch on self-closing action.**

P2	Within 1 - 3 months. Rapid Fire Response JM:11819059	14/09/2023
07/33	5 <sup>th</sup> floor chute room door requires adjustment to overcome latch.

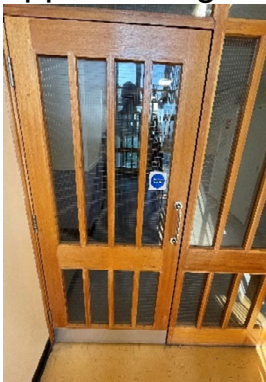
**35) 3<sup>rd</sup> floor communal door to stairs a gap slightly larger than 4mm was noted however cold smoke seal maintains contact with opposite edge.**

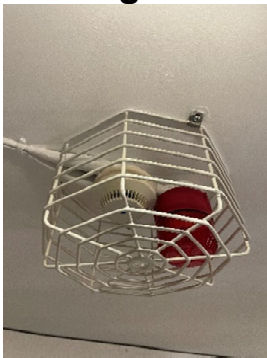
**At the time of the assessment it was noted that a sounder in zone 9 / 8<sup>th</sup> floor had been isolated. Confirmation was received by email from the electrical compliance manager (4/9/23) that attempts to locate a replacement device were ongoing due to the original sounder now being obsolete.**

<p>P2</p>	<p>Within 1 - 3 months. Rapid Fire Response JM:11819420</p>	<p>15/09/2023</p>
<p>08/05</p>	<p>Replace isolated sounder on the 8<sup>th</sup> floor zone 9</p>	<p>N/A</p>	<p>P2</p>	<p>Within 1 - 3 months. Electrical Compliance Manager</p>	<p><i>Sounder is obsolete attempts being made to source a replacement.</i></p>
<p>12/02</p>	<p>Review fire evacuation notices. Is stay put unless advice being abandoned, and consideration needs to be given to the fact that a communal fire alarm is currently installed and conflicts with stay put unless guidance and fire notice.</p>
