# Fire Risk Assessment

## Lissimore House

**Maria Street, West Bromwich,  
B70 6DR**

**Date Completed: 18/12/2023**

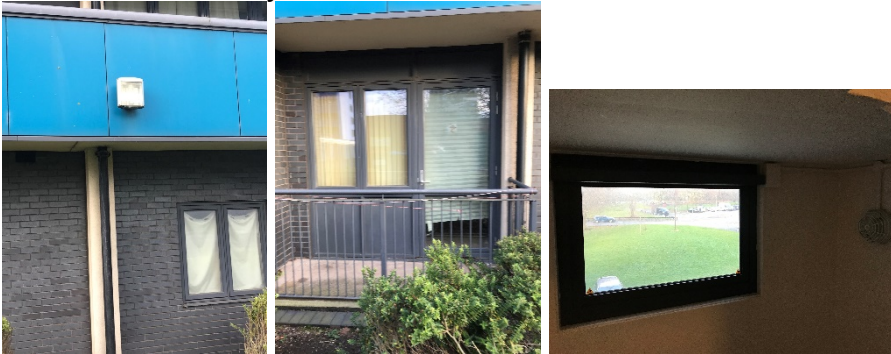
- 8) Open air natural ventilation Along the bin chute lobby area made of concrete construction at the rear of the block, it was noted that netting was present along this section of the premise the netting does not run down to the ground level and does not have easy access combined with sufficient compartmentation within the block and the stay put unless policy the council has reduces the overall risk. However an alternate option should be explored with future upgrades to the premises.

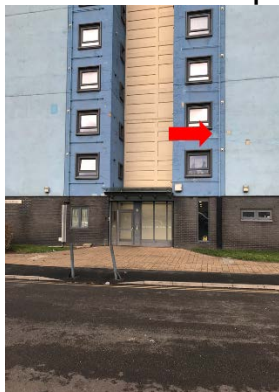
- 10) Flat 16 – netting placed on the balcony

*Under no circumstances should netting or screening be attached to balconies as they can support fire spread across the external of the building. Other options should be explored.*

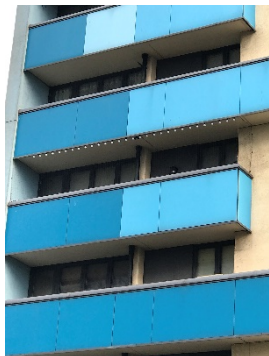
- 11) Flat 9 – Netting placed on the balcony.

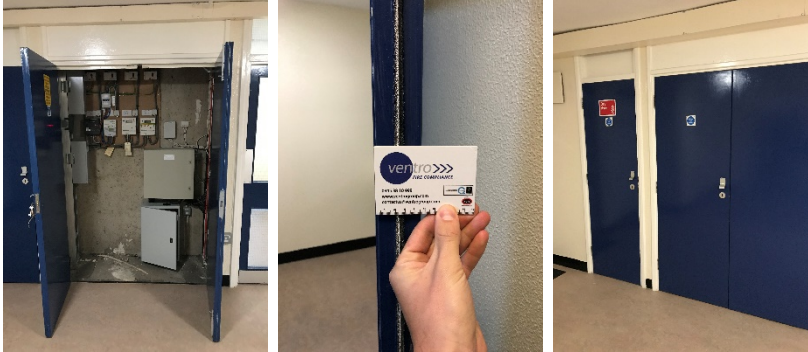
- 14) Noted the use of expanding foam was present within the communal cupboards around cabling as part of the fire stopping knowing that intumescent pads and a concrete slab is present and this foam is only used as an enhancement it is deemed tolerable. This should be enhanced as part of future works to the building and replaced with intumescent mastic to improve fire stopping.

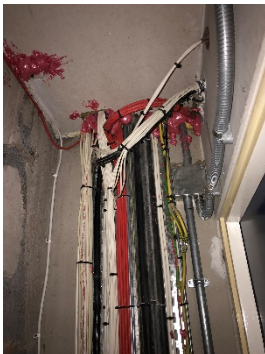
- 15) It is noted that there is some wear and tear was beginning to show on some cold smoke seals on communal doors and communal cupboards.
- 16) Third floor electrical riser/ meter cupboard & dry riser cupboard are damaged around ironmongery and cannot be secured correctly and expose large gaps. This has previously been highlighted and an email was sent while on site to get this resolved as soon as possible.
-

Update\* An order has been made for the replacment of the dammaged doors (see comments bellow)
