# Fire Risk Assessment

## Lissimore House

**Maria Street, West Bromwich,  
B70 6DR**

**Date Completed: 06/12/2024.**

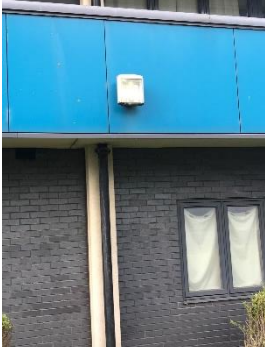
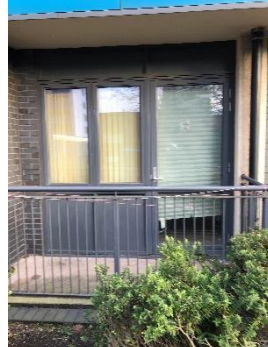
- 5) Bin store located at the rear elevation of the block; bin store is secured with a roller shutter door.
- 6) It was noted that some balconies had combustible materials in the form of hanging washing, this is deemed an acceptable risk due to the likelihood of a fire starting in this area being low combined with the temporary nature of the activity.
- 7) Aluminium faced timber composite windows to resident's flat windows/balcony doors and communal windows.

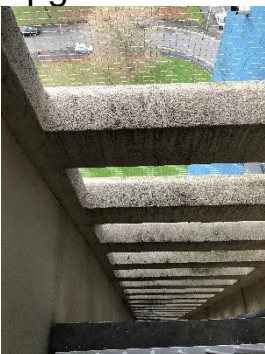
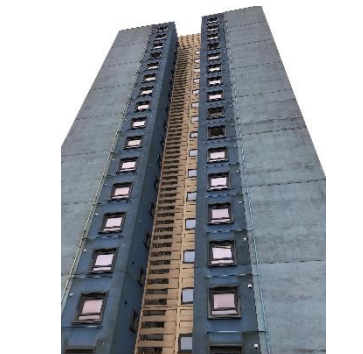
- 8) Open air natural ventilation along the bin chute lobby area made of concrete construction along the rear elevation. It was noted that netting was present along this section. The netting does not run down to the ground level and does not have easy access, combined with sufficient compartmentation within the block and the stay put unless policy, the council has reduced the overall risk. However an alternate option should be explored with future upgrades to the premises.

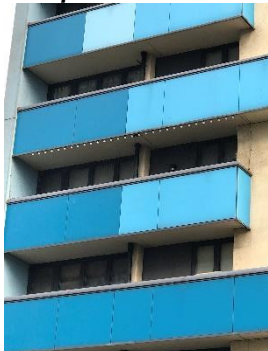
- 10) Flat 16 – netting placed on the balcony (*This was highlighted in the previous risk assessment*).

*Under no circumstances should netting or screening be attached to balconies as they can support fire spread across the external of the building. All netting should be removed, and other options should be explored.*

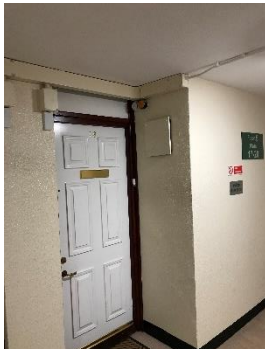
- 12) Access panels to stop taps are fixed to masonry and bedded on Intumescent material.**

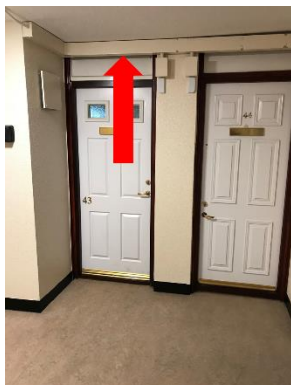
- 13) It was noted that metal trunking had been used within the communal areas to house cabling.**

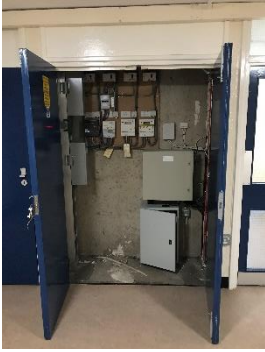
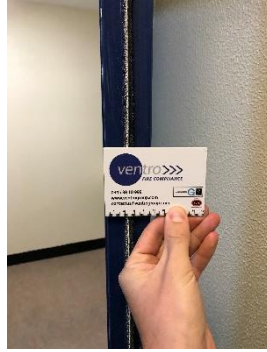
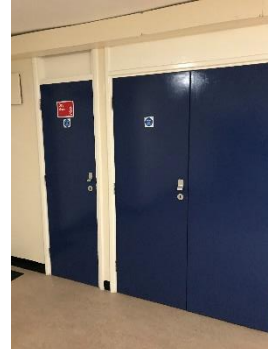
**15)** Noted the use of expanding foam was present within the communal cupboards around cabling as part of the fire stopping knowing that intumescent pads and a concrete slab is present and this foam is only used as an enhancement it is deemed tolerable. This should be enhanced as part of future works to the building and replaced with intumescent mastic to improve fire stopping.

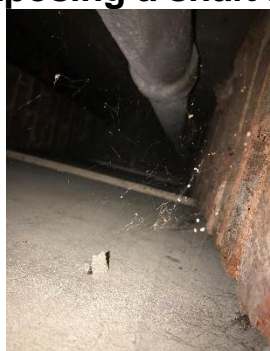
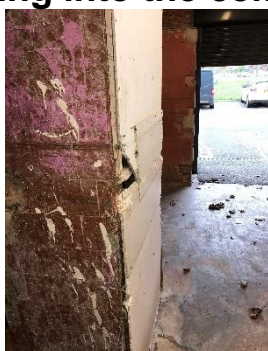
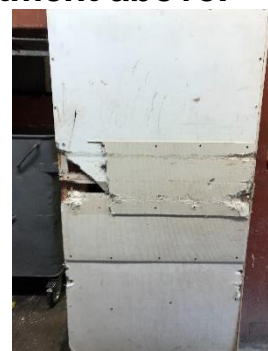
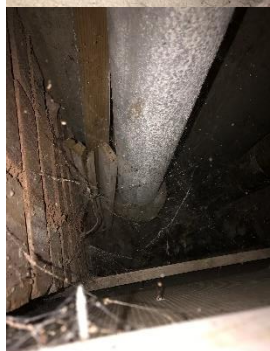
**18) Section within the ground floor bin room had been damaged exposing a shaft running into the compartment above.**

10/18	Bin store - Repair damage and install fire resistant board.

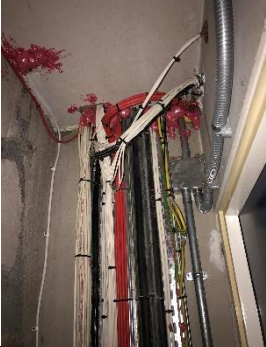
<p>Noted the use of expanding foam was present within the communal cupboards around cabling as part of the fire stopping knowing that intumeccent pads and a concrete slab is present and this foam is only used as an enhancement it is deemed tolerable. This should be enhanced as part of future works to the building and replaced with intumeccent mastic to improve fire stopping.</p>

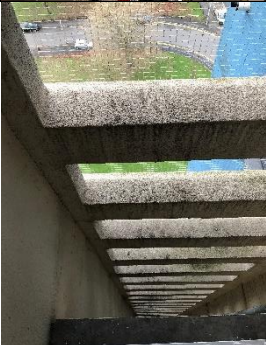
<p>It was noted that netting was present along the rear elevation of the premise Alternate option should be explored with future upgrades to the premises.</p>
