Fire Risk Assessment

Allen House

**1-36, West Road,
Great Barr, B43 5PS**

Date Completed: 24/11/2023

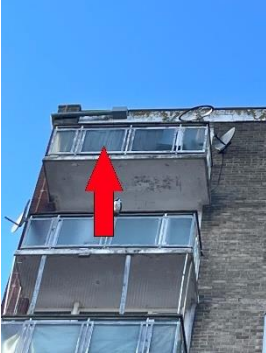
16) Flat 35 – Combustible screening installed to balcony.

P2	Within 1-3 months Housing Manager	
6/16	Flat 35 to remove combustible screening from balcony

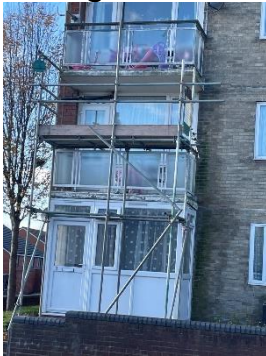
17) A temporary scaffolding structure was noted to the rear elevation during the assessment. The risk is considered as trivial.

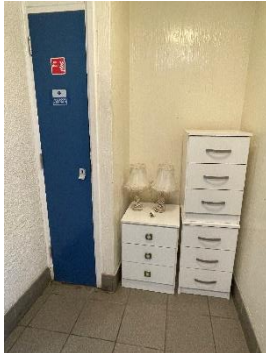
Discarded furniture was noted in the ground floor lift lobby however, this was immediately removed by caretaking staff.

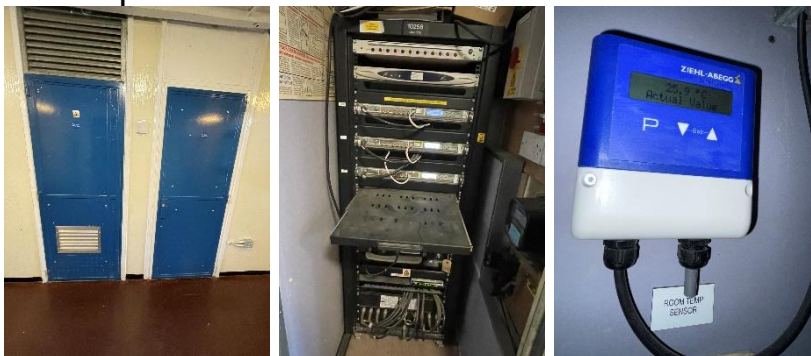
- 19) There is a service cupboard in the 7th floor lift lobby which contains equipment linked to the telecommunications equipment on the roof. There is an extraction fan within the cupboard which draws air through an intumescent louvre vent within the door. The fan then exhausts air through an intumescent louvre vent above to the transom. The air temperature within the cupboard is monitored by a sensor which is linked to the client via telemetry. The cupboard is secured with a nominal 30-minute steel fire door.

Relocate telecommunication equipment in the 7th floor service cupboard to a more suitable location.

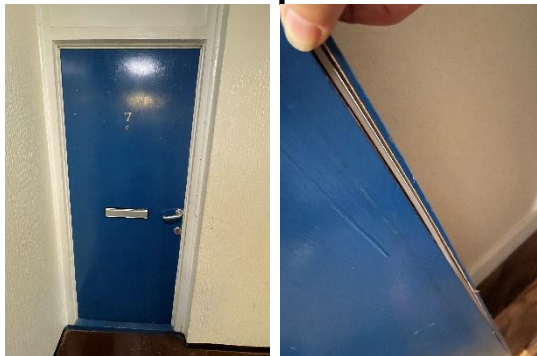
a) Flat 7 – Minor split in door leaf requires repair.

P2	Within 1-3 months Housing Manager	
7/23a	Flat 7 entrance door - repair split in door leaf.

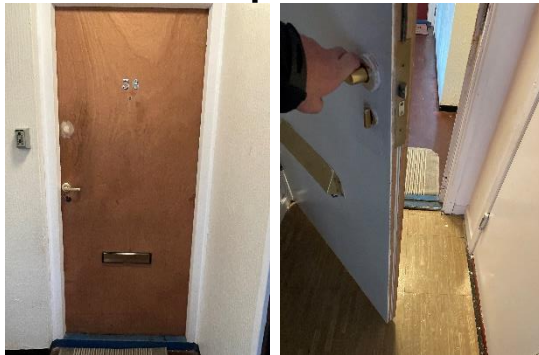
c) Flat 36 – Cold smoke seal missing from section of combined strip.

7/23c	Flat 36 entrance door – Replace missing section of combined cold smoke seal.

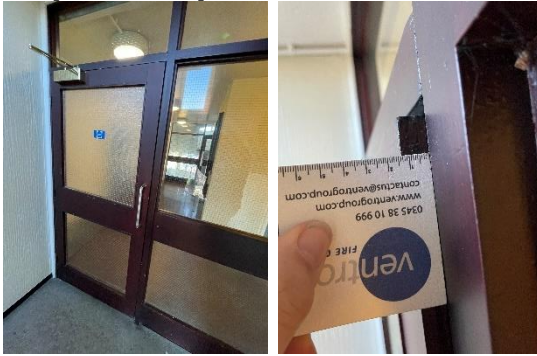
11) Communal landing door 6th floor by flat 27 warped and requires replacement.

P2	Within 1-3 months Rapid Fire Team JM:12594977	15/12/2023
10/11	6 th floor landing door by flat 27 warped / replacement required.

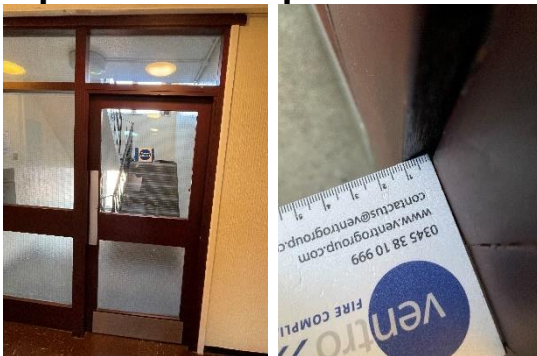
12) Communal landing door 3rd floor by flat 15 warped replacement required.

P4	Programmed work exceeding 6 months. Repairs.	
10/12	3 rd floor landing door by flat 15 warped / replacement required.

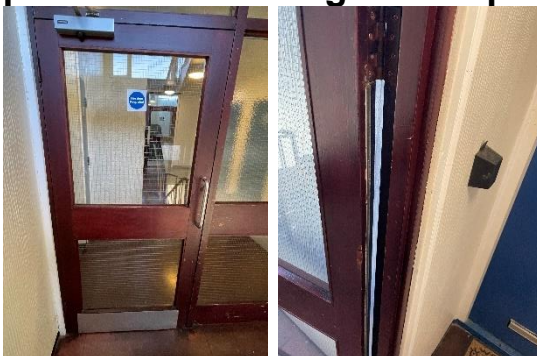
13) Communal landing door by flat 5 / 1st floor has only 2 hinges plus screw missing from top hinge.

10/13	1 st floor landing door by flat 5 install 3 rd hinge and replace missing screw to top hinge.

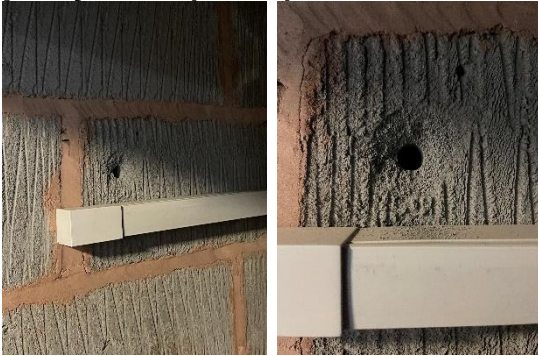
- 14) 1st floor service cupboard fire stopping required to hole in party wall (flat 7) above trunking.

P2	Within 1-3 months Rapid Fire Team JM:12595113	19/12/2023
10/14	1 st floor service cupboard - Fire stop hole to party wall (flat 7) above trunking.

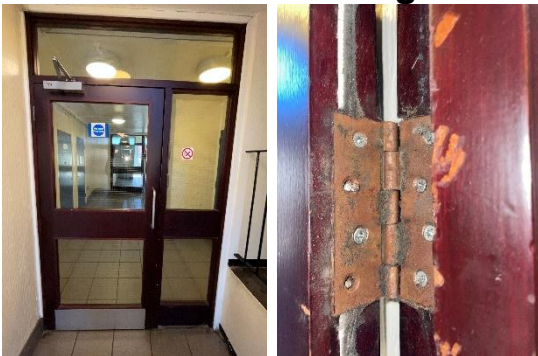
- 15) Communal door to rear staircase / ground floor – 2 x screw heads detached in hinge.

P2	Within 1-3 months Rapid Fire Team JM:12595171	19/12/2023
10/15	Ground floor rear staircase door – replace screws to top hinge with detached heads.

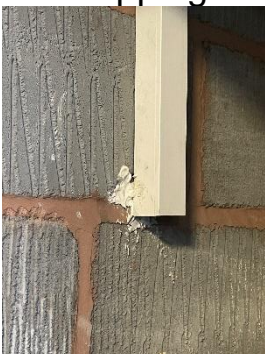
- 17) Plastic cable trunking was evident within some service cupboards. Firestopping was noted where cables penetrate party walls to flats.

Replace plastic trunking for cables in some service cupboards with a metal alternative with intumescent pads or pillows.
