Fire Risk Assessment

Allen House

**1-36, West Road,
Great Barr, B43 5PS**

Date Completed: 08/11/2024

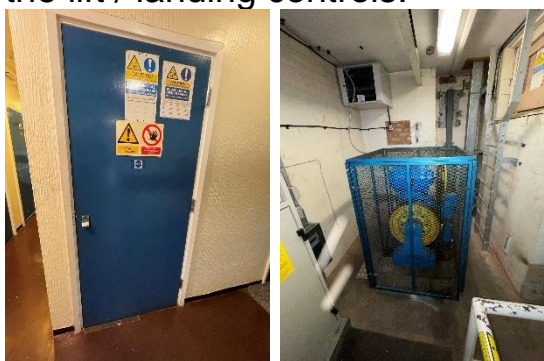
The lift car serves to the 7th floor with the motor room being located on the 8th. The lift system has **no** override facility for firefighters to secure the lift / landing controls.

Replace plastic trunking for cables in some service cupboards with a metal alternative with intumescent pads or pillows.	 	
Install firefighter override controls to the lift system.	n/a

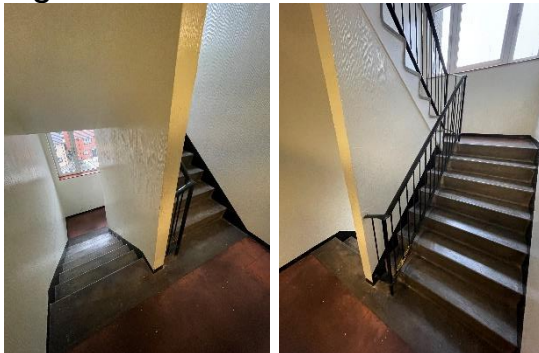
- 2) The staircase width is reduced to approximately 920mm on one flight between the 4th and 5th floor due to the dividing wall.

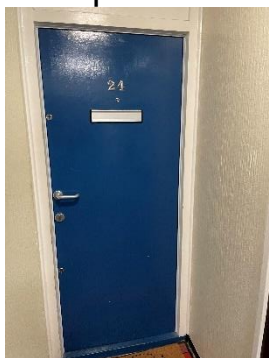
- 21) Access is gained to a sample of properties as part of the fire risk assessment to ensure the doors have not been tampered with by residents etc.
- a) Flat 24 Leaseholder property – Short section of intumescent strip / cold smoke seal on slamming edge slightly loose. Occupier has temporary repaired

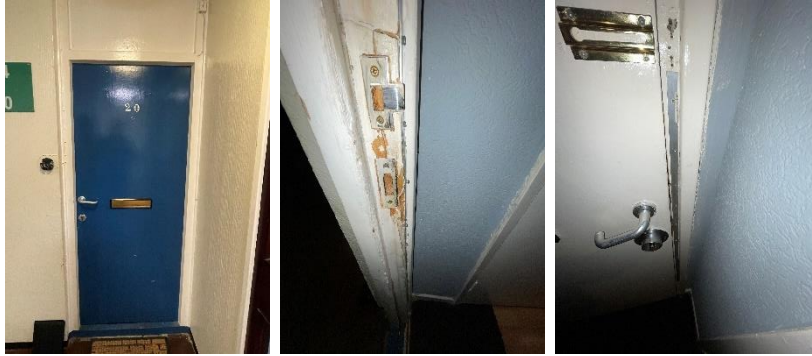
- b) Flat 20 – Significant damage to the frame around the latch resulting in the door failing to fully self-close (the tenant has attempted to repair). Also, the screws to the top hinge are not fully seated. Door and frame set will need to be replaced.
-

Question/ Ref No	Required Action	Supporting photograph	Priority	Timescale and Person Responsible	Date Completed
7/21b	<p>Flat 20 – install new FD30s flat entrance door & frame / transom set replacing existing damaged door / frame.</p> <p><i>Approximate measurements of existing door set. Door 1965 x 833mm Frame 2470 x 930mm</i></p>

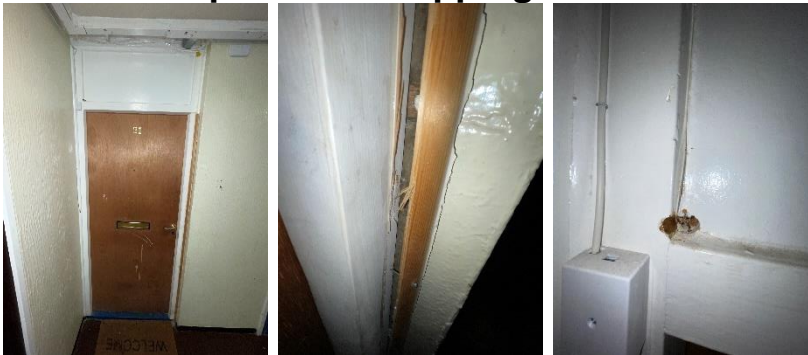
17) 7th floor flat 31 – vertical beading slamming side of frame is coming away from door frame. Fibreoptic cable noted through transom requires firestopping / intumescent mastic.

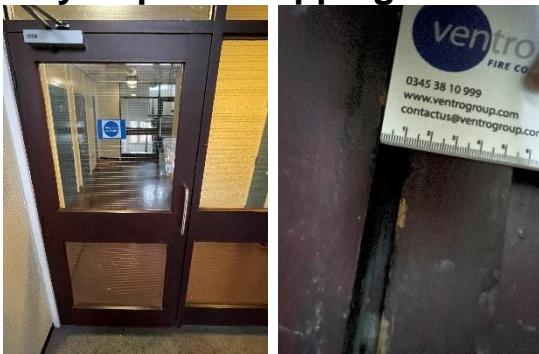
19) 5th floor communal / landing door by flat 23 – excessive gap approximately 15mm slamming edge from handle down. Door may require re-lipping.

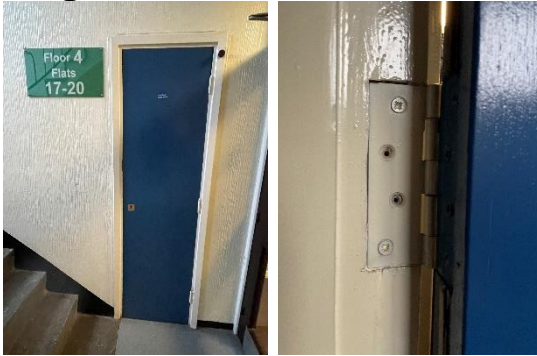
20) 4th floor cupboard on landing is missing screws from all hinges.

P2	Within 1-3 months Fire Rapid Response	
10/20	4 th floor landing service cupboard replace missing screws in hinges.

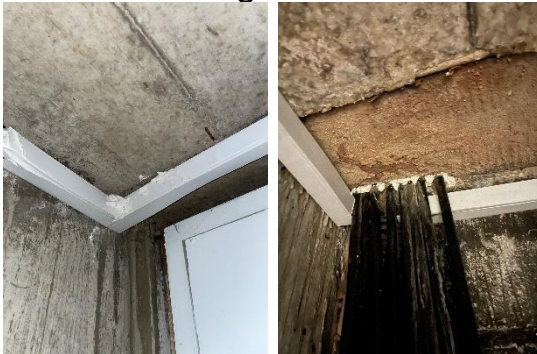
22) Plastic trunking was evident within some service cupboards.

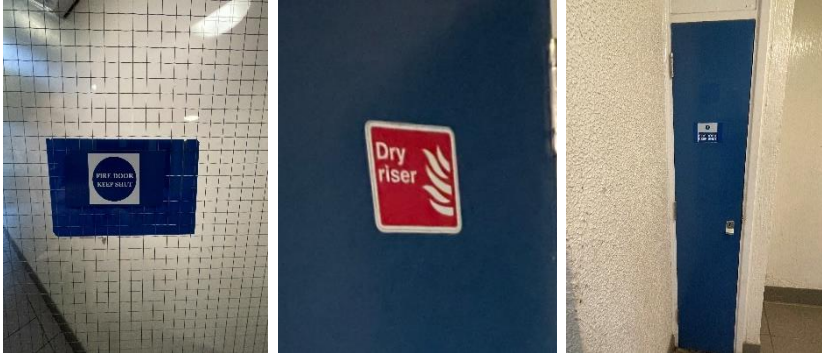
- 1) All fire doors display appropriate signage. **Ground floor dry riser inlet cupboard door is missing riser signage.**
