Fire Risk Assessment

Meadow Avenue (Aspen)

**Charlemont Farm, West Bromwich,
B71 3EF.**

Date Completed: 25th January 2024

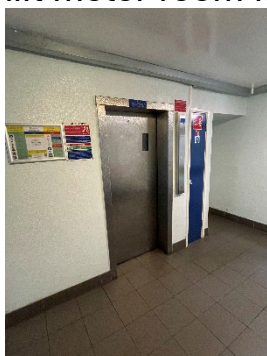
There is one lift car that serves the floors but only goes to floor 7 as the lift motor room is located on the top floor.

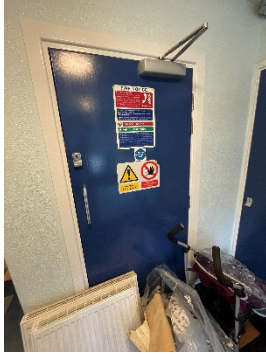
The lift motor room is located on the 8th Floor. Access to motor room via full height 60-minute timber fire door. A steel ladder provides access to the upper level then a further fixed vertical steel ladder provides access up to a three-quarter size steel door that leads out on the roof. Email sent to Caretaking Manager concerning waste outside.

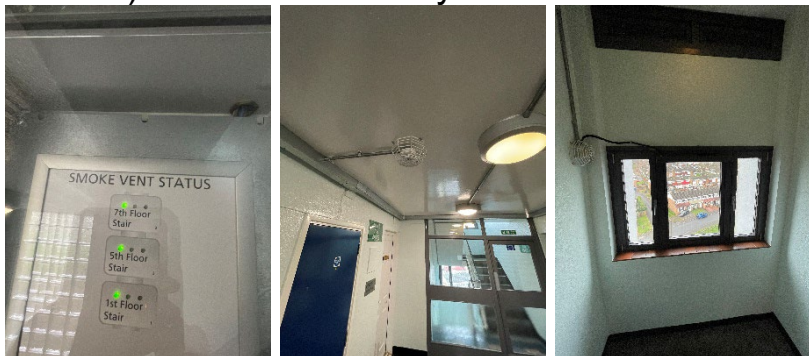
- 9) Automatic smoke ventilation is employed to the front staircase on floors: 1,5 and 8. This is tested, inspected and maintained by a competent procured contractor in accordance with BS7346. The frequency for the maintenance checks are twice per year (April and October) of each calendar year.

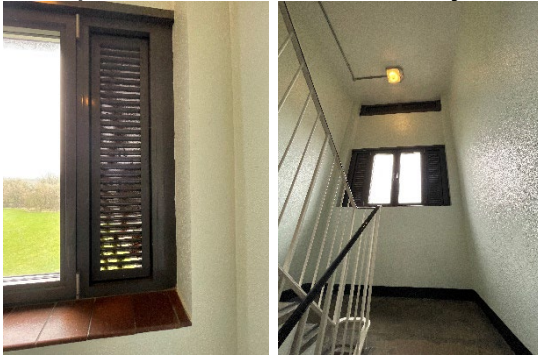
- 10) The rear staircase has louvre ventilation on all floors. Windows can be opened with use of a key.

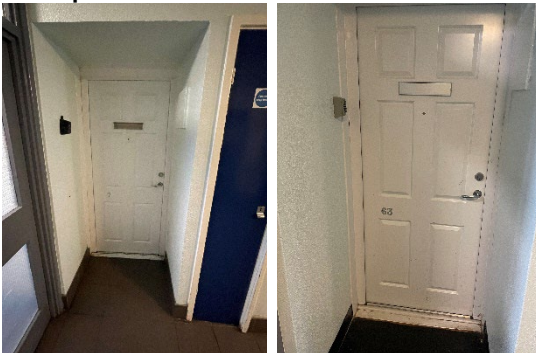
- 19) Individual flat entrance doors are FD 30S rated Permadoor of composite construction.

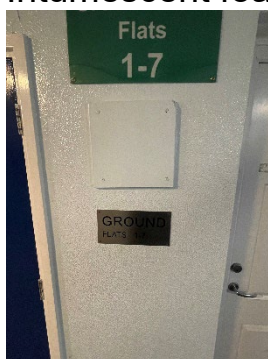
11) Access panels to stop taps are fixed to masonry and bedded on Intumescent foam.

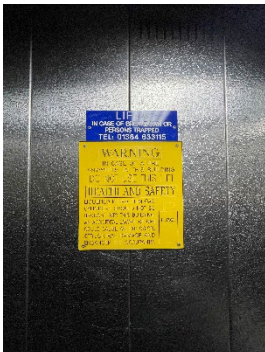
- 3) Yellow LPG warning signs are displayed within the lift cars.
