# Fire Risk Assessment

## Brookview

**Stanhope Road,  
Smethwick, B67 6HG**

**Date Completed: 17/07/2023**

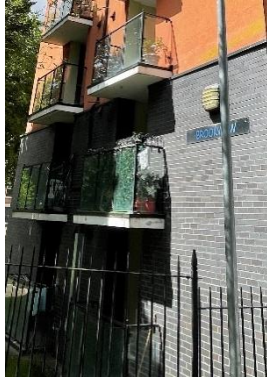
- a) 1<sup>st</sup> floor flat 4 - decorative mesh screening.

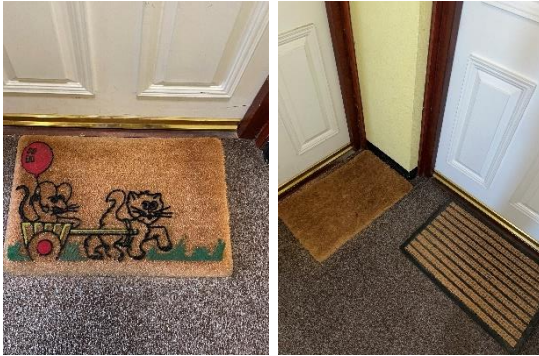
- 14) Individual floor mats were noted outside some flats. Fire rating of the mats is unknown but deemed to be of low risk.

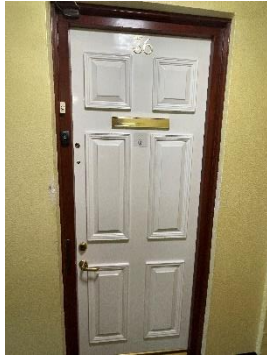
- b) Flat 36 – Overhead self-closing device missing from door.**

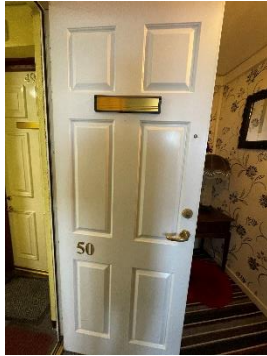
- d) Flat 50 – Overhead self-closing device missing from door.**

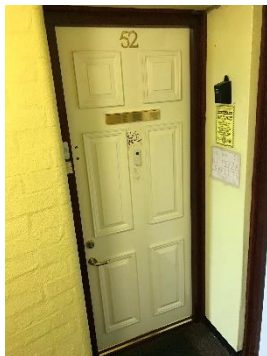
- e) Flat 52 - Overhead self-closing device missing from door.**

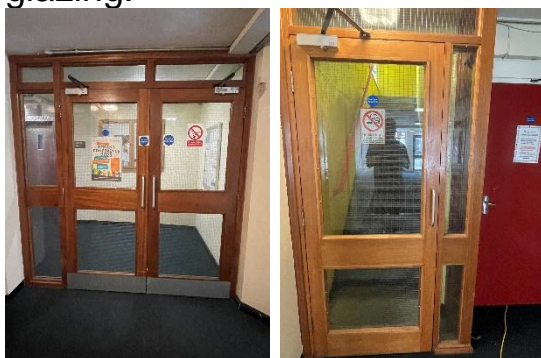
- 11) Floor L – communal door opposite flat 60, excessive gap to leading edge however smoke seals remain in contact with opposite edge.

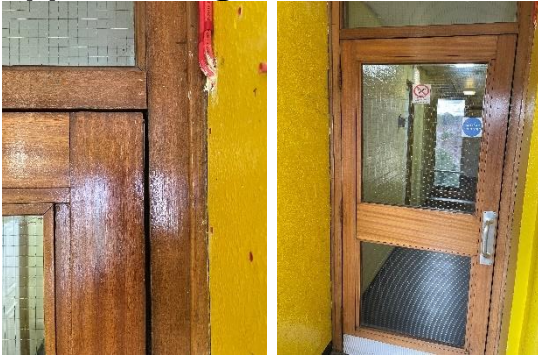
- 12) Floor J – communal door opposite flat 43, excessive gap to head. Smoke seals still meet opposite surface.

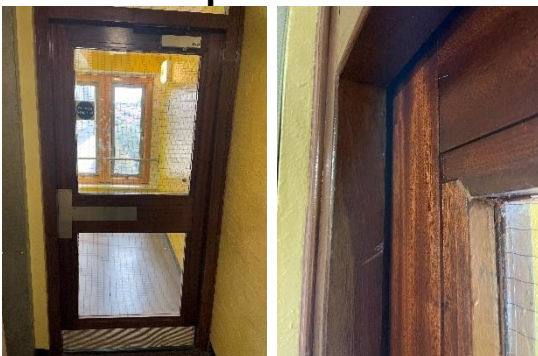
- 14) Floor G – communal door opposite chute room has excessive gap along the head. Cold smoke seal not touching the opposite surface.**

P3	Within 3 - 6 months. Repairs	
10/14	Floor G opposite chute room. Re-hang communal door to stairs to correct excessive gap to head.

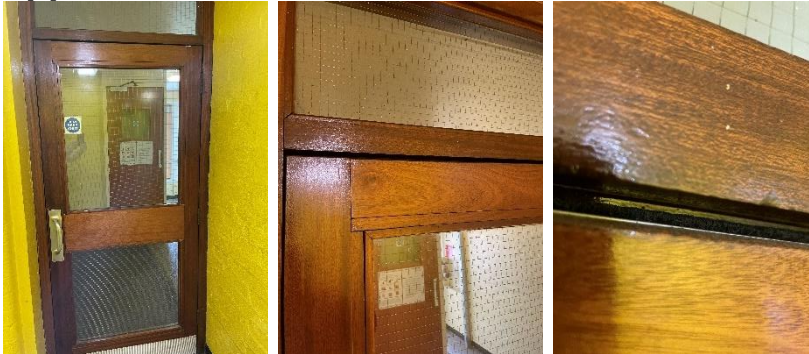
- 15) Floor F – communal stairwell door opposite flat 30 doesn't close fully against the stop because it is warped. There is a gap of around 8mm between the stop and the door.**

10/15	Floor F – communal door to stairwell opposite flat 30 – - Replace warped door to stairwell with FD30s certified door set with 30 minute fire resistant vision panels & transom window.

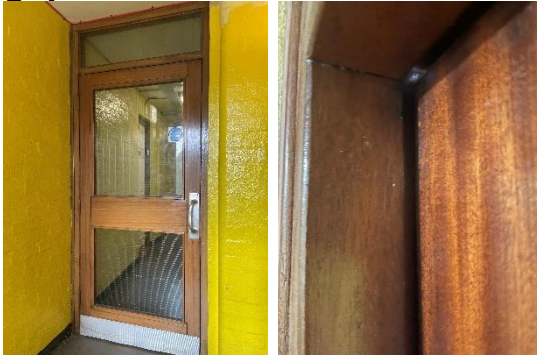
- 16) Floor F – communal door to stairs opposite chute room, excessive gap to head and leading edge. Cold smoke seals are not in contact with opposite edge.**

P3	Within 3 - 6 months. Repairs	
10/16	Floor F – communal door to stairwell opposite chute room – Re-hang door to correct excessive gap to head & handle side

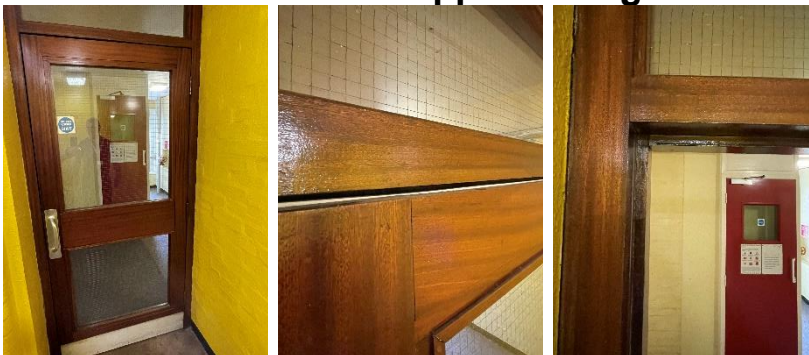
- 17) Floor E – communal door to stairs opposite chute room, door not closing fully against stop also has an excessive gap to head.

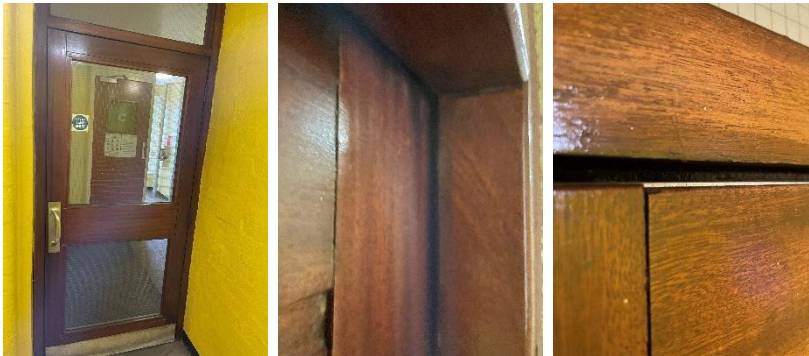
- 18) Floor D – communal door to stairs opposite chute room, excessive gap of approximately 8mm. Smoke seals remain in contact with opposite edge.

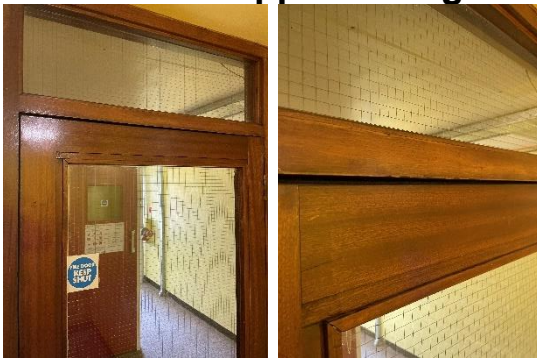
- 19) Floor D – communal door to stairs opposite flat 18 is warped along bottom edge creating a gap of around 10mm between the door and frame.

10/19	Floor D - communal door to stairwell opposite flat 18 –  - Replace warped door to stairwell with FD30s certified door set with 30 minute fire resistant vision panels & transom window.	 	P3	Within 3 - 6 months. Repairs	
10/20	Floor C – communal door to stairwell opposite chute room - Re-hang door to correct excessive gap to head.	 	P2	Within 1 - 3 months. Rapid Fire Response JM:11976151	04/10/2023

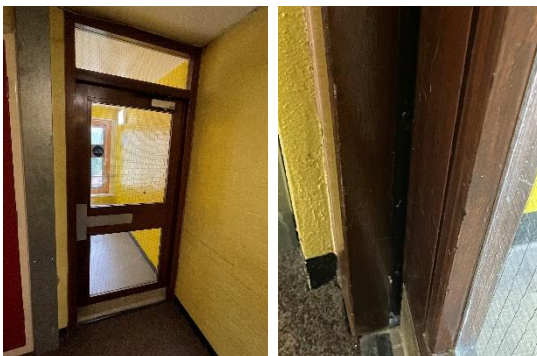
**20) Floor C – communal door to stairs opposite chute room has excessive gap to head.**

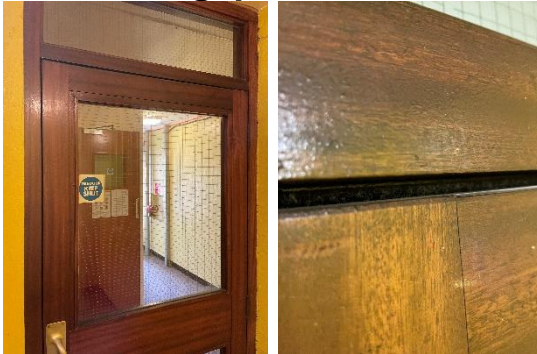
**21) Floor B - communal door to stairs opposite chute room excessive gap to head, cold smoke seal does meet opposite edge.**

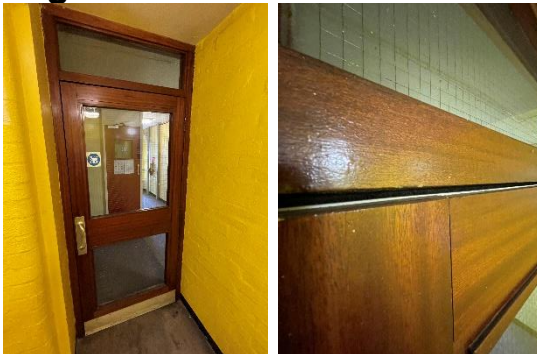
**22) Floor B – communal door to stairs by flat 6 is significantly warped and fails to shut fully against stop.**

P2	Within 1 - 3 months. Rapid Fire Response JM:11976194	04/10/2023
10/22	Floor B – communal door to stairwell by flat 6 - - Replace warped door to stairwell with FD30s certified door set with 30 minute fire resistant vision panels & transom window.

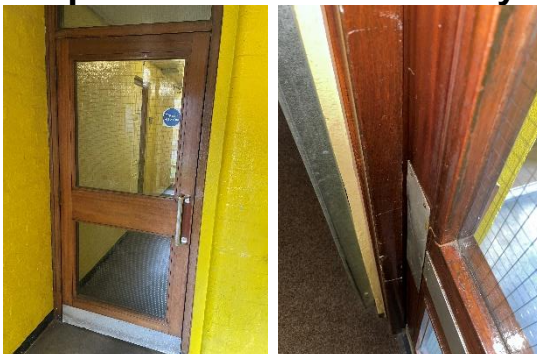
- 23) There is a small hole approximately 3 x 2 cm within the corner of the combination frame to the ground floor communal door to the protected stairs adjacent the cleaners store.

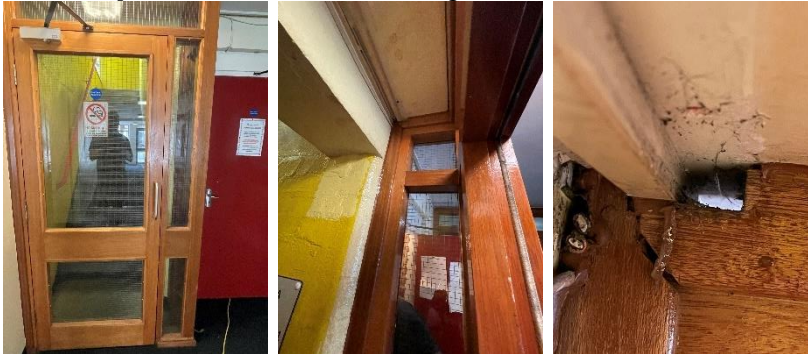
- 24) There is a small gap to the top of the combination frame above communal doors from lift lobby to entrance lobby. Also, the cold smoke seal is worn in parts along leading edge creating a slight gap between the doors.

10/24	Ground communal doors / lift lobby – Replace worn combined cold smoke seal to reduce gap between doors & apply intumescent mastic to gap beneath trunking.

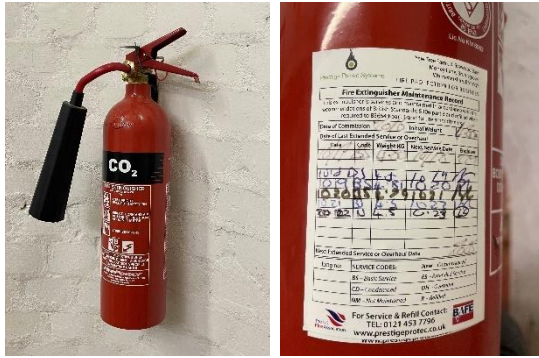
- 6) The CO<sub>2</sub> fire extinguisher within the lift motor room is not easily accessible because the user would have to step across an open floor hatch to gain access. The extinguisher should be mounted on a suitable stand and re-located as per the image below.
