# Fire Risk Assessment

## Kynaston House

**Rydding Lane, Millfield's,  
B71 2HD**

**Date Completed: 06/03/2024.**

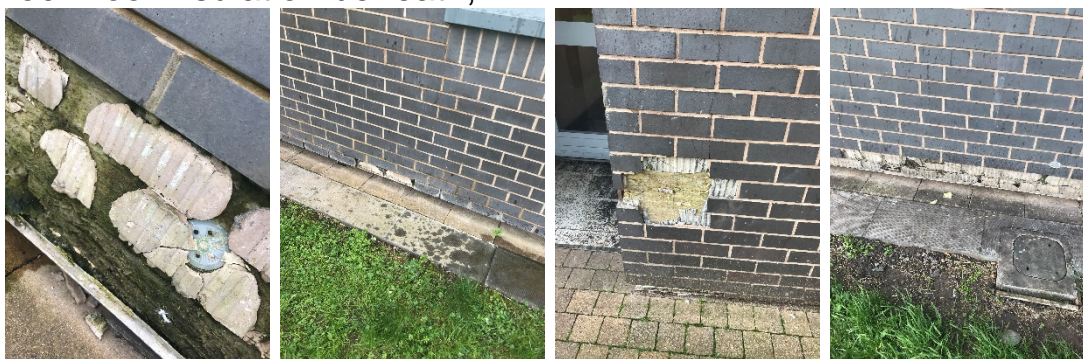
- 10) Brick slips were seen to be coming away from the external envelope of the building on all four elevations exposing the rockwool insulation beneath,

Brick slips were seen to be coming away from the external envelope of the building on all four elevations exposing the rockwool insulation beneath measures are being implemented to make patchwork repairs.	This has been actioned. It has been sent to contractor Tyra to make good the defects
The use of foam was identified around door frames on the ground floor service cupboard this should be removed and enhanced in the next cyclical checks at the block that are completed every 12 weeks.	This has been passed to the inhouse Fire Rapid Response Team to be completed before end of March 2024.
Access could not be gained to the PIB (Premise Information Box) due to a faulty lock, Gerda the supplier of the box has been notified and an engineer is to make an appointment to make necessary urgent repairs.

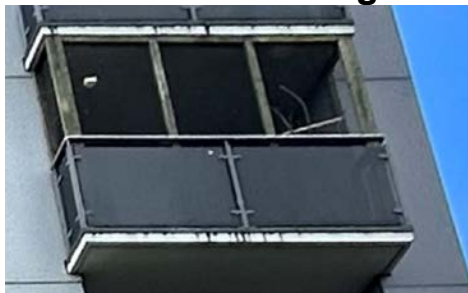
- 11) Flat 22 on the rear elevation balcony contains a timber structure and netting.

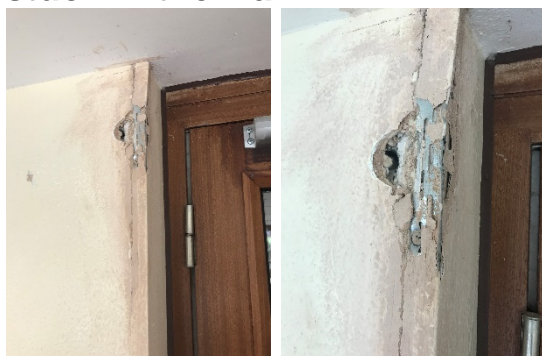
- 21) **Damage to wall near the lift entrance lobby can leave door so that it can't close into frame due to the self-closer getting stuck in the wall.**

07/21	Repair damage to wall in ground floor lobby area and fire stop appropriately

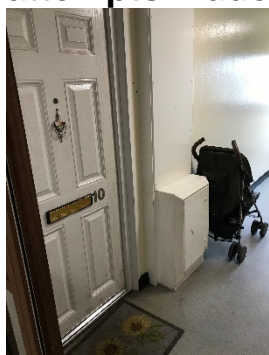
- 22) **3<sup>rd</sup> floor Pushchair left in communal area outside flat 10 attempts made to make contact while on site**

P2	1-3 Months Fire Rapid response	
07/22	3 <sup>rd</sup> floor flat 10 Remove pushchair from communal landing
