Fire Risk Assessment

Lawrence Court

Aldridge Road Smethwick, B68 OHB

Date Completed: 07/05/24.

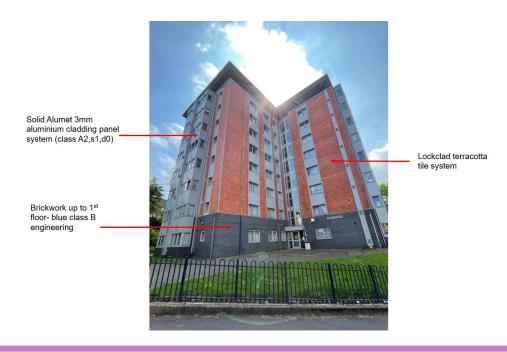
It is deemed that the combination and application of these materials in conjunction with a non-combustible mineral wool insulation present an acceptable level of fire risk.

- 1. Lawrence Court has 3 separate areas of cladding consisting of.
 - Brickwork up to 1st floor blue class B engineering.
 - Solid Alumet 3mm aluminium cladding panel system (class A2,s1,d0).
 - Lockclad terracotta tile system.
- 2. The pitched roof was installed during 2007 refurbishment works and consists of a steel frame & aluminium standing seam mineral wool core construction.

- 3. Windows to flats are composite timber framed with external powder coated aluminium finish. Communal windows are powder coated aluminium.
- 4. Intumescent pillow has been used to enhance the fire stopping where a gas boiler flue has been removed.
