# Fire Risk Assessment

## Oak Court

**Acacia Avenue, Yew Tree Estate,  
WS5 4BH**

**Date Completed: 22/02/2024.**

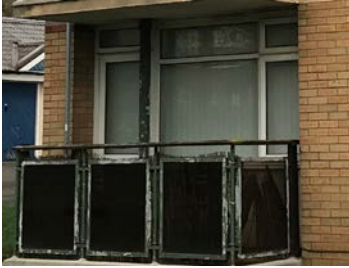
- 8) Flat 44 timber screening attached to the ground floor balcony.

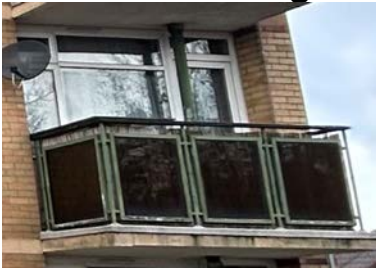
- 9) Flat 47 Screening attached to 1<sup>st</sup> floor balcony.

06/09	Flat 47 Remove screening from balcony	 	P3	3-6 months Housing Manager	
06/10	Flat 46 Remove fire loading from balcony	 	P3	3-6 months Housing Manager	
07/28	Communal door nearest flat 72, replace missing intumescent strips form door and check top hinge	 	P3	3-6 months Fire Rapid Response

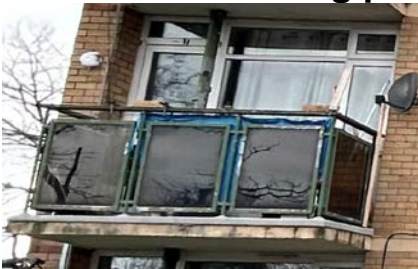
- 10) Flat 46 Fire loading present on balcony

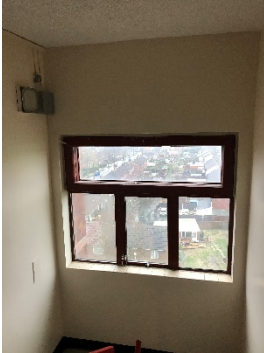
26) Wayfinding signange has been introduced on all floors within the block including lift lobby and each stair landing area. It was noted that during the FRA there was painting taking lpace at the block and some signage had been removed during the process

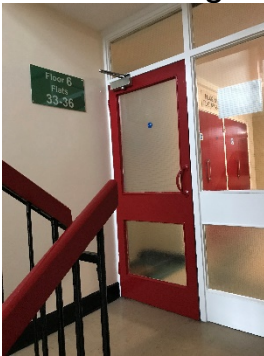
27) It was noted that some doors had slightly larger gaps around door however due to them being notional door with a 25mm rebate and th doors already being upgraded to include intumescent strips and cold smoke seals this was deemed tolerable

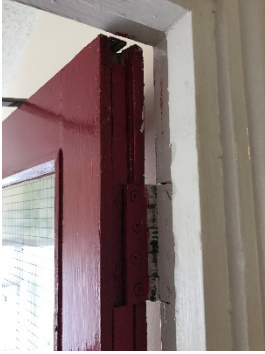
- 28) **Communal door nearest flat 72 on the top is missing intumescent strips from the top and bottom hinge side of door and ironwork (hinge) requires check**

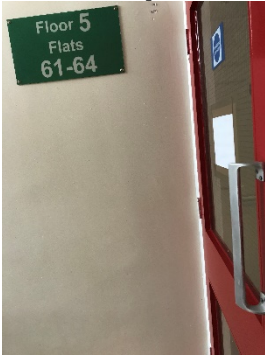
- 29) **Handle to 5<sup>th</sup> floor rear staircase is loosely fasten attached to door requires tightening**

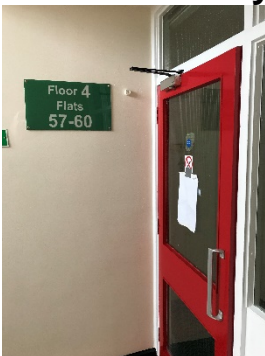
- 30) **4<sup>th</sup> floor front stairwell door does not fully self close into frame correctly**

P3	3-6 months Fire Rapid Response	
07/30	4 <sup>th</sup> floor front stairwell communal door make good so self closes into frame correctly

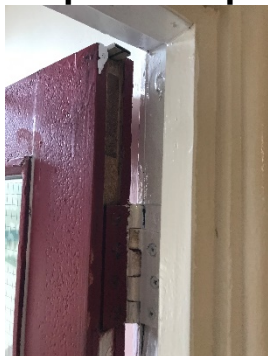
- 31) 2<sup>nd</sup> floor communal door nearest flat 52 missing intumescent strip from top hinge side of door

P3	3-6 months Fire rapid response	
07/31	2 <sup>nd</sup> floor nearest flat 32 replace missing intumescent strip from top hinge side of door

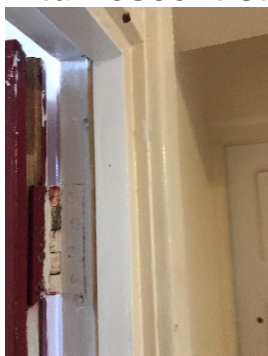
- 32) 1<sup>st</sup> floor Communal door nearest flat 46 missing intumescent strip form top hinge side of door

07/32	1 <sup>st</sup> floor communal door nearest flat 46 replace missing intumescent strip

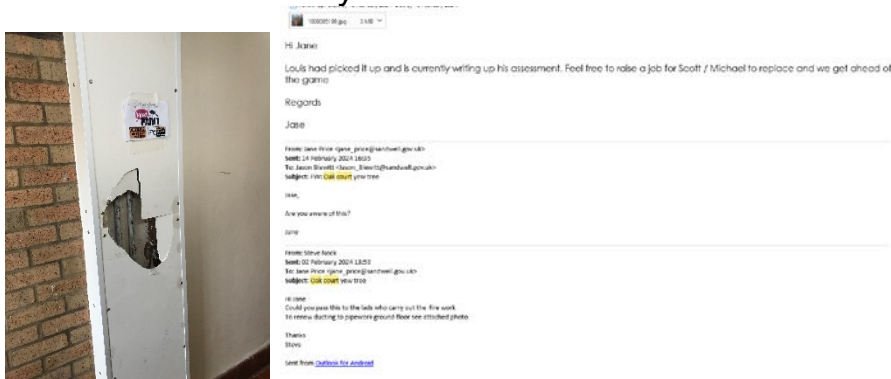
- 34) Noted Damaged conduit was found in the ground floor communal area and has already been actioned

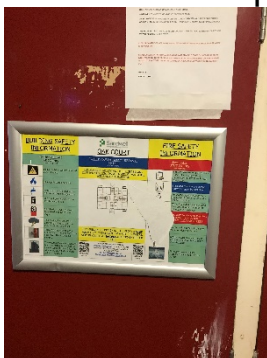
- 10) Information regarding building safety is contained within a Building Safety Notice. This is affixed to the wall on the ground floor lift lobby of high-rise blocks, noted the sign was damaged and needs a replacement.
