# Fire Risk Assessment Broadmede House

# Pavilion Avenue, Smethwick, B67 6LB

**Date Completed:** 24/04/2024.

Officer: C. Hill Fire Risk Assessor

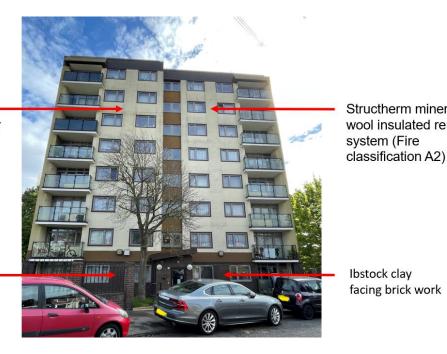
#### Front Elevation

However, the presence of anti-bird netting (flat 24) and timber trellis (flat 20) that has been installed to two balconies could potentially support the external spread of flame in the event of a fire.

Structherm mineral wool insulated render system (Fire classification A2)

Ibstock clay

facing brick work
