# Fire Risk Assessment Scott House

Langdale Road Great Barr, B43 5RD

**Date Completed:** 21/10/2024

**Current Risk Rating = Tolerable**

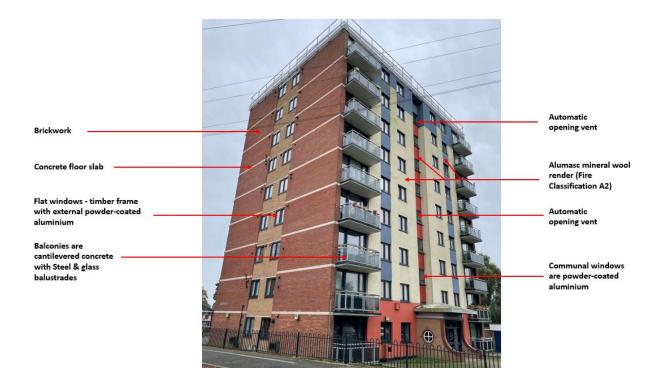
The addition of combustible screening to one balcony could potentially support the surface spread of flame in that area which is an unnecessary risk. Once this is removed the level of risk presented by materials present to the external envelope of this building would become acceptable

2) Flat 12 was noted to have installed combustible screening to the balcony.
