Fire Risk Assessment

Lancaster House

**1-120, Oldbury Rd,
Rowley Regis, B65 0QF**

Date Completed: 10/04/2024

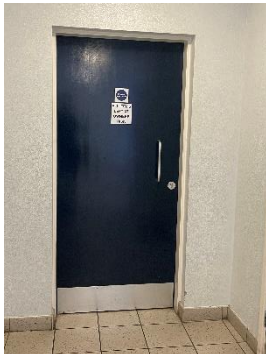
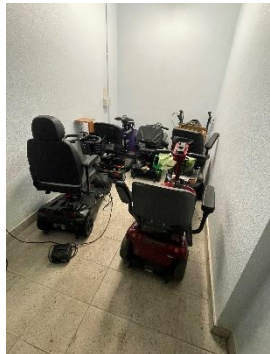
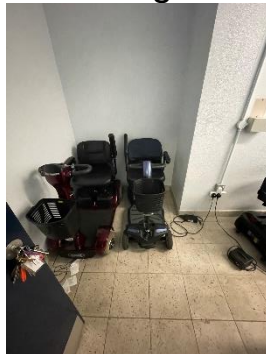
There is storage room to the ground floor lobby which is used by residents to store and charge mobility scooters. It was noted that this room does not have any means of fire detection and is secured by a nominal FD30s door which isn't self-closing.

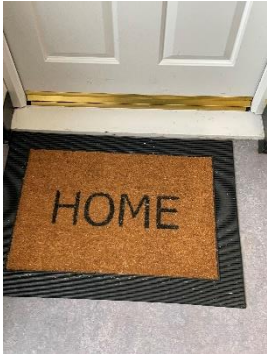
- 15) Individual floor mats were noted outside some flats. Fire rating of the mats is unknown but deemed to be of low risk.

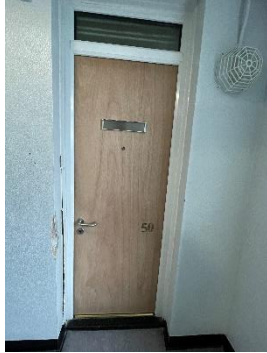
j) Flat 50 – The door installed was temporary timber flush FD30s nominal door. The door was noted as correct but with some slight damage to the frame. A new composite FD30s

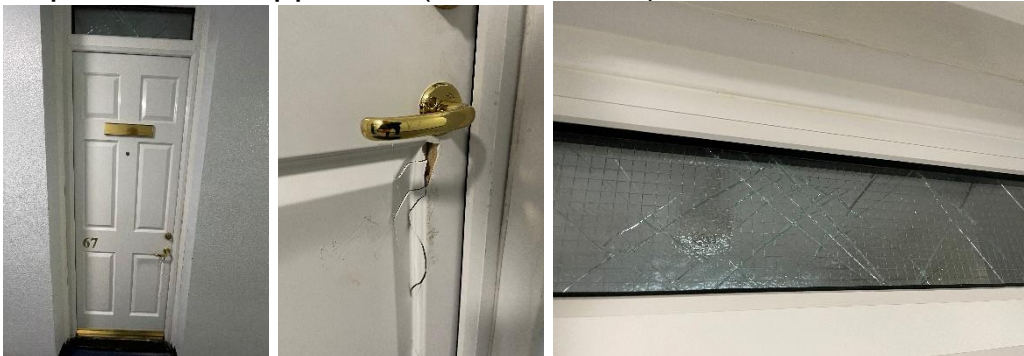
23) Flat 67 wasn't accessible however, it was noted that the door and transom had superficial damage. SMBC Job Manager system confirms that an emergency replacement fire door set has been requested and approved (JM13397529).

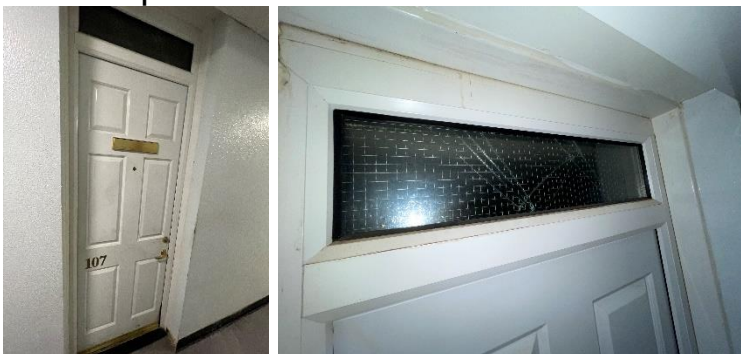
24) Flat 107, the transom glass above the entrance door has been damaged and is cracked. SMBC Job Manager system confirms that a replacement has been ordered.

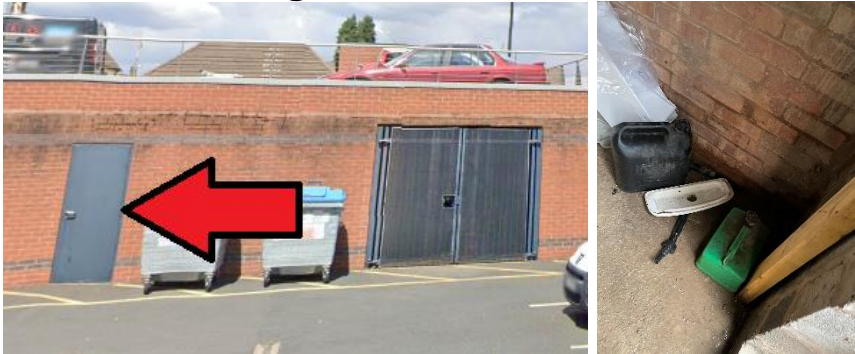
- 7) Two fuel cans were noted in the left side store. Fuel cans should be stored in an appropriate steel container or removed from the building.

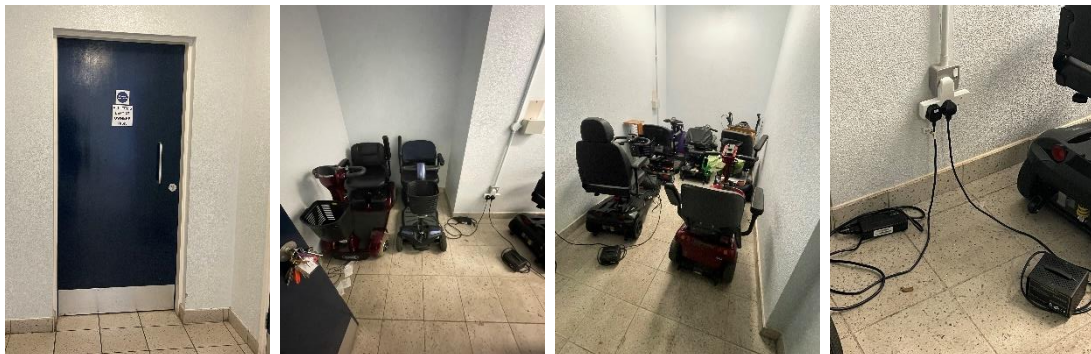
- 8) There is a room utilised for the storage of resident's mobility scooters. The room is accessed from the ground floor lift lobby via a secured FD30s nominal timber fire door (not self-closing). There was evidence of battery charging with two scooters plugged in to a single gang socket via an extension adaptor. The 13-amp adaptor was noted as not being overloaded (8 amps). Other items such as a folding mattress and a shelving unit were noted in the room. There is no fire detection system to alert residents prior to entering the room nor is there any fire suppression system. Fire & smoke logging in this location could potentially affect the lift lobby should a resident fail to close the door upon discovering a fire.

P1	Within 10 days Repairs	18/04/2024
18/8	Establish a policy for the safe storage and charging of mobility scooters or reduce the risk by installing fire detection or by removing the facility to charge batteries in this room. Also
