Fire Risk Assessment

Sheapcoate House

**Beaconview Road, West Bromwich,
B71 3PP**

Date Completed: 29/01/2024

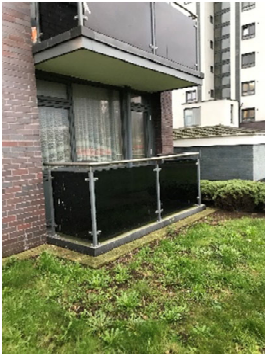
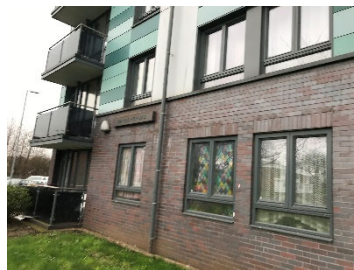
- 6) It was noted that some balconies may have had combustible materials in the form of hanging washing this is deemed acceptable risk due to the likelihood of a fire starting in this area being low and combined with the temporary nature of the activity
- 7) Aluminium faced timber composite windows to residents flat windows/balcony doors and communal windows

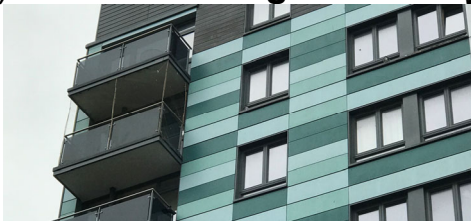
- 12) **Flat 29 Netting to balcony**

Under no circumstances should netting or screening be attached to balconies as they can support fire spread across the external of the building. Other options should be explored.

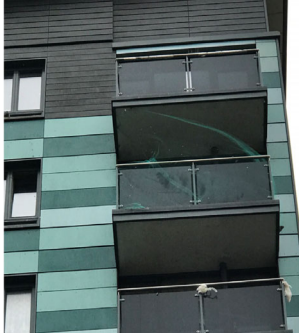
13) Flat 30 Netting to balcony

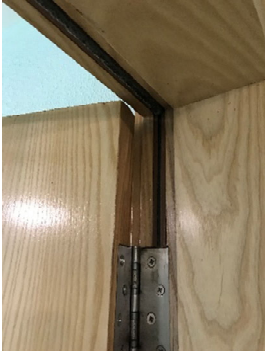
- 22) 4th floor missing cold smoke seal at top corner hinge side**

P3	Housing Manager 3-6 months	
07/21	Ground floor Replacement of missing cold smoke seal to lift lobby communal door	N/A	P2	Fire Rapid Response 1-3 months	
07/22	4 th floor Replacement of cold smoke seal missing from communal door to lift lobby

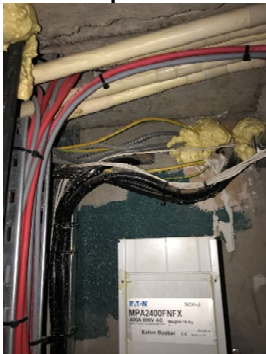
- 12) Noted the use of expanding foam was present within the communal cupboards around cabling as part of the fire stopping knowing that intumescent pads and a concrete slab is present and this foam is only used as an enhancement it is deemed tolerable. This should be enhanced as part of future works to the building and replaced with intumescent mastic to improve fire stopping

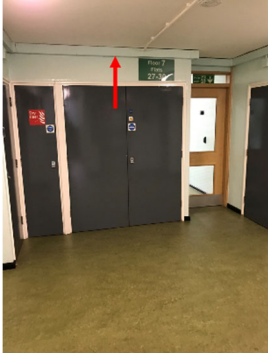
- 14) It was noted that metal trunking had been utilised to house cabling in communal areas
