Fire Risk Assessment

Stanton House

**Beaconview Road, West Bromwich,
B71 3PW**

Date Completed: 29/01/2024

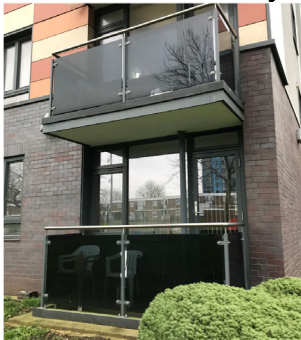
- 6) It was noted that some balconies may have had combustible materials in the form of hanging washing this is deemed acceptable risk due to the likelihood of a fire starting in this area being low and combined with the temporary nature of the activity
- 7) Aluminium faced timber composite windows to residents flat windows/balcony doors and communal windows

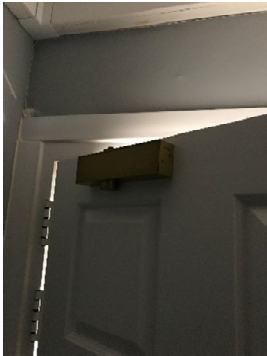
Flat 23 had no self-closer attached to door and no cold smoke seals

Question/ Ref No	Required Action	Supporting photograph	Priority	Timescale and Person Responsible	Date Completed
07/19	Flat 23 attach missing self-closing device and install cold smoke seals

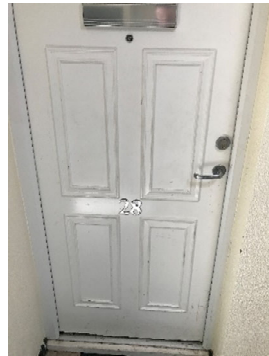
- 21) Large gaps along the bottom edge of door where it is visible to see into the flat from hallway no access granted on day of risk assessment email has been sent to GA.

Update: Email from GA confirming that this has been added to the emergency door list and for someone to attend 07/02/2024

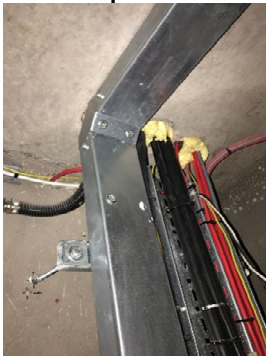
- 12) Noted the use of expanding foam was present within the communal cupboards around cabling as part of the fire stopping knowing that intumescent pads and a concrete slab is present and this foam is only used as an enhancement it is deemed tolerable. This should be enhanced as part of future works to the building and replaced with intumescent mastic to improve fire stopping

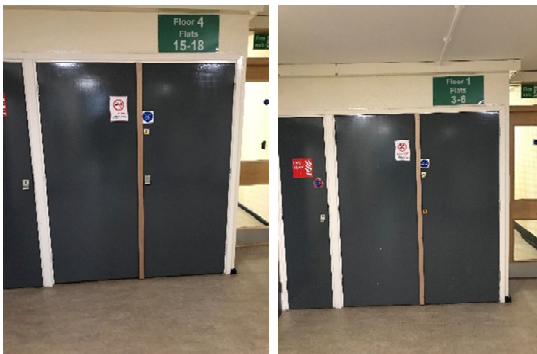
- 15) It was noted that a timber strip had been installed to the electrical installations cupboards on the 1st and 4th floors, as these are 54mm notional timber doors and this strip has been added with the intention of upgrading the resistance to smoke/flame this is deemed tolerable however with future upgrades to the block some consideration should be made to upgrading the doors to fully certified FD30s doors.

Observations	
<p>It was noted that a timber strip had been installed to the electrical installations cupboards on the 1st and 4th floors, as these are 54mm notional timber doors and this strip has been added with the intention of upgrading the resistance to smoke/flame this is deemed tolerable however with future upgrades to the block some consideration should be made to upgrading the doors to fully certified FD30s doors.</p>

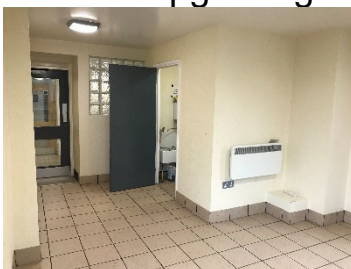
- 16) Noted the store cupboard located within the 1st floor veiwing pod is missing any intumescent strips and cold smoke seals, due to this door being a 44mm notional FD30 timber door the regular checks by cleaning and caretaking services, additional notional door protecting the vewing pod from the means of escape and level of risk being minimal this is deemed as tolerable however however with future upgrades to the block some consideration should be made to upgrading the doors to fully certified FD30s door.

<p>Noted the store cupboard located within the 1st floor viewing pod is missing any intumescent strips and cold smoke seals, due to this door being a 44mm notional FD30 timber door the regular checks by cleaning and caretaking services, additional notional door protecting the viewing pod from the means of escape and level of risk being minimal this is deemed as tolerable however however with future upgrades to the block some consideration should be made to upgrading the doors to fully certified FD30s door.</p>	
<p>Large gaps along the bottom edge of door where it is visible to see into the flat from hallway no access granted on day of risk assessment email has been sent to GA to confirm whether this is already on a programme</p>	<p>Update: Email from GA confirming that this has been added to the emergency door list and for someone is attending 07/02/2024</p>
