Fire Risk Assessment

Nelson House

**1-34, Upper Church Lane,
Tipton, DY4 9PW**

Date Completed: 21/11/2023

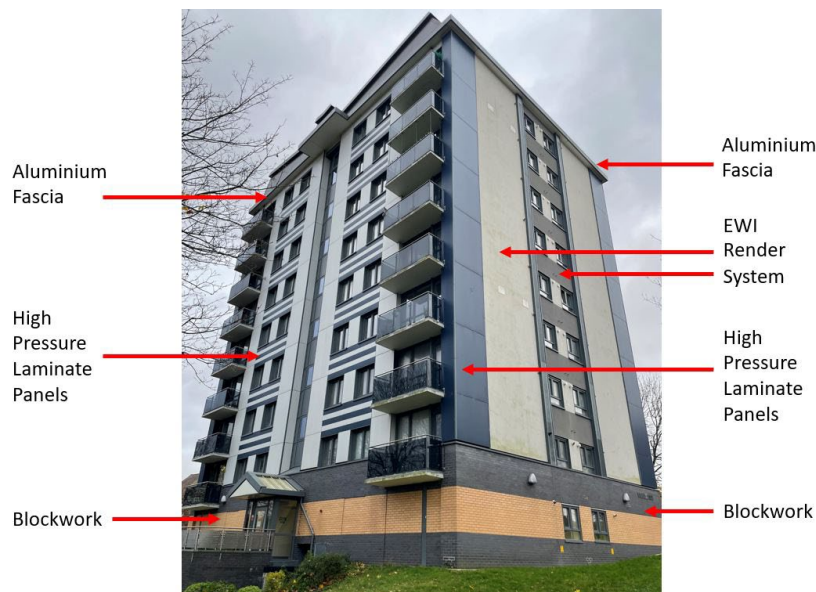
However, the presence of combustible screening & netting that some residents have installed to their balconies could potentially support the external spread of flame in the event of a fire.

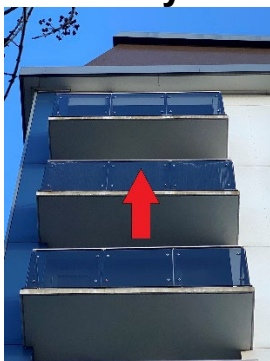
9) Combustible bamboo screening has been installed to the balcony of flat 27.

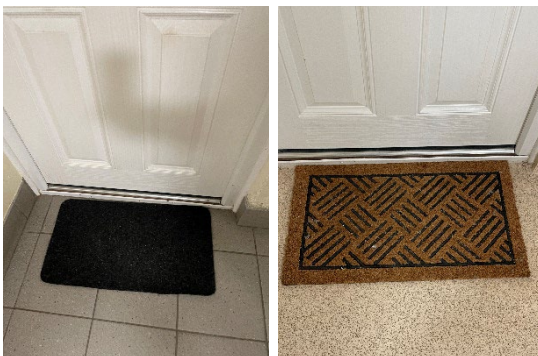
23) Individual floor mats were noted outside some flats. Fire rating of the mats is unknown but deemed to be of low risk.

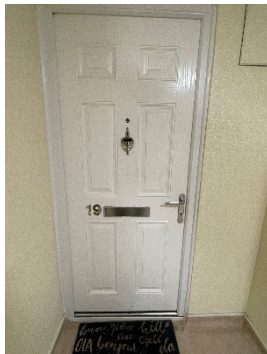
- b) Flat 19 – Door was correct.

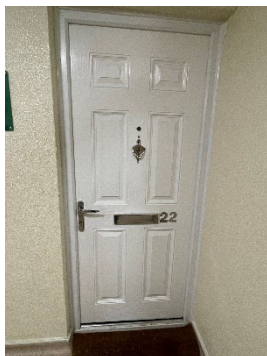
- c) Flat 22 – Door was correct.

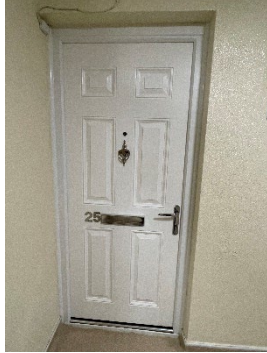
d) Flat 25 – Door was correct.

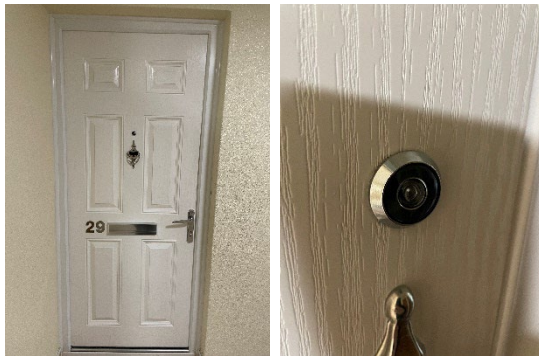
e) Flat 29 - Door viewer within leaf was loose and not secure.

| 7/29e | Flat 29 – secure loose door viewer to flat entrance door. | | P2 | Within 1-3 months Rapid Response Fire Team | |

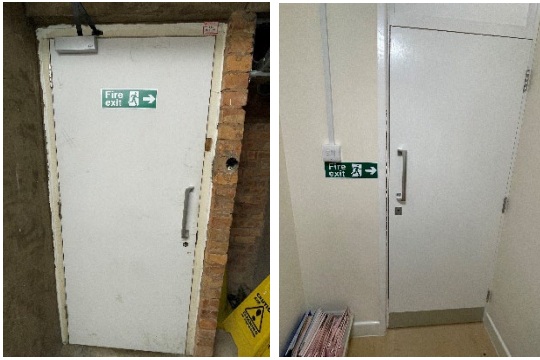
- 7) Directional fire escape sign to the door between the rear stairwell lobby and the welfare / storage should indicate the correct direction of travel (upwards arrow / progress forwards here).
-

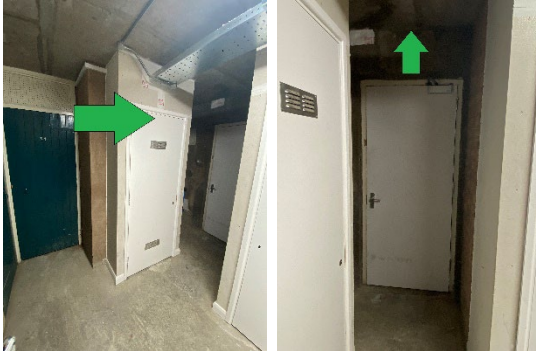
- 8) There are no directional fire escape signs within the resident's storage area on the dry riser side of the building. It is recommended that directional signage is installed above the battery store with a right-hand arrow and above the exit door with an upwards arrow.

| 12/8 | Install 2 x escape signage to the storage room on dry riser side of the building as per the attached images. | | P2 | Within 1-3 months Rapid Response Fire Team | |

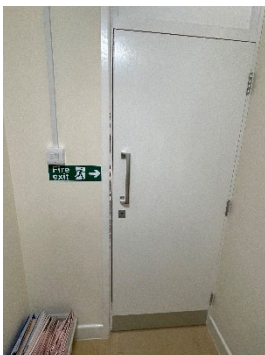
- 9) Escape signage depicting the wrong direction of travel was removed from the welfare room at the time of the assessment. It is not necessary to replace this sign due to the simple layout and small size of the room.
