Fire Risk Assessment

Harry Price House

Hartlebury Rd, Oldbury,
B69 1EQ

Date Completed: 05/06/2024.

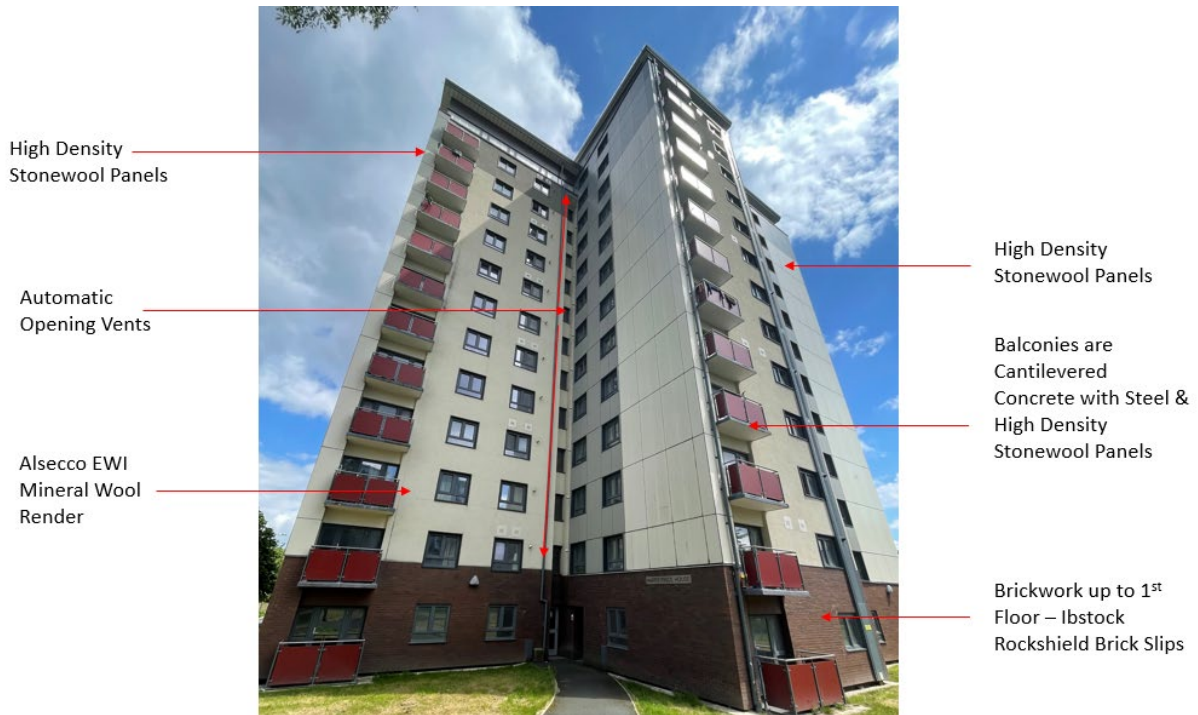
However, the presence of screening to 2 x balconies and a plastic greenhouse that's been erected on another present an unnecessary risk and therefore should be removed.

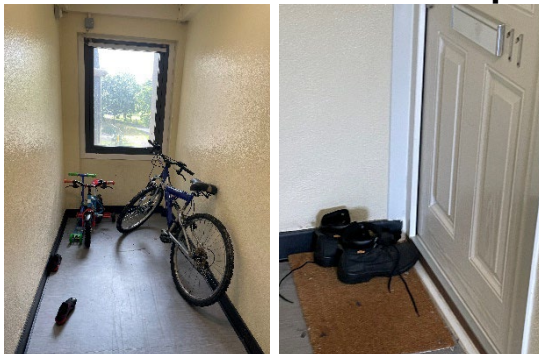
b) **2nd floor near flats 9,10,11 – 2 x bicycles and pairs of shoes in the means of escape.**

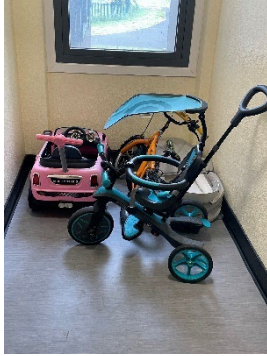
c) **1st floor near flats 3, 4, 5 – Childs' ride on toys x 2 and babies cot in the means of escape.**

P2	Within 1-3 months Housing Manager	
7/14c	1 st floor near flats 3,4,5 remove children's toys and cot from communal corridor.

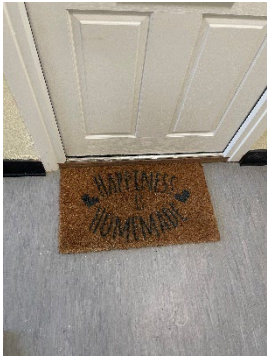
- 15) Individual floor mats were noted outside some flats. Fire rating of the mats is unknown but deemed to be of low risk.

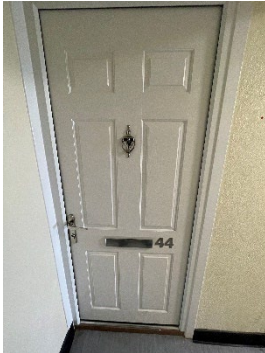
c) Flat 44 – The door fails to positively engage the latch when self-closing.

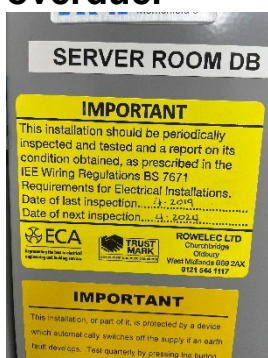
- 2) Hot working is not normally carried out. If essential maintenance requires the use of hot work processes, then corporate policies and procedures are to be followed.
- 3) Portable electrical equipment used as part of the Caretaking / Cleaning regime is subject to annual PAT Testing. This information is held by the Estate Services Manager Bryan Low.
- 4) The fixed electrical installation shall be tested every 5 years. **The last inspection was noted as April 2019 therefore may now be overdue.**

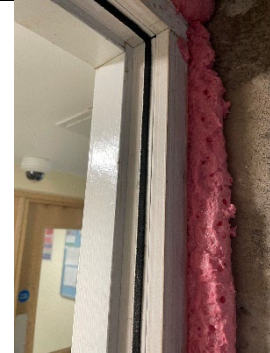
PU pink fire foam filler was noted around the void flat entrance door frames to the ground floor. Removing and replacing this foam with a more suitable product should be considered during door replacements or future refurbishment works.
