# Fire Risk Assessment

## Hamstead House

**Coniston Crescent,  
Great Barr, B43 5NT**

**Date Completed: 27/11/2024**

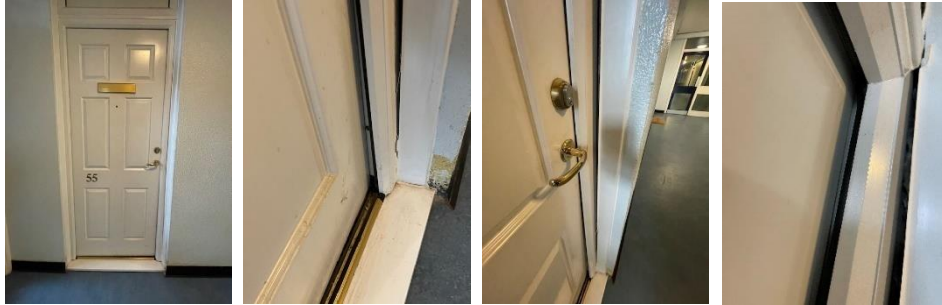
- G. Flat 55 entrance door was not inspected on both sides (occupier not home) however it was noted that the door is bowed and there is damage to the frame. **Urgent replacement has been requested on 29/4/24 (within 28 days). The assigned job number is JM13779319.**

<p>07/17g</p>	<p>Flat 55 entrance door is bowed and there is damage to the frame. Urgent replacement has been requested on 29/4/24 (within 28 days). The assigned job number is JM13779319.</p>

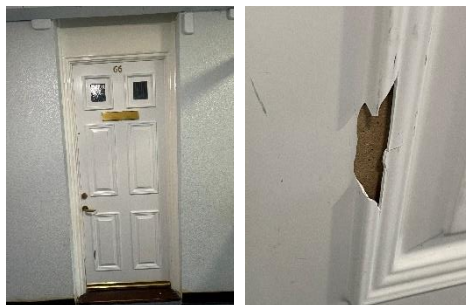
- I. Flat 66, some damage to flat entrance door noted. However, the occupier was not home to investigate. **Further investigation work required to establish the integrity of the door and if a repair that does not compromise the door can be established.** (Resident not home at the time of the assessment).

<p>P2</p>	<p>Within 1-3 months Repairs</p>	
<p>07/17i</p>	<p>Flat 66, some damage to flat entrance door was noted. Further work required to establish the integrity of the door and if a repair can be carried out without compromising the F.R. of the door.</p>

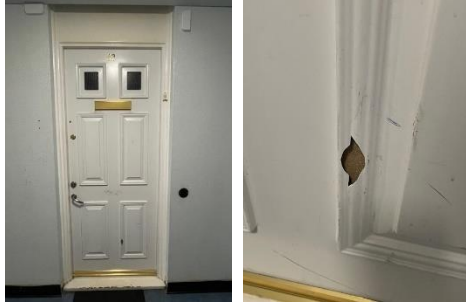
- J. Flat 32, some damage to flat entrance door noted. However, the occupier was not home to investigate. **Further investigation work required to establish the integrity of the door and if a repair that does not compromise the door can be established.** (Resident not home at the time of the assessment).

07/17j	Flat 32, some damage to flat entrance door was noted. Further work required to establish the integrity of the door and if a repair can be carried out without compromising the F.R. of the door.

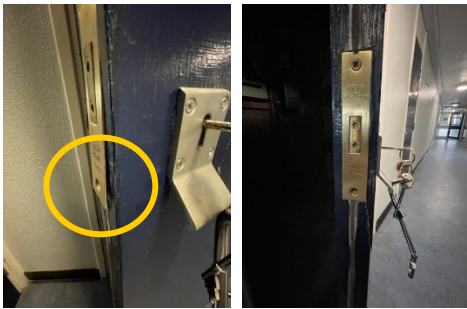
- 23) On the 8<sup>th</sup> floor, the electrical cupboard door is missing a screw from the mortice lock. Fit a screw into the mortice lock as wear over a period of time could result in damage occurring to fire stopping materials.

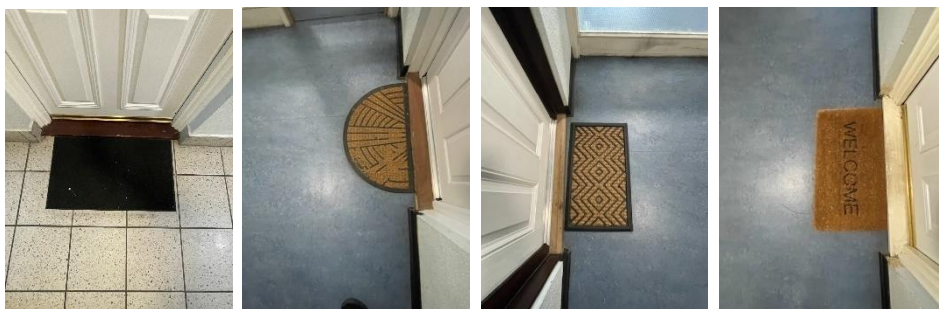
- 24) Individual door mats are present outside a number of flat entrance doors within the building, fire rating of the mats is unknown.

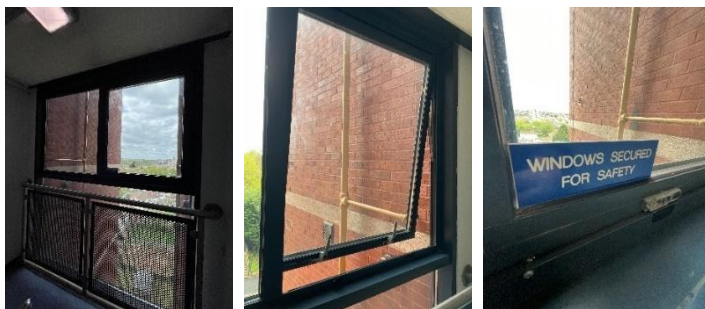
- 25) There are communal windows on multiple floors in both stairwells some are not openable because of handles missing and have been screwed shut. Signage states windows have been secured for safety. This is not a fire safety concern as smoke control is still present via AOV's between floors 1<sup>st</sup> / 2<sup>nd</sup> & 5<sup>th</sup> / 6<sup>th</sup> and a louvre vent system to the top of each stairwell.

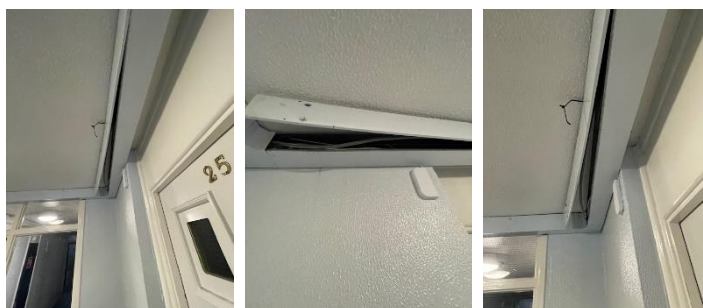
- 26) 3<sup>rd</sup> floor by flat 25 – Trunking not adequately secured above flat entrance door. Cables are open to residents, visitors etc.

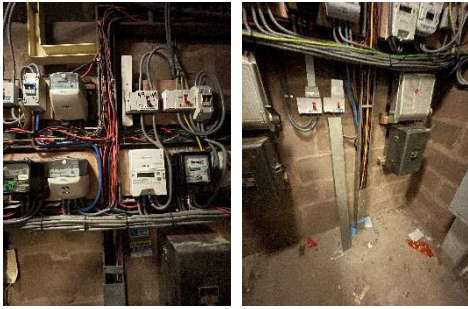
- 30) Wiring and associated equipment in the electric cupboard on the 6th floor are missing metal trunking cover(s). Example Photo:**

P2	Within 1-3 months Electrical compliance	
07/30	Wiring and associated equipment in the electric cupboard on the 6th floor are missing metal trunking cover(s).

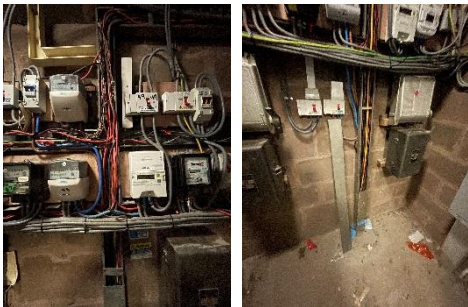
- 33) 2nd floor - Wiring and associated equipment in the electric cupboard is missing metal trunking cover(s). Example Photo:**

07/33	Wiring and associated equipment in the electric cupboard on the 2 <sup>nd</sup> floor are missing metal trunking cover(s).

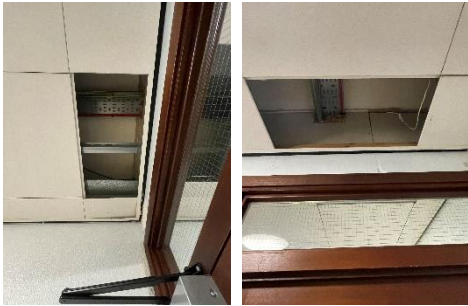
- 13) It was noted on the ground floor, and adjacent to Flat 1, that several ceiling tiles were missing. These should be replaced at the earliest opportunity.

P2	Within 1-3 months Electrical compliance	
10/13	Replace missing ceiling tiles adjacent to Flat 1, These should be replaced at the earliest opportunity.

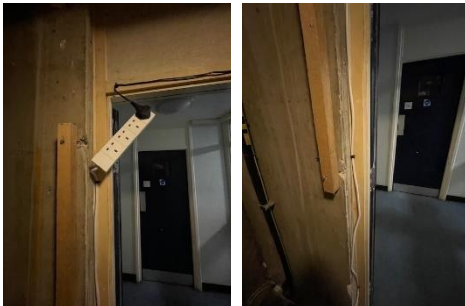
- 7) It was noted that an extension lead had been put in the electrical cupboard on the 9<sup>th</sup> floor. It should be established who this belongs to, resident or contractor and removed from use.
