Fire Risk Assessment

Hamstead House

**Coniston Crescent,
Great Barr, B43 5NT**

Date Completed: 24/04/24

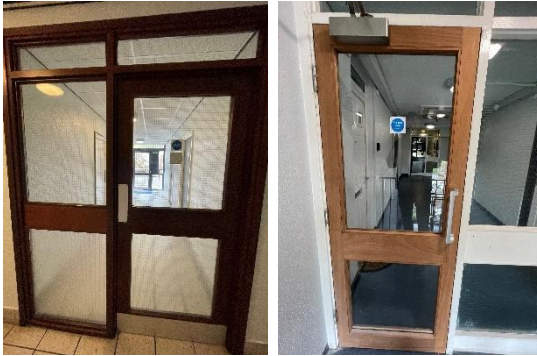
- 5) The communal landing / staircases are protected by use of notional FD30s timber fire doors with vision panels. It was noted on the 10th floor that a replacement nominal FD30s timber fire has been installed.

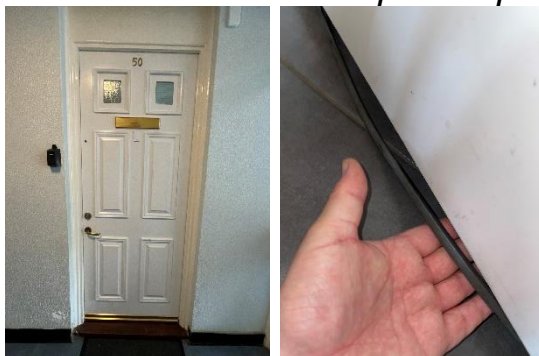
A. Flat 50, door is not reliably self-closing due to seal along the bottom of the door. *Repair requested JM 13382489.*

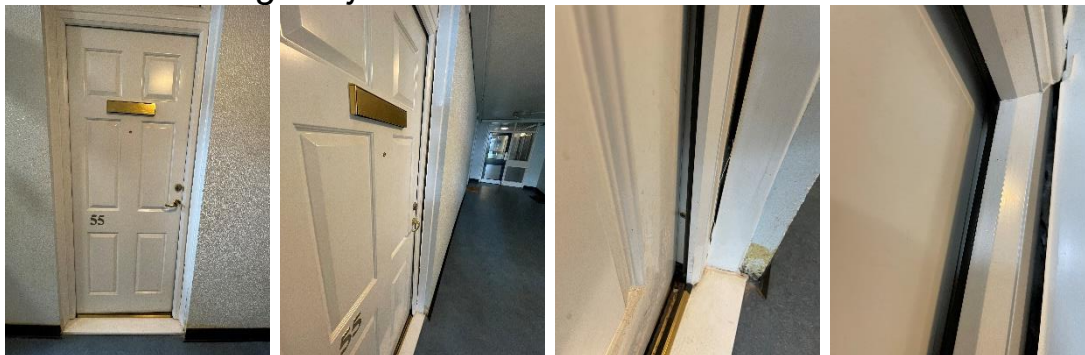
- F. Flat 55 entrance door was not inspected on both sides (occupier not home) however it was noted that the door is bowed and there is damage to the frame. *Urgent replacement has been requested 29/4/24 (within 28 days). The assigned job number is JM13779319.*

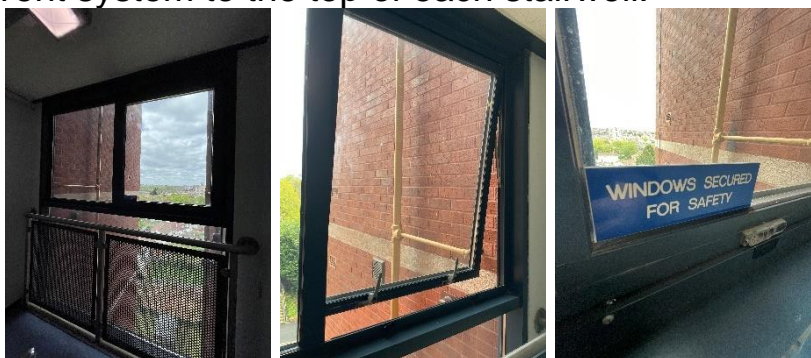
- 18) Individual door mats are present outside many flat entrance doors within the block, fire rating of these is unknown.
- 19) There are communal windows on multiple floors in both stairwells some are not openable because of handles missing and have been screwed shut. Signage states windows have been secured for safety. This is not a fire safety concern as smoke control is still present via AOV's between floors 1st / 2nd & 5th / 6th and a louvre vent system to the top of each stairwell.

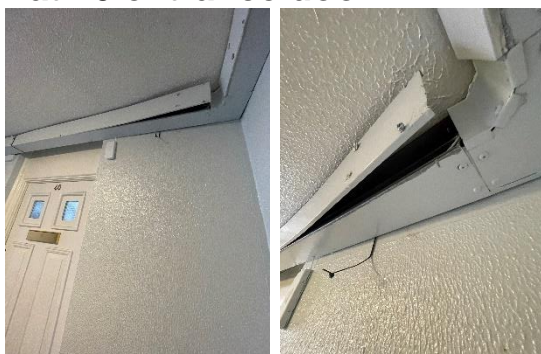
- 20) 5th floor by flat 40 – Trunking not adequately secured above flat 40 entrance door.

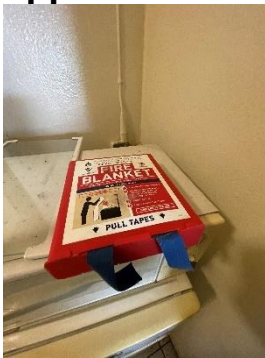
- 6) The fire blanket in the kitchen should be fixed to the wall opposite the cooking appliance.
