Fire Risk Assessment

Hackwood House

Hartlebury Rd, Oldbury,
B69 1EG

Date Completed: 22/05/2024.

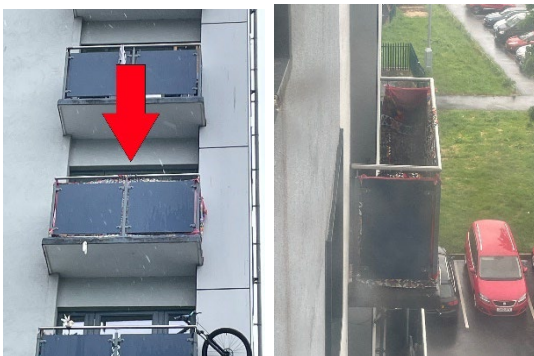
8) Flat 32 / 5th floor – Installed screening / material installed to balcony has the potential to support the external spread of flame.

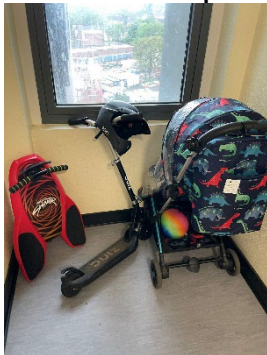
- a) **9th floor by flats 54,55,56 – Childrens toy, scooter and push chair left in corridor blocking access to the AOV.**
It has been noted that an action was created for what appears to be the same pushchair during the previous FRA (September 2022). The occupier of flat 55 agreed to remove the pushchair.

28) Pushchair left in the communal area on the 9th floor.

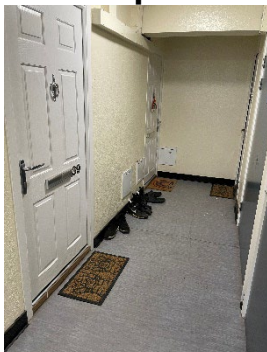
- b) **7th floor outside flats 39 & 40 – several pairs of shoes in corridor which are potential trip hazards in the means of escape.**

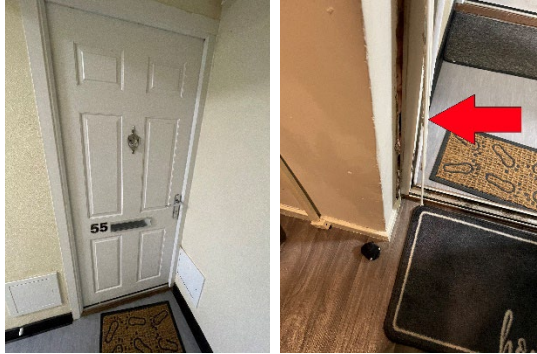
- a) **Flat 55 - Entrance door not reliably fully self-closing onto latch / requires adjustment. Also, the trim has come away from the left side of the door frame. It was noted that pink PU foam has been used in the cavity behind.**

P2	Within 1-3 months Housing Manager	
7/19a	Flat 55 / 9 th floor – Adjust self-closer to ensure door positively engages latch. Also, remove pink PU foam and replace with suitable product (rockwool) then re-fit trim.

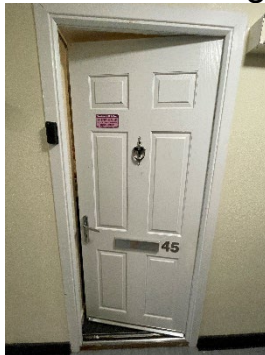
- b) Flat 45 – Self-closing arm was disconnecting when under load which made access & egress difficult for the tenant. An appointment to repair the fault was scheduled the same day for the following morning 23/5/24.

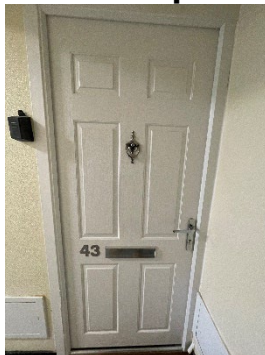
- c) **Flat 43 - Entrance door not reliably fully self-closing onto latch / requires adjustment.**

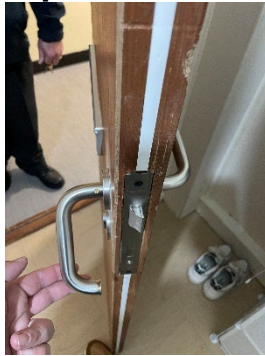
- d) Flat 13 – There is no cold smoke seal installed to door or frame and, the external door handle rotates almost 360 degrees which is clearly defective and requires replacement.

P2	Within 1-3 months Fire Rapid Response	
7/19d	Flat 13 / 2 nd floor – install combined intumescent / cold smoke seal to door. Also, replace defective lock / handle with thumb turn type device.

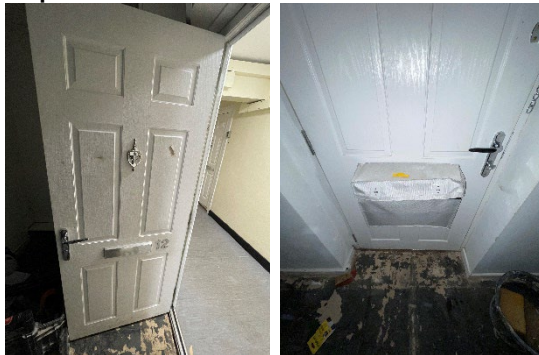
- e) Flat 12 – Intumescent filler has been applied to repair superficial damage to the exterior of the door and a fire retardant letter box protector has been installed. The door failed to reliably fully self-close however the SMBC voids repairs team were in attendance and agreed to rectify this.

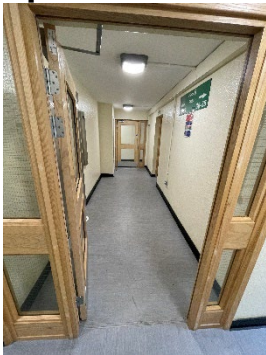
11) 6th floor communal door by flat 35 fails to self-close when fully opened.

P2	Within 1-3 months Electrical Compliance Manager	
10/11	6 th floor communal door by flat 35 requires adjustment to ensure its capable of self-closing from all angles.

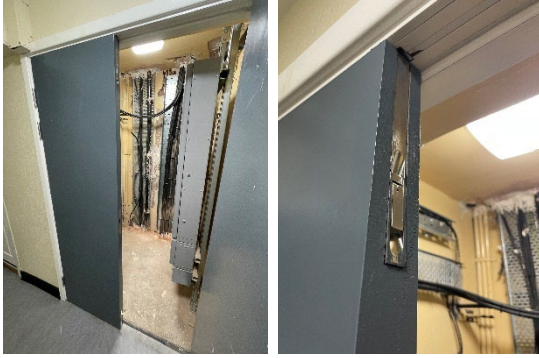
13) 2nd floor service cupboard – flush bolts on slave door are not releasing.

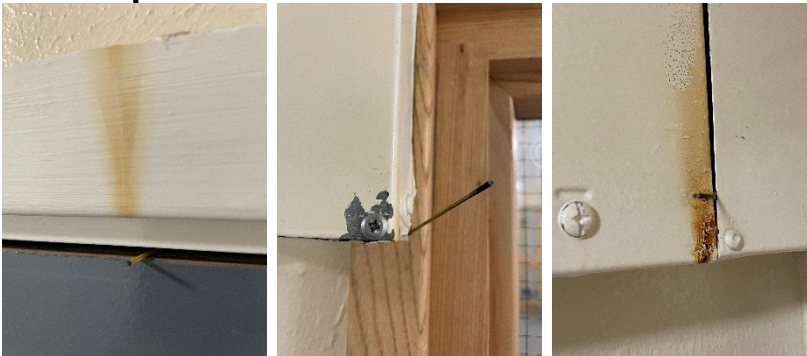
- 6) **There is evidence of scorching to several surfaces in various communal locations on the 10th floor. Some of the scorching may be historic due to inappropriate use of Incense sticks which was raised as a concern in the previous FRA to this (September 2022).**

However, Incensed sticks were once again noted wedged in various places on the 10th floor all of which were found to be extinguished. All used incense sticks should be removed and residents to all 6 flats on this floor should be contacted and reminded that the use of incense sticks within the communal area is prohibited.
