Fire Risk Assessment

Thompson Gardens

**1-89, Hales Lane,
Smethwick, B67 6RX**

Date Completed: 28/08/2024.

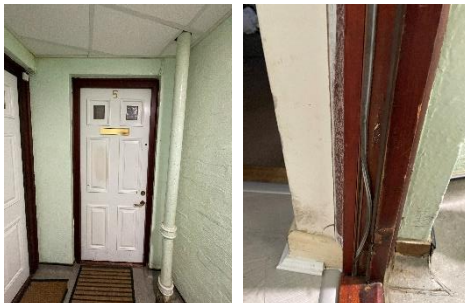
e) Flat 5 – The self-closer functioned well when tested. However, the cold smoke seal was partially detached.

7/21e	Flat 5 - Replace partially detached cold smoke seal to the leading edge of the flat entrance door.

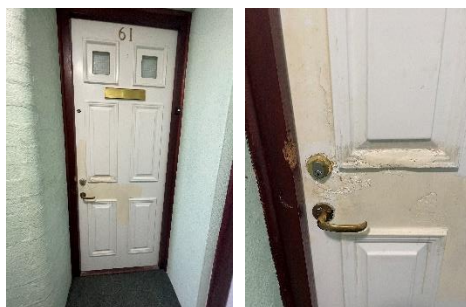
f) Flat 61 – Access not gained but evidence of repair to the finish of the flat entrance door. Further investigations are required to establish if this door is fit for purpose.

P2	Within 1-3 months Fire Rapid Response	
7/21f	Flat 61 – Access not gained but evidence of repair to the external door leaf finish. Investigate further to establish if this door is fit for purpose.

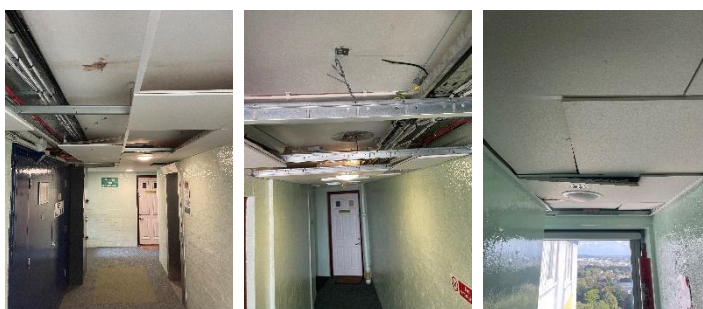
22) Numerous ceiling tiles were noted as missing from the suspended ceilings within lobbies on floors P/14th, O/13th, N/12th, L/10th, K/9th, G/6th, E/4th, D/3rd & C/2nd. The missing tiles revealed that electrical cabling above was secured to cables trays utilising a combination of metal and plastic fastenings.

23) As set out above, it is recommended that ceiling tiles are reinstated to protect the cabling above from any potential fire or other ignition sources, it's recognised that the missing tiles of from a sterile area and good practice dictates that tiles are replaced.

P2	Within 1-3 months Fire Rapid Response	
07/23	Replace missing ceiling tiles within lobbies on floors P/14 th , O/13 th , N/12 th , L/10 th , K/9 th , G/6 th , E/4 th , D/3 rd & C/2 nd .

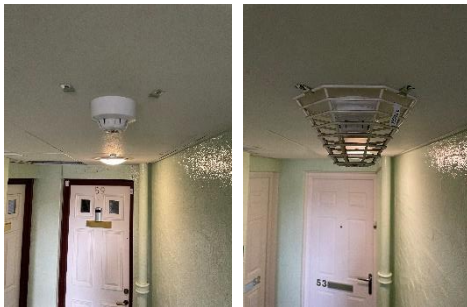
- 6) The automatic vent detector head (AOV) on Floor K, 9th floor, outside flat 59 has the protective cage missing. Below is an example on the left and how it should look on the right. (Email sent to resolve this issue).

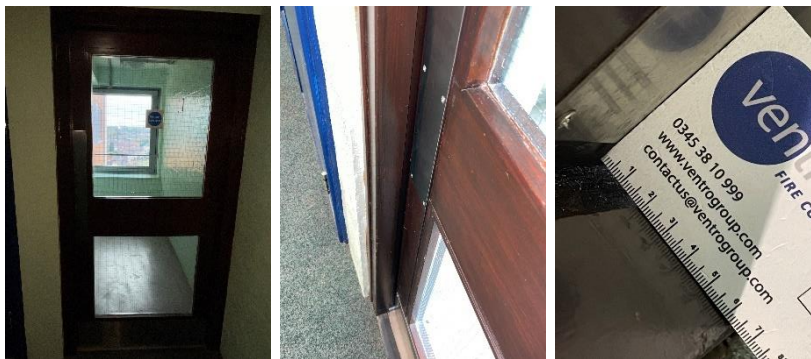
- 7) It has been recognised that all of the landing / staircase notional doors in this block have been upgraded with combined intumescent strips & cold smoke seals to enhance their original design. There were minor shortcomings that have been identified and actions have been created for corrective works or replacement.
- 8) **Floor L (10) – Communal door to stairwell by flat 63, leaf is warped and requires replacement.**

<p>P2</p>	<p>Within 1-3 months Repairs</p>	
<p>10/08</p>	<p>Floor L (10) – Communal door to stairwell by flat 63, leaf is warped and requires replacement. <i>Previously recorded on the FRA, awaiting Joinery</i></p>

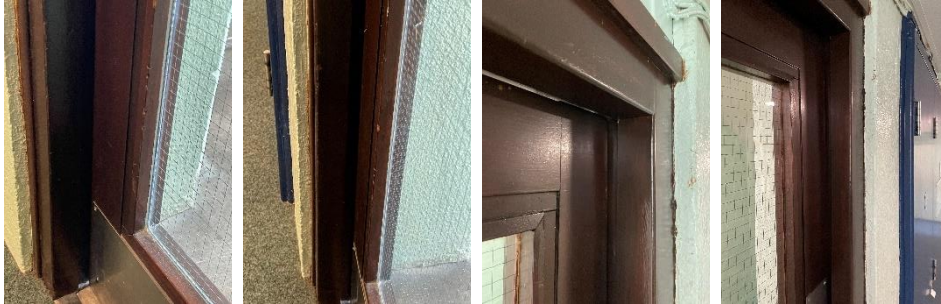
- 9) **Floor H (7) – Communal door to stairwell by flat 42, leaf is warped and requires replacement.**
- 10) **Floor F (5) – Communal door to stairwell by flat 30, leaf is warped and requires replacement.**
- 11) **Floor D (3) – Communal door to stairwell by flat 21, leaf is warped and requires replacement.**
-

- 12) Floor C (2) – Communal door to stairwell by flat 15, leaf is warped and requires replacement.
- 13) Floor B (1) – Communal door to stairwell by flat 9, leaf is warped and requires replacement. Examples shown below.

<p>P3</p>	<p>Within 3 - 6 months Repairs.</p>	
<p>10/09</p>	<p>Floor H (7) – Communal door to stairwell by flat 42, leaf is warped and requires replacement. <i>Previously recorded on the FRA, awaiting Joinery</i></p>

10/10	Floor F (5) – Communal door to stairwell by flat 30, leaf is warped and requires replacement. <i>Previously recorded on the FRA, awaiting Joinery</i>

P3	Within 3 - 6 months Repairs.	
10/11	Floor D (3) – Communal door to stairwell by flat 21, leaf is warped and requires replacement. Examples shown below. <i>Previously recorded on the FRA, awaiting Joinery</i>

P3	Within 3 - 6 months Repairs.	
10/12	Floor C (2) – Communal door to stairwell by flat 15, leaf is warped and requires replacement. Examples shown below.

10/13	Floor B (1) – Communal door to stairwell by flat 9, leaf is warped and requires replacement. Examples shown below.

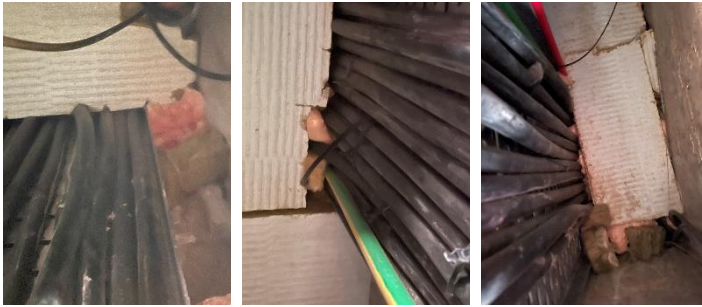
- a) Floor N 12th Floor, remove foam and replace with appropriate fire stopping materials.
- b) Floor M 11th Floor, remove foam and replace with appropriate fire stopping materials. Images below:

P3	Within 3 - 6 months Repairs.	
10/17a	Electrical cupboard on Floor N 12th Floor, remove foam and replace with appropriate fire stopping materials.

P2	Within 1-3 months Fire Rapid Response	
10/17b	Electrical cupboard on Floor M 11th Floor, remove foam and replace with appropriate fire stopping materials.

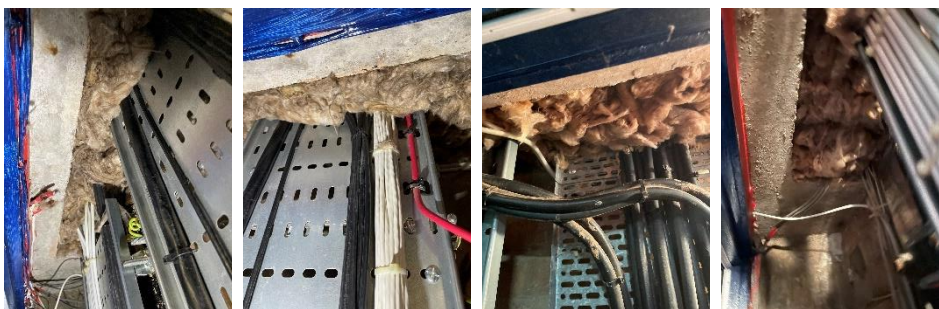
18) There were several electrical cupboards where mineral wool type materials should be replaced with appropriate Fire resisting Batts board. These were located: -

10/18a	Electrical cupboard on floor H, 7 th Floor replace mineral wool with appropriate Fire resisting Batts board.

P2	Within 1-3 months Fire Rapid Response	
10/18b	Electrical cupboard on Floor G, 6th Floor replace mineral wool with appropriate Fire resisting Batts board.

P2	Within 1-3 months Fire Rapid Response	
10/18c	Electrical cupboard on Floor F, 5th Floor replace mineral wool with appropriate Fire resisting Batts board.

10/18d	Electrical cupboard on Floor D, 3rd Floor replace mineral wool with appropriate Fire resisting Batts board.

P2	Within 1-3 months Fire Rapid Response	
10/18e	Electrical cupboard on Floor C, 2 nd Floor replace mineral wool with appropriate Fire resisting Batts board.

P2	Within 1-3 months Fire Rapid Response	
10/18f	Electrical cupboard on Floor B, 1 st Floor replace mineral wool with appropriate Fire resisting Batts board.

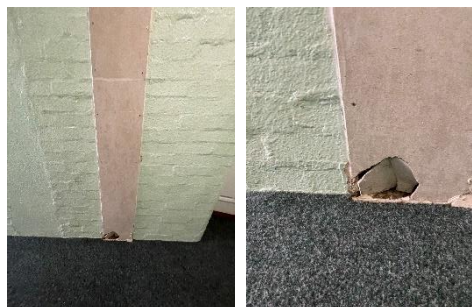
19) Access panel to service pipework outside flat 20 damaged and needs repairing with appropriate fire stopping materials.

<p>10/19</p>	<p>Access panel to service pipework outside flat 20 needs repairing with appropriate fire stopping materials.</p>

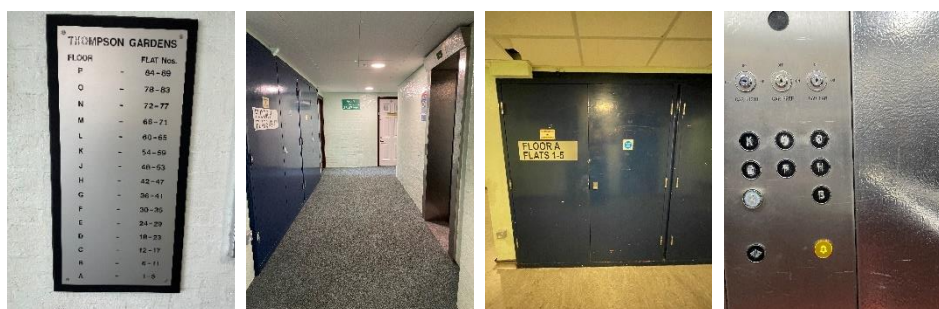
The mixture of signage could cause confusion, particularly in an emergency. Therefore, signage should be reviewed to read the same in order to maintain consistency throughout the building.

<p>P2</p>	<p>Within 1-3 months Fire Rapid Response</p>	
<p>12/05</p>	<p>The wayfinding signage is inconsistent throughout the building. (See main report) The mixture of signage could cause confusion, particularly in an emergency. Therefore, signage should be reviewed to read the same in order to maintain consistency throughout the building.</p>

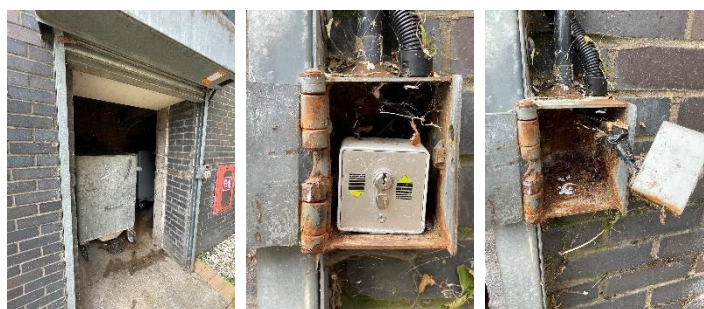
- 4) Refuse containers are located in the bin store to the side elevation which is the right-hand side of the main entrance. Access is via a motorised roller shutter; the key is stored in the firefighter's white box. All refuse containers are emptied regularly under a service contract.
- 5) **It was noted at the time of the assessment that the roller shutter door to the bin room was defective. The switch key was also detached from its housing.**

15/05	The roller shutter to the bin room and its operating keypad are defective and to be repaired or replaced.	 	P2	Within 1-3 months Asset Management	
-------	---	--	----	---------------------------------------	--

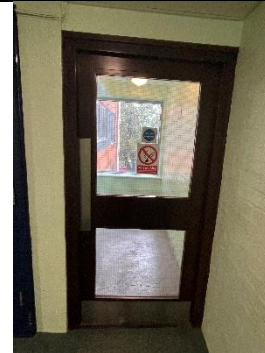
Some notional communal stairway doors show signs of wear and tear due to age. Consideration should be given to upgrade all doors with certified FD30s door sets as part of future programmed works.
