Fire Risk Assessment

Thompson Gardens

**1-89, Hales lane,
Smethwick, B67 6RX**

Date Completed: 16/10/2023

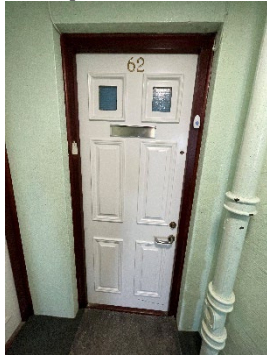
- g) Flat 62 – Door not reliably self- closing fully into frame. Carpet has been fixed to the glazing on the internal side.**

| <p>7/21g</p> | <p>Flat 62 floor L (10th) – Adjust self-closing device & remove carpet from glazed panels of door.</p> | | <p>P2</p> | <p>Within 1-3 months Fire Rapid Response JM:12141962 JM12294629</p> | |

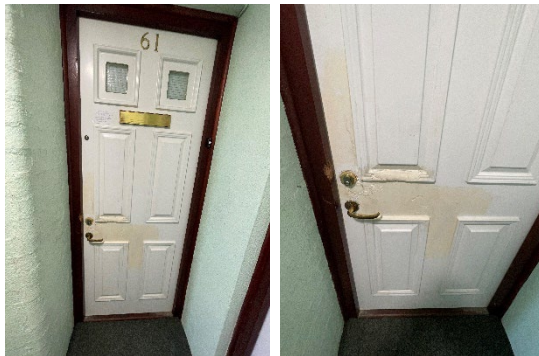
- h) Flat 61 – Access not gained but evidence of repair to the external door leaf finish.**

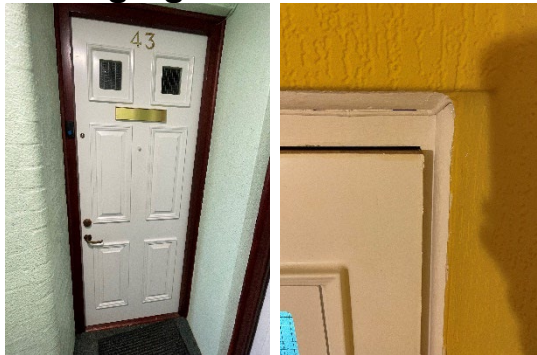
k) Flat 43 – Door will not reliably self-close and may need rehanging.

| <p>7/21k</p> | <p>Flat 43 floor H (7th) – Adjustment to flat door to ensure reliably self-closes.</p> | | <p>P2</p> | <p>Within 1-3 months Fire Rapid Response JM:12142020</p> | <p>01/11/2023</p> |

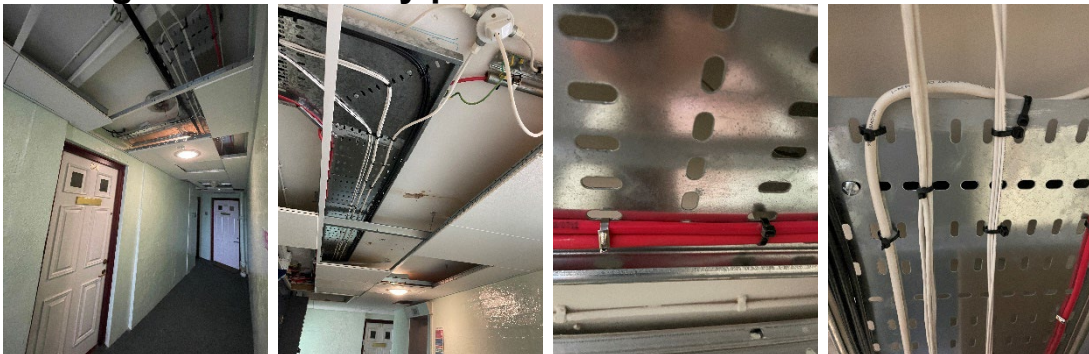
22) Numerous tiles were noted as missing from the suspended ceilings within lobbies on floors P/14th, K/9th, D/3rd & C/2nd. The majority were missing from the 14th floor lobby. The missing tiles revealed that the cabling above was secured to cables trays utilising a combination of metal and plastic fastenings. **Although it's recognised that the missing tiles of from a sterile area it's recommended that the tiles are reinstated to protect the cabling above from any potential fire.**

| 7/22 | Reinstate missing tiles to suspended ceilings on floors P, K, D, C (floor lobbies). | | P3 | Within 6 months Repairs | |

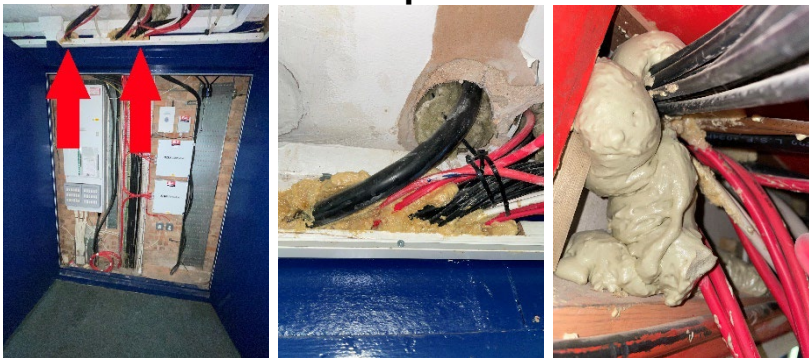
- 11) Floor P (14) – Cables have been fire stopped with expanding foam above service cupboard doors in lift lobby.

| 10/11 | Floor P (14 th) Remove foam and enhance firestop to head of service cupboard | | P2 | Within 1-3 months Fire Rapid Response JM:12142034 | 02/11/2023 |

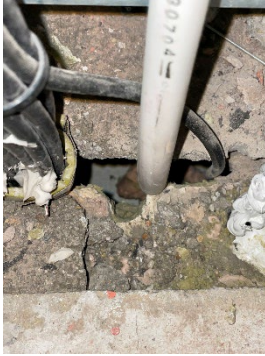
- 12) Floor O (13) – Fire stopping required in right hand service cupboard where cables penetrate floor slab.
-

| 10/12 | Floor O (13 th) Firestop were cables penetrate floor slab R/H/S service cupboard. | | P2 | Within 1-3 months Fire Rapid Response JM:12142050 | 01/11/2023 |

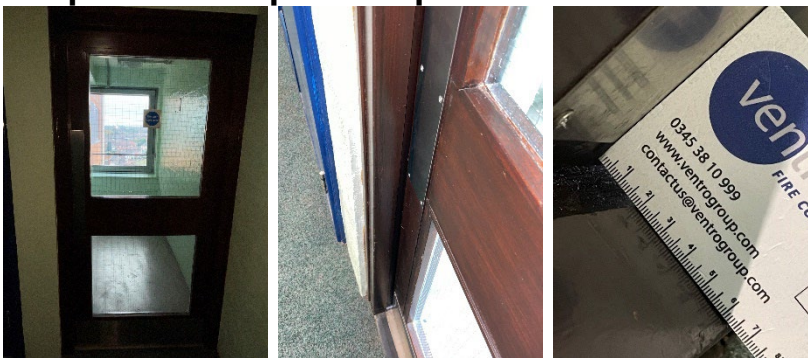
13) Floor L (10) – Communal door to stairwell by flat 63, leaf is warped and requires replacement.

| 10/13 | Floor L (10 th) Stairwell door leaf by flat 63 is warped and requires measuring for replacement | | P4 | 6 months + Programmed work Fire Rapid Response. JM:12142099 | |

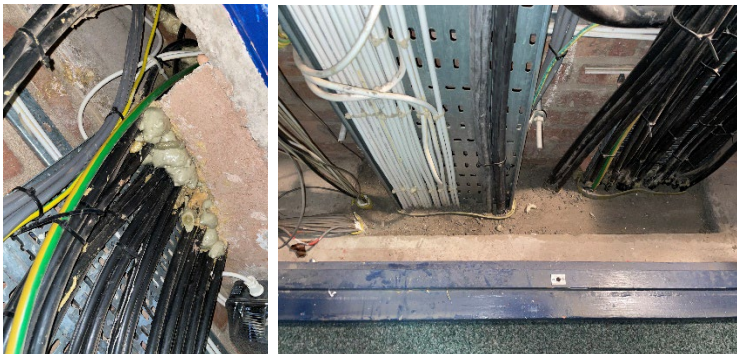
14) Floor L (10) – Remnants of expanding foam in service cupboard were cables penetrate ceiling to cupboard above. Fire stopping checked above and deemed as suitable.

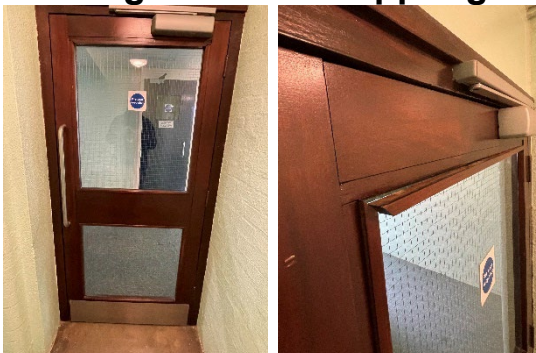
15) Floor L (10) – Communal door to stairs by chute room, beading is loose to upper glazed panel.

| 10/15 | Floor L (10 th) Beading loose to stairwell door. | | P2 | Within 1-3 months Glazing Repairs JM12319452 | |

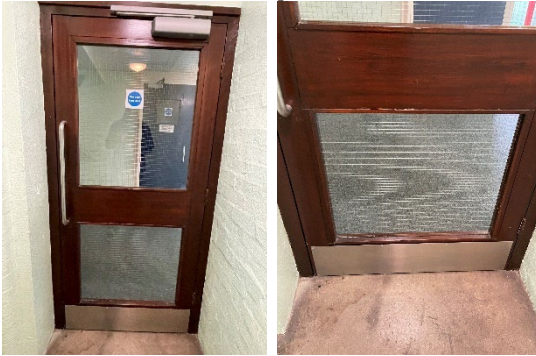
- 16) Floor L (9) - Communal door to stairs by chute room, glazing rattles in lower panel.**

| 10/16 | Floor L (9 th) – Secure glazing within lower panel / rattles, stairwell door by chute room. | | P2 | Within 1-3 months Glazing Repairs JM 12319522 | |

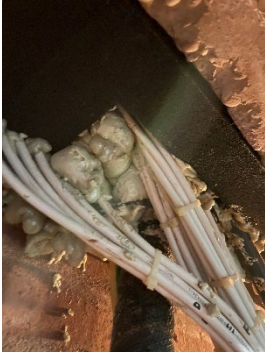
- 17) Floor L (9) – Expanding foam noted in service cupboard around cables however, intumescent sponge has been applied to enhance fire stopping. Fire stopping above penetration is sufficient.**

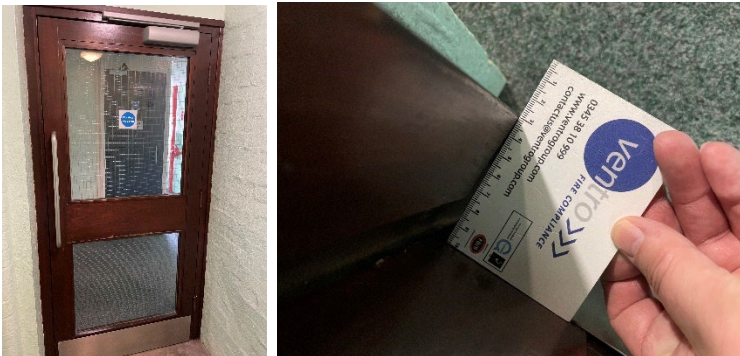
- 18) Floor H (7) Communal door to stairs by chute room warped from the handle down.**

| 10/18 | Floor H (7 th) Stairwell door leaf by chute room is warped and requires measuring for replacement. | | P4 | 6 months + Programmed work Fire Rapid Response. JM:12142731 | |

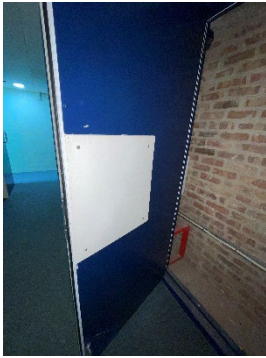
- 19) Floor G (6) – Door leaf to service cupboard has evidence of a previous repair. Repairs completed to internal leaf using Supalux board.**
-

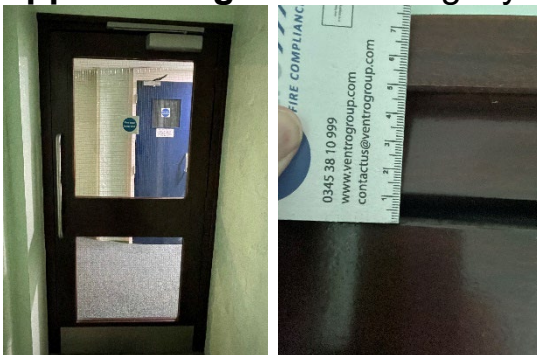
20) Floor G (6) – Communal door to stairs by chute room excessive gap to head, cold smoke seal not in contact with opposite edge. Door is slightly warped to bottom edge.

| 10/20 | Floor G (6 th) C Stairwell door by chute room / correct excessive gap to head / CSS not in contact with opposite edge. | | P2 | Within 1-3 months Fire Rapid Response JM:12142754 | 01/11/2023 |

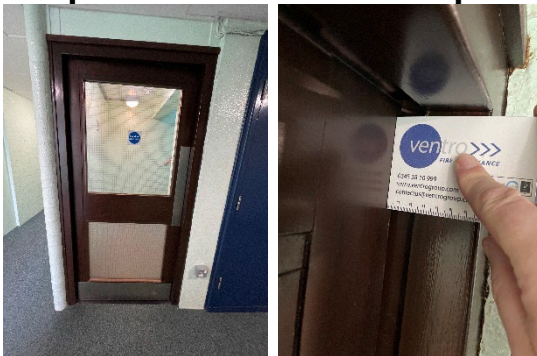
21) Floor F (5) - Communal door to stairs by chute room is warped towards head. Replacement required.

a) Glazing to lower panel rattles (door above).

| 10/21 | Floor F (5 th) Stairwell door leaf by chute room is warped and requires measuring for replacement | | P4 | 6 months + Programmed work Fire Rapid Response. JM:12142915 | |
| 10/21a | Floor F (5 th) Stairwell door by chute room – glazing to lower panel loose needs securing. (same door as above). | | P2 | Within 1-3 months Glazing Repairs JM:12319669 | |

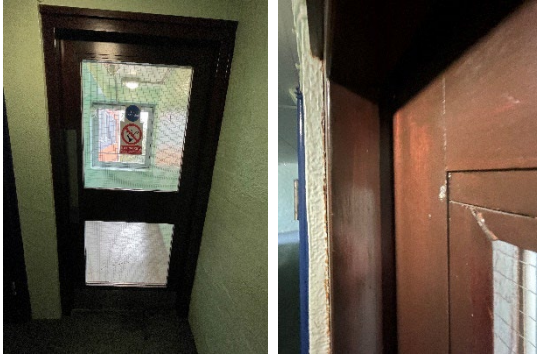
22) Floor E (4) Communal door to stairs by flat 27 not reliably fully self-closing.

| <p>10/22</p> | <p>Floor E (4th) – Stairwell door by flat 27. Adjust self-closer / door not reliably fully closing.</p> | | <p>P2</p> | <p>Within 1-3 months Fire Rapid Response JM:12142953</p> | <p>02/11/2023</p> |

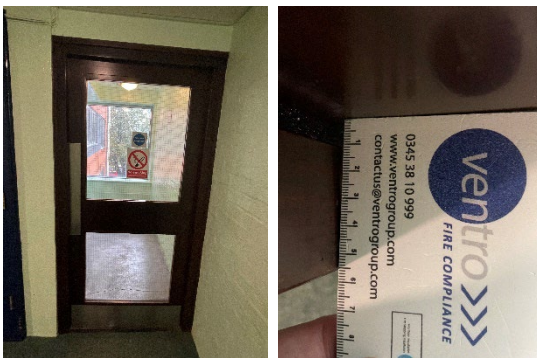
23) Floor D (3) - Communal door to stairs by flat 21 warped towards bottom of door leaf. Replacement required.

| <p>10/23</p> | <p>Floor D (3rd) Stairwell door leaf by flat 21 is warped and requires measuring replacement.</p> | | <p>P4</p> | <p>6 months + Programmed work Fire Rapid Response. JM:12143115</p> | |

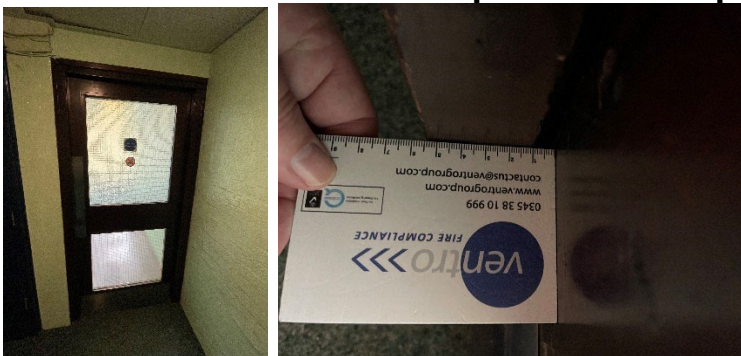
24) Floor B (1) - Communal door to stairs by flat 9 is warped towards bottom of leaf. Replacement required.

| <p>10/24</p> | <p>Floor B (1st) Stairwell door leaf by flat 9 is warped and requires Measuring for replacement</p> | | <p>P4</p> | <p>6 months + Programmed work Fire Rapid Response. JM:12143152</p> | |

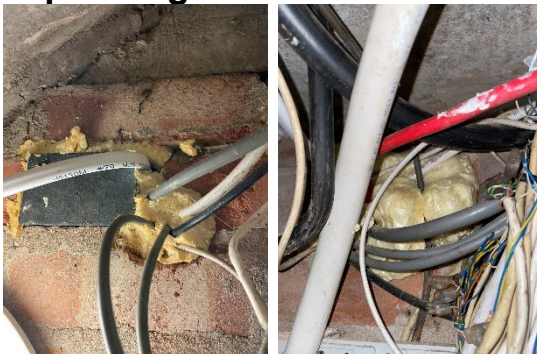
25) Ground floor – Cable penetration between service cupboard and cleaners store (beneath stairs) has been fire stopped with expanding foam.

| 10/25 | Ground floor – Remove foam and enhance firestopping were cables penetrate service cupboard to cleaners cupboard under stairs. | | P2 | Within 1-3 months Fire Rapid Response JM:12143172 | 02/11/2023 |

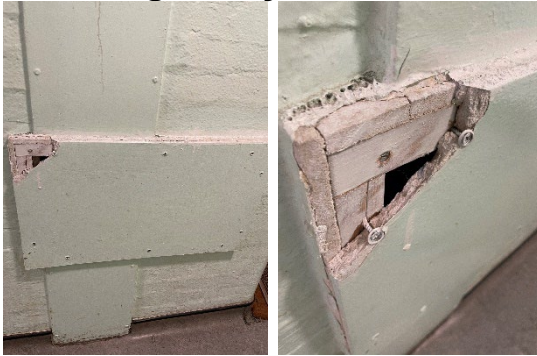
26) Access panel to service pipework by flat 1 is damaged revealing cavity behind.

| 10/26 | Replace damaged access panel to services by flat 1 | | P2 | Within 1-3 months Fire Rapid Response JM:12143195 | 02/11/2023 |

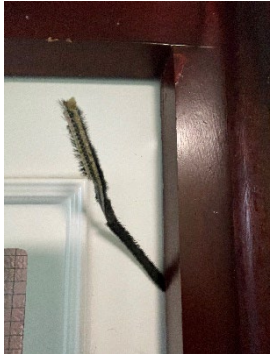
| Question/ Ref No | Required Action | Supporting photograph | Priority | Timescale and Person Responsible | Date Completed |
|---|--|--|---|--|---|
| 7/21f | Flat 60 floor L (10 th) Replace cold smoke seal. (access not gained during FRA) | | P2 | Within 1-3 months Fire Rapid Response JM:12141939 JM:12294550 | |

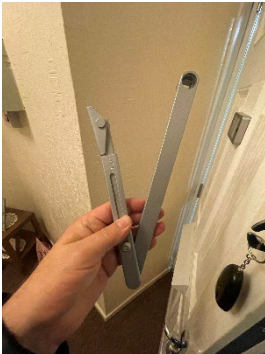
- i) Flat 52 – The arm to the Self-closing device has been disconnected by the tenant. The tenant has retained the original arm.**

| <p>7/21i</p> | <p>Flat 52 floor J (8th) – reinstate connecting arm to self-closer. Tenant has the missing arm.</p> | | <p>P2</p> | <p>Within 1-3 months Fire Rapid Response JM:12141995</p> | <p>01/11/2023</p> |

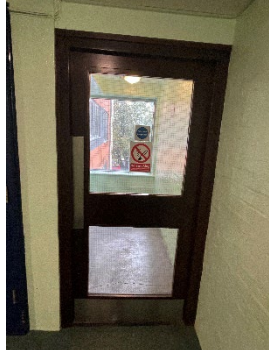
| Observations | |
|---|--|
| Some notional communal stairway doors show signs of wear and tear due to age. Consideration should be given to upgrade all doors with certified FD30s door sets as part of future programmed works. | |
