Fire Risk Assessment

Heronville House

**Sedgley Rd East,
Tipton, DY4 7TX**

Date Completed: 18/06/2024

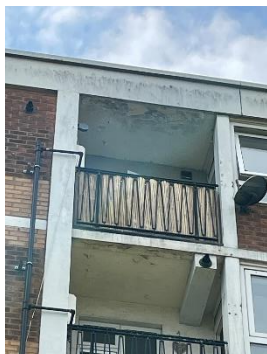
The addition of screening to one balcony and the build-up of combustible waste on another could potentially, support the surface spread of flame in those areas which is an unnecessary risk. Once this is removed the level of risk presented by materials present to the external envelope of this building would become trivial.

- A. Flat 112 (5th floor) Screening that is likely to be combustible has been installed to balcony.

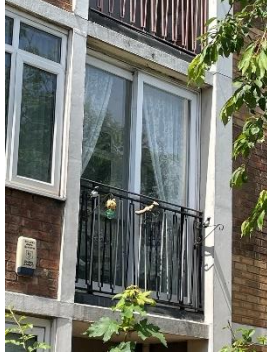
B. Flat 76 (1st floor) The balcony has been enclosed UPVC doors.

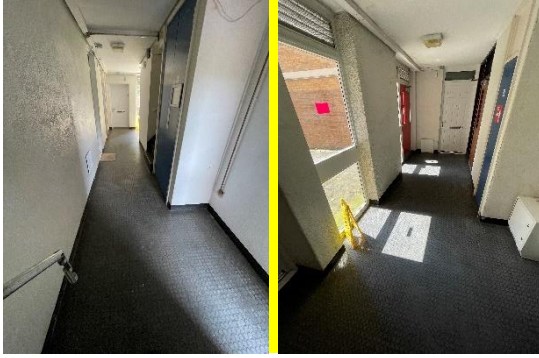
- 3) Within the means of escape there is a single corridor that forms a dead end and is located on the ground floor. However, the corridor is protected with fire resisting construction, has natural ventilation via a louvre vent, is a place of relative safety and leads to a final exit door. The maximum travel distance along the corridor is 13 metres (from flat 120 to the final exit) as per the guidance at the time 1962 - 71. All communal doors within the corridor are notional FD30s with the flat entrance doors being FD30s rated composite door sets. Flats 66, 64, 62 all have balconies that could be used as an alternative means of escape, flat 68 is immediately adjacent the final exit door (1m).

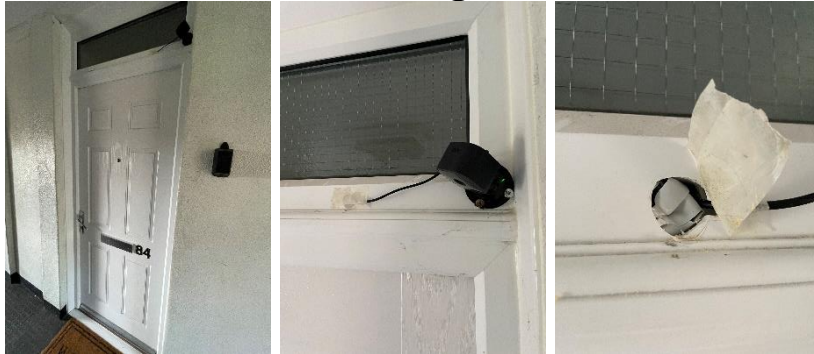
- b) Flat 84 – A hole approximately 20mm has been drilled through the frame to accommodate the cable for a cctv camera. Access was not gained to this flat.

7/21b	Flat 84 to remove camera from entrance door. Housing officer to arrange temporary repair via Fire Rapid Response Team and refer for door set replacement via Repairs (recharge).

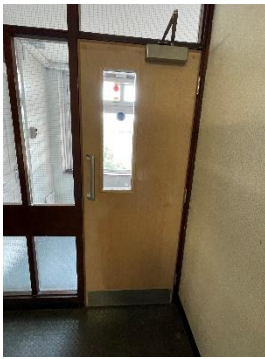
- 8) The communal door adjacent flat 88 has recently been replaced with a nominal FD30s fire door.

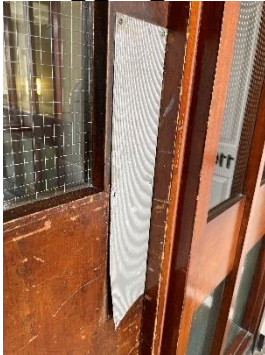
- 9) Aluminium push plate on the communal door adjacent flat 110 / 5th floor has come away & requires fixing to prevent snagging on escaping persons.

P2	Within 1 to 3 months. Housing Manager
10/9	5 th floor communal door by flat 110 – re-fix corner of aluminium push plate.
