Fire Risk Assessment

Paget House

**Sedgley Rd East,
Tipton, DY4 7TU**

Date Completed: 18/06/2024

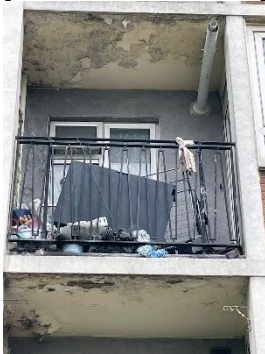
A. Flat 142 (2nd floor) There appears to be a build-up of combustible waste on the balcony. This has the potential to support the external spread of fire.

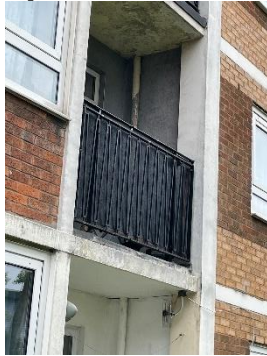
- B. Flat 136 (1st floor) Screening has been installed to balcony which could potentially support the external spread of fire.**

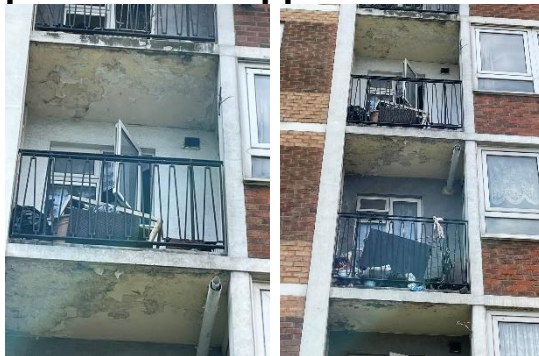
- C. Flat 152 (3rd floor) There appears to be a build-up of combustible waste on the balcony. This is directly above another balcony with the same issue. This has the potential to support the external spread of fire.**

P2	Within 1 to 3 months. Housing Manager
06/03c	Flat 152 - Remove build-up of combustible waste from balcony.

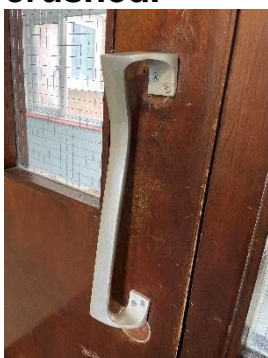
- 6) **Communal door handle by flat 158 / 3rd floor has been crushed.**

P2	Within 1 to 3 months. Housing Manager
07/06	Repair or replace damaged / crushed aluminium handle to communal door by flat 158 / 3 rd floor.

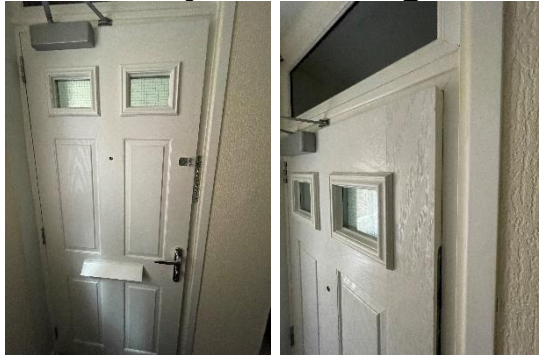
a) Flat 126 – Door is binding on slamming edge therefore not reliably self-closing.
