Fire Risk Assessment

Wallace House

Badsey Rd, Oldbury,
B69 1ER

Date Completed: 10/06/2024.

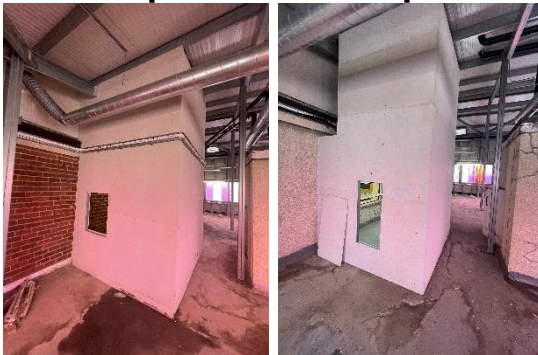
- 11) **Access panels were noted as missing from both ventilation shafts on the 12th floor. Once the repairs to the AOV (below) are completed access panels should be re-instated.**

7/11	Re-instate access panels to each ventilation shaft on the 12 th floor. <i>(Repairs / Inspection to the AOVs may need to be completed first)</i>

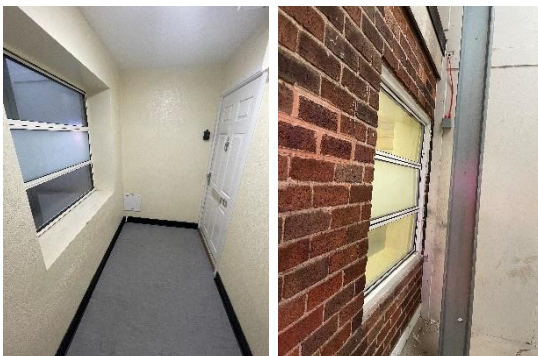
- 12) **The automatic opening vent adjacent flat 69 / 12th floor didn't open when tested during this FRA. Further inspection revealed that the AOV wasn't connected to power and the actuator appeared to be missing. WMFS will need to be informed via their portal if longer than 24hrs to repair. *WMFS have been informed, order raised to correct the defective, 6-8 weeks lead time.***

P2	Within 1-3 months Fire Rapid Response	
7/12	AOV by flat 69 / 12 th floor is not functioning and requires actuator & connecting to system.

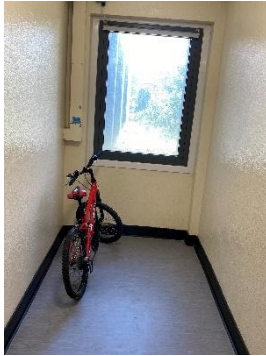
3rd floor near flats 15,16,17 – Childrens bicycle parked in communal corridor.

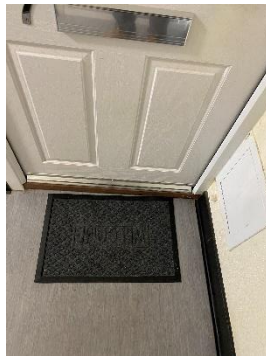
- 17) Individual floor mats were noted outside some flats. Fire rating of the mats is unknown but deemed to be of low risk.

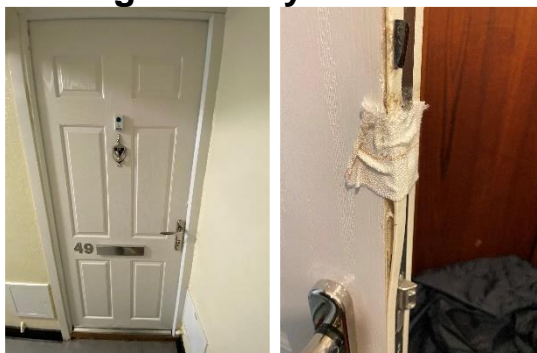
- b) Flat 49 – Trim is coming away from slamming edge. Tenant has made a temporary repair; door was observed closing correctly.

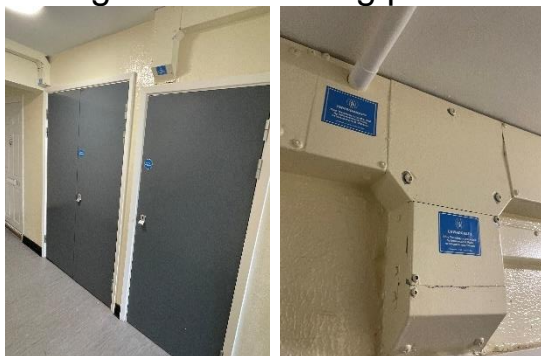
- 6) **Cover to cable trunking by flat 36 is open and requires securing.**
-

Trunking in communal corridor by flat 36 requires securing.	
Section 11	<p>Fire Fighting Equipment</p> <p>There is a fire hydrant adjacent the front main entrance.</p> <p>The dry riser inlet is located in the main entrance foyer.</p> <p>The dry riser serves all floors above ground.</p> <p>There is a CO2 fire extinguisher within the lift motor room and caretaker's office.</p> <p>There's a fire suppression system in the bin store.</p> <p>Maintenance contracts are in place to service the dry riser, chute closure plate & suppression system twice yearly and the fire extinguishers annually.</p>	Trivial
Section 12	<p>Fire Signage</p> <p>Sufficient signage is displayed throughout the building.</p>	Trivial
Section 13	<p>Employee Training</p> <p>All staff receive basic fire safety awareness training.</p>	Trivial
Section 14	<p>Sources of Ignition</p> <p>The fixed electric tests should be done every 5 years. Confirmation required that the last inspection was within 5 years.</p>	Tolerable
