Fire Risk Assessment

Wyrley House

**Sedgley Rd East,
Tipton, DY4 7TT**

Date Completed: 18/06/24

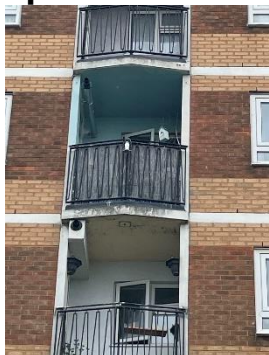
- A. **Flat 224 (4th floor) has timber / willow screening installed to balcony. This has the potential to support the external spread of fire.**

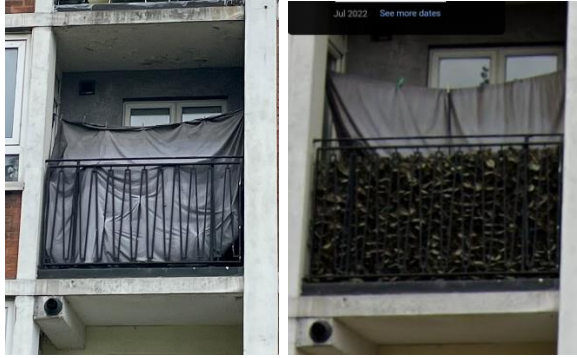
- B. **Flat 206 (2nd floor) has a large sheet which appears to be used as screening and could potentially support the external spread of flame. Historic images suggest the sheet has been in place since at least July 2022. *Second image below from July 2022***
-

06/3b	Flat 206 – Remove large sheet from balcony. Sheet is potentially used as screening as can be seen on historic images of the block.	 	P2	Within 1 to 3 months. Housing Manager	
07/20b	Flat 220 – re-instate self-closing device to flat entrance door. Assess lock / repair or replace, if necessary, as tenant states door locks him out when self-closes	 	P2	Within 1 to 3 months. Rapid Fire Response

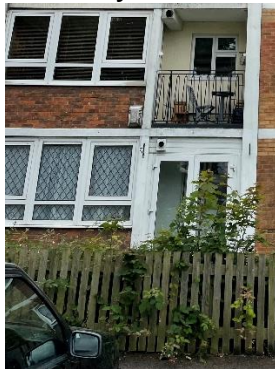
C. Flat 186 (ground floor) There are UPVC doors installed to the balcony with a section of UPVC shiplap cladding above.

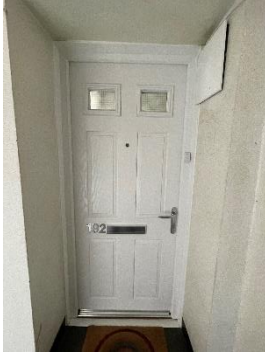
a) Flat 192 – door was correct.

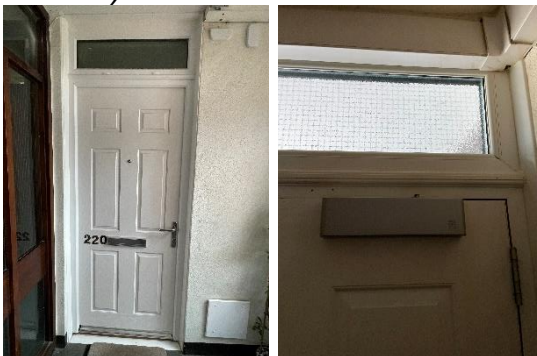
b) Flat 220 – self closing device has been removed from door. *(Tenant states the door locks him out when self closes).*

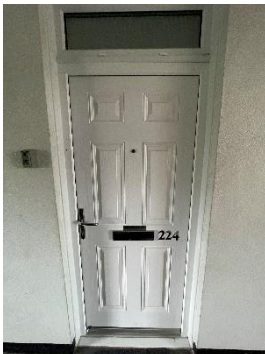
c) Flat 224 – door was correct.

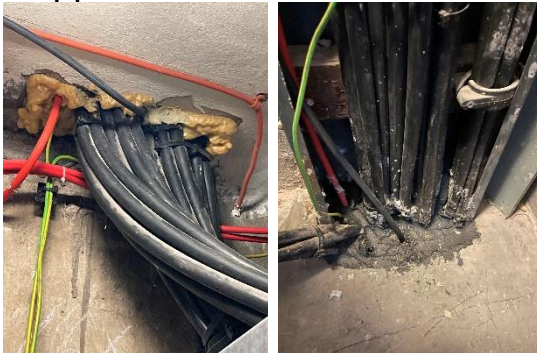
- 6) There is a minimal amount of foam present where power cables penetrate through the slab from the service cupboard to the service cupboard above (ground to 1st floor). This has not been removed due to the close proximity of live terminals within the mains distribution board. Where the cables enter the 1st floor service cupboard above the penetration has been suitably fire stopped.

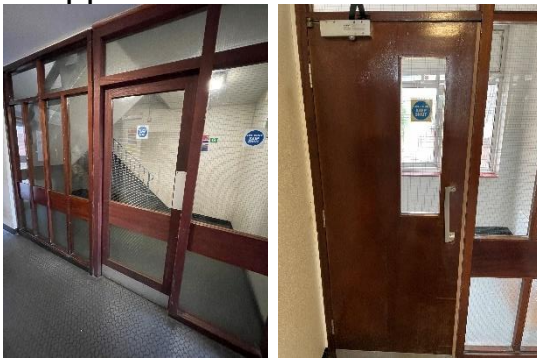
- 8) The communal corridors, landing & staircases are protected by use of notional self-closing 44mm 30-minute timber fire doors with vision panels & 25mm stops, along with 30 minute notional hardwood fire screens with GWPP glazing (stairwell). It is recognised that these doors do not meet today's benchmark of a certified FD30s fire door /screen install however, because they were installed at the time of the building's construction and to the standard of that time they are deemed as acceptable so long as the doors /screens are free of damage and function as they were intended to do so. It has been recognised that all of the landing / staircase notional doors in this block have been upgraded with combined intumescent strips & cold smoke seals to enhance their original design and minimise departures from today's standards. Were minor shortcomings have been identified, actions have been created for corrective works for example, some doors have been re-lipped with hardwood.

Observations	
<p>Some notional communal landing doors show signs of wear and tear due to age. Consideration should be given to upgrade with certified FD30s door sets, combination frames / screens as part of any future refurbishment works.</p>
