Fire Risk Assessment

Wesley Court

**Southbank Rd, Oldbury,
Cradley Heath, B64 6LQ**

Date Completed: 21/10/22

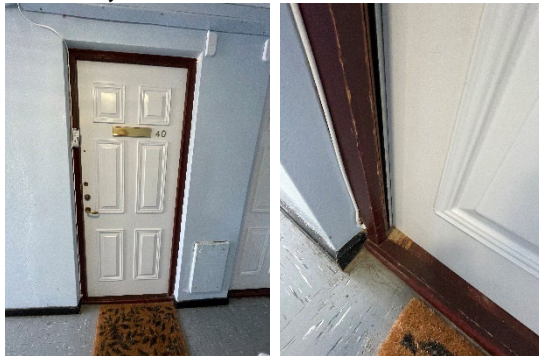
A. Flat 40 – Entrance door doesn't reliably self-close into frame, rubs on threshold.

P2	Within 3 months of action plan date. Rapid Response Fire. JM:9860778	08/11/2022
07/20a	Flat 40 entrance door requires adjustment, rubs on threshold and doesn't reliably self-close into frame.

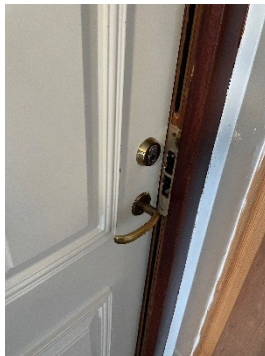
B. Flat 23 – Entrance door doesn't reliably self-close into frame. 16/03/23 replacement FD30s composite door set fitted.

P2	Within 3 months of action plan date. Rapid Response Fire. JM:9860796 JM:10206804	16/02/2023
07/20b	Flat 23 entrance door requires adjustment, doesn't reliably self-close into frame.

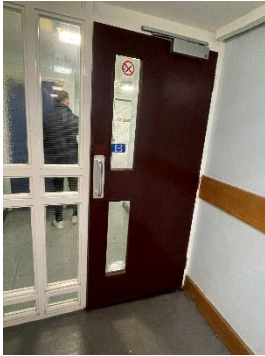
- 22) Ground floor communal door by service cupboard / dry riser has a loose handle.**

Composite door set installed.	
07/22	Ground floor communal door requires loose handle fixing.

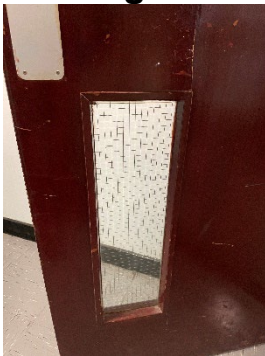
- 23) Ground floor communal door, lower glass is loose behind beading near flat 2.**

P2	Within 3 months of action plan date. Rapid Response Fire. JM:9861053	08/11/2022
07/23	Ground floor communal door by flat 2 requires loose glass panel securing within frame.

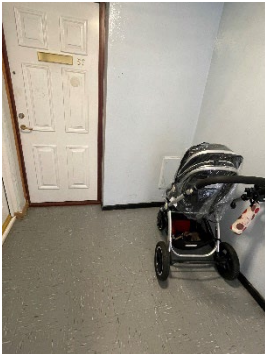
27) 9th floor outside flats 56 & 57 there is a pushchair in the communal area.

<p>P2</p>	<p>Within 3 months of action plan date. Rapid Response Fire. JM:9861074</p>	<p>08/11/2022</p>
<p>07/27</p>	<p>Pushchair in corridor outside flats 56 & 57 to be removed.</p>

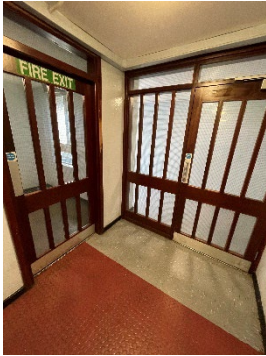
28) 8th floor - The handle is loose on both the stairwell door and communal door by flat 49.

07/28	8 th floor – handles are loose & require tightening on both stairwell door and communal door by flat 49.

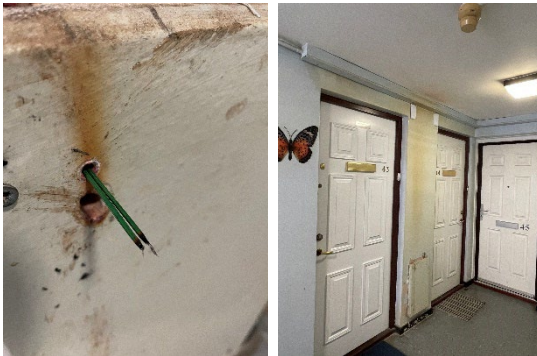
29) 7th floor - Incense sticks were found alight and wedged in a crevice outside flat 43. There is a significant amount of yellow staining to the wall above and therefore it is presumed that the burning of incense sticks in this location is a regular occurrence. At the time of this discovery the occupants of flat 43 were informed that this activity is prohibited within any communal area. The occupant was receptive to the advice given however the message should be reaffirmed by means of further communication from the housing officer.

P2	Within 3 months of action plan date. Rapid Response Fire. JM:9861571	08/11/2022
07/29	Contact occupiers of flat 43 and reinforce message not to burn incense sticks in communal corridor.

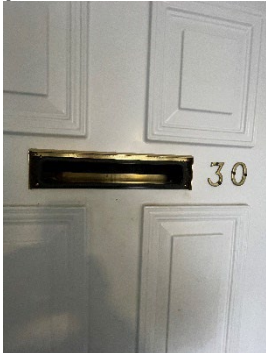
30) 4th floor Flat 30 – Outer letter box plate is missing.

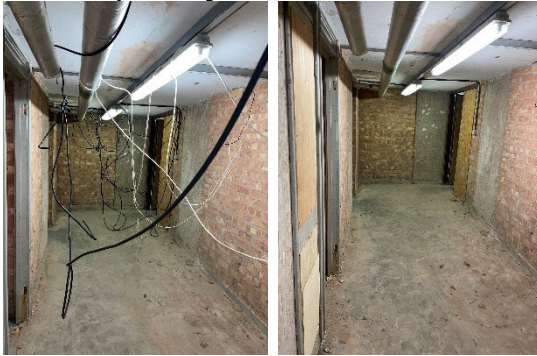
32) There were several unconnected cables tied around fittings within a basement corridor. It is presumed that the cables were put there to facilitate a WMFS training exercise. The cables were subsequently removed at the time of the FRA.

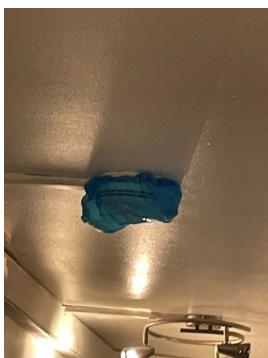
In flat 21 the 2 detectors within hall were found to be covered over. The occupier stated that they did this as temporary measure only, to avoid false actuations whilst cooking. The covers were immediately removed, and appropriate fire safety advice was given to which the occupier was receptive.

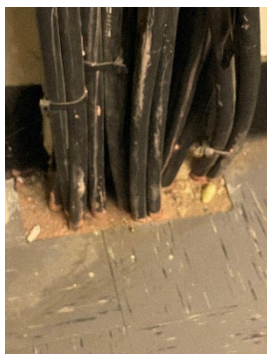
- 4) All service cupboards to communal landings are lockable. Keys are held centrally unless containing resident's meters. **The identity and therefore suitability of previously used firestopping products around cable penetrations in service cupboards between floors could not be determined, therefore it is recommended to enhance this firestopping with a suitable modern-day product.**

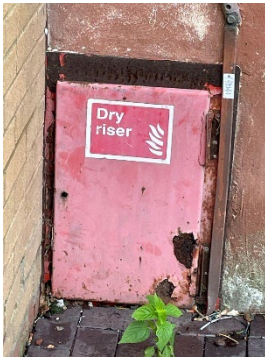
- 1) The dry riser inlet cabinet is located on the side elevation adjacent the bin store room. This is on the side of the block which borders Woodcroft Close.

The cabinet door was found to be detached from its hinges however this has since been rectified prior to the FRA being written. The door is secured by means of a budget lock. A budget key has been placed in the white firemans box above the front entrance.

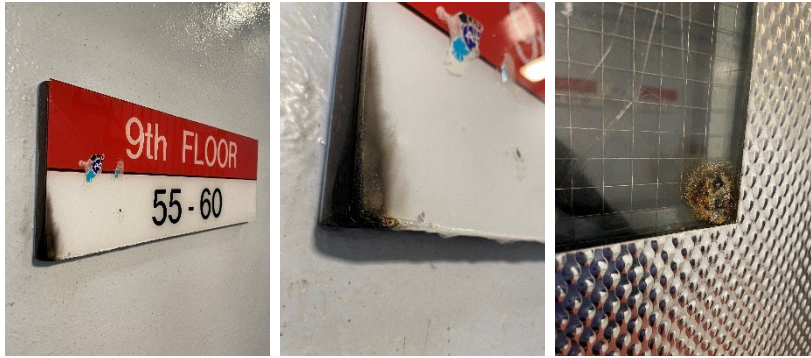
- 4) There is some evidence of arson to the 9th floor landing stairwell signage, resulting in some minor damage from applied heat to the lower left-hand corner. There is also a small area burnt to the vision panel of the lift car door on the 8th floor. Both items are still functional.
-

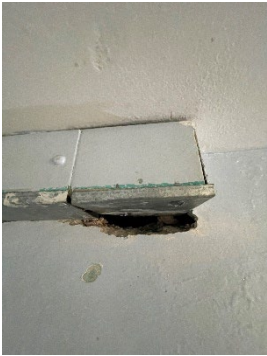
<p>P3</p>	<p>Within 3 months of action plan date. Rapid Response Fire. JM:9861058 JM:10992120</p>	<p>29/06/2023</p>
<p>07/26</p>	<p>11th floor by flat 72 firestopping required to hole beneath trunking on service cupboard wall.</p>

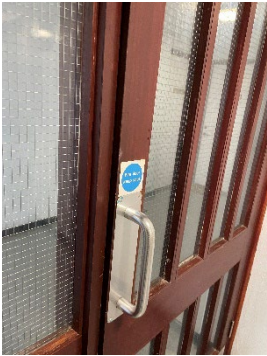
P2	Within 3 months of action plan date. Rapid Response Fire. JM:9861591	08/11/2022
07/31	1 st floor communal door by flat 7 not reliable self-closing into frame, requires adjustment.

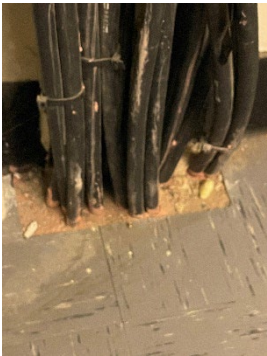
P2	Within 3 months of action plan date. Rapid Response Fire. JM:9861606	08/11/2022
10/04	Enhance firestopping around cable penetrations in all service cupboards.
